**CAT Report 2257  
Issued March 2026**

**Historic building recording of  
The Old Palace, 23 Kneesworth Street, Royston,  
Hertfordshire, SG8 5AB**

**CAT project ref.: 2025/12g  
CAT Report 2257  
OASIS id: colchest3-540229**

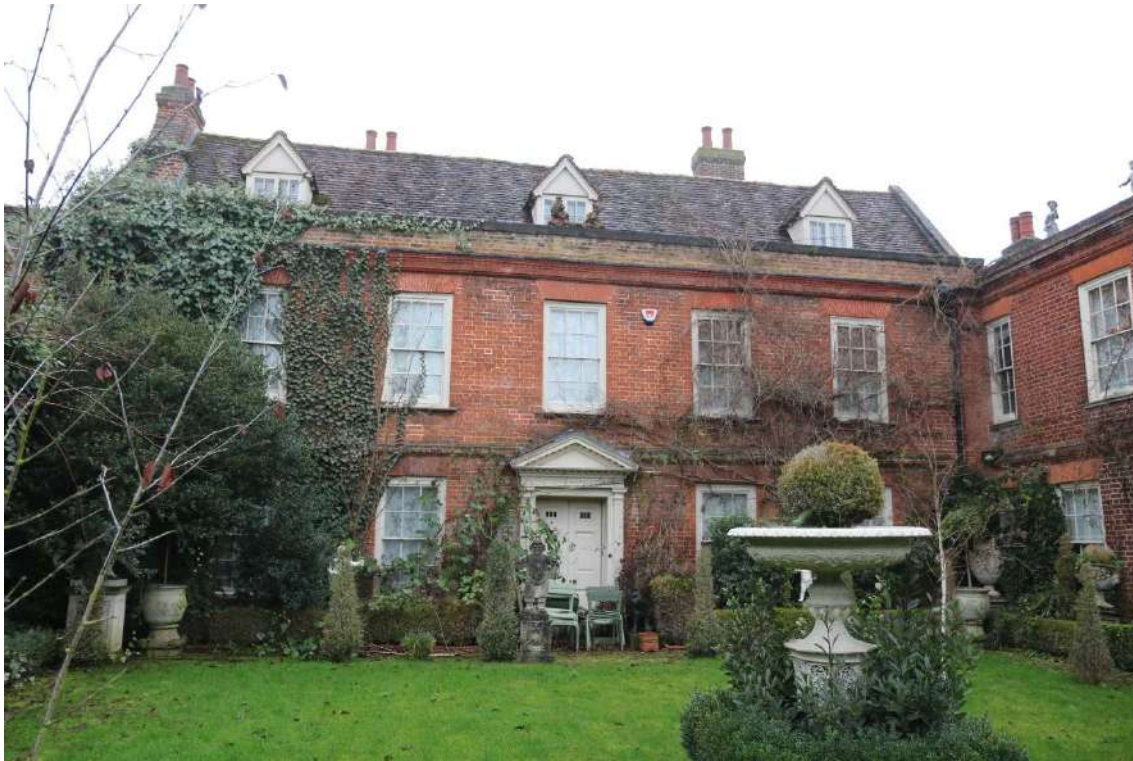
**Photograph 1** North-eastern elevation of range 1. Photograph taken facing west south-west.

The north-eastern elevation of range 1 comprises red brick (brick dimensions: 220 x 100 x 60mm) laid in Flemish bond (Photograph 1). It has symmetrical fenestration, comprising nine twelve-light sash windows, each of which is flanked by queen closer bricks (Photograph 2), indicating that all the openings are original to the brickwork. In the centre of the elevation is a modern door, with a decorative surround comprising fluted Doric pilasters, a running-fret frieze and moulded cornicing topped with triangular pediment. The lack of obvious queen closers suggests that this doorway is either inserted or, more plausibly, has been expanded to accommodate a larger door. A second, smaller door is present at the south-eastern end of the elevation. Decorative moulded brickwork is present at the top of elevation as well as between the ground and first floors (Photograph 2). The decorative brickwork continues along the north-eastern elevation of range 3 (Photograph 3).

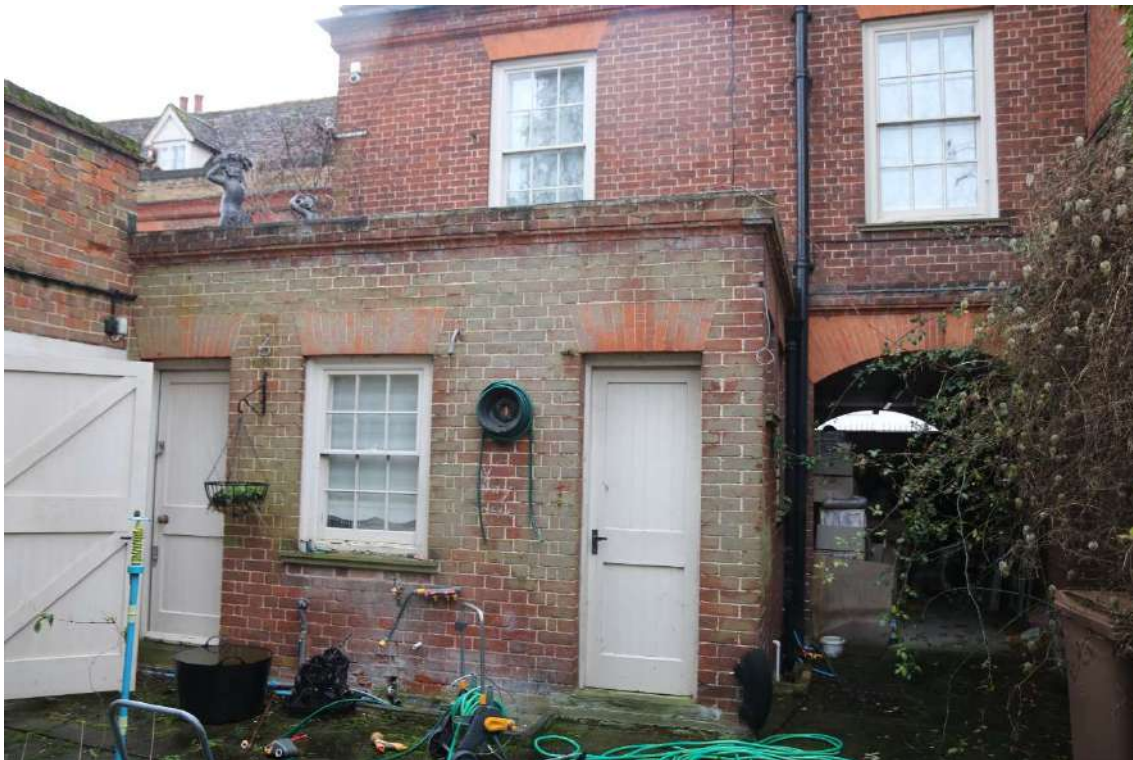
**Photograph 3** North-eastern elevation of range 3. Photograph taken facing south south-west.

Range 3 also comprises red brick (brick dimensions: 225 x 110 x 65mm) laid in Flemish bond. There are two doors in this elevation of range 3, both of which have flat-arch brick lintels and stone steps, along with three sash windows, all of which are surrounded by queen closers. The arched opening of the passageway has a substantial arched brick lintel with a central brick keystone.

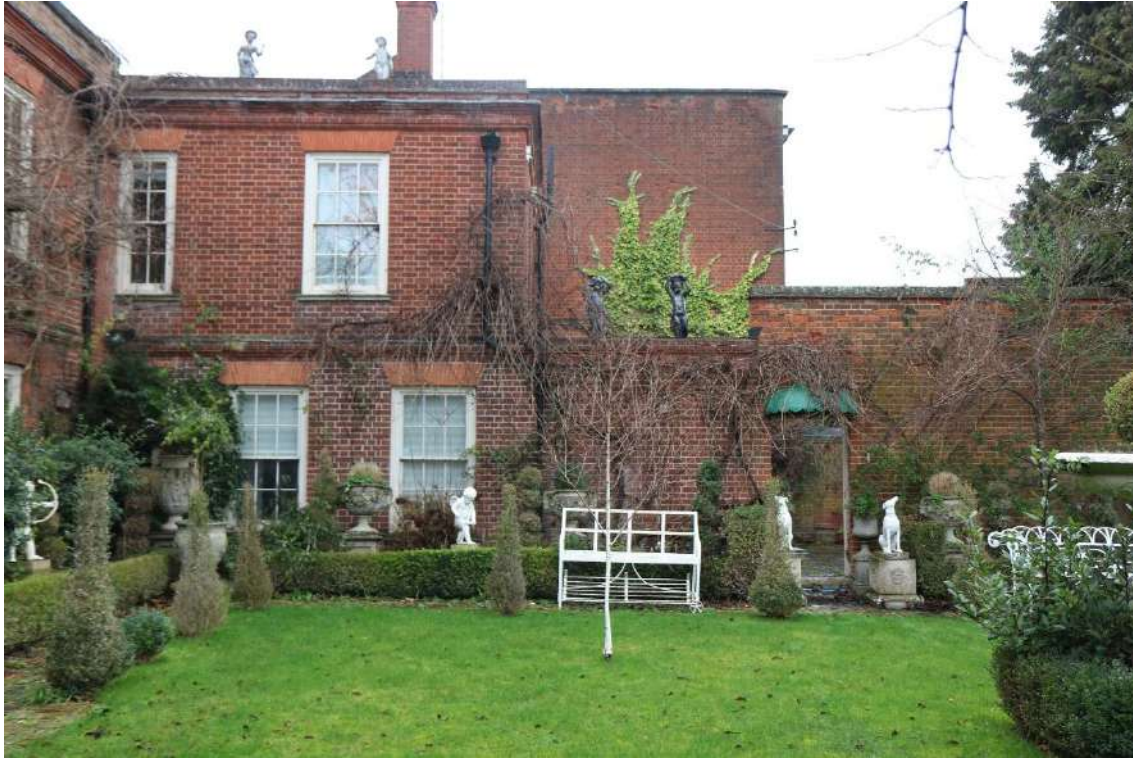
**Photograph 4** South-eastern elevation of ranges 3 and 4. Photograph taken facing north-west.

A further four sash windows are set into the south-eastern elevation of range 3 (Photograph 4), along with a narrow doorway, again all flanked by queen closers. The decorative brickwork continues along this elevation. A large, red brick chimney, with oversailing brickwork, is visible from this elevation, projecting from the roof of range 3.

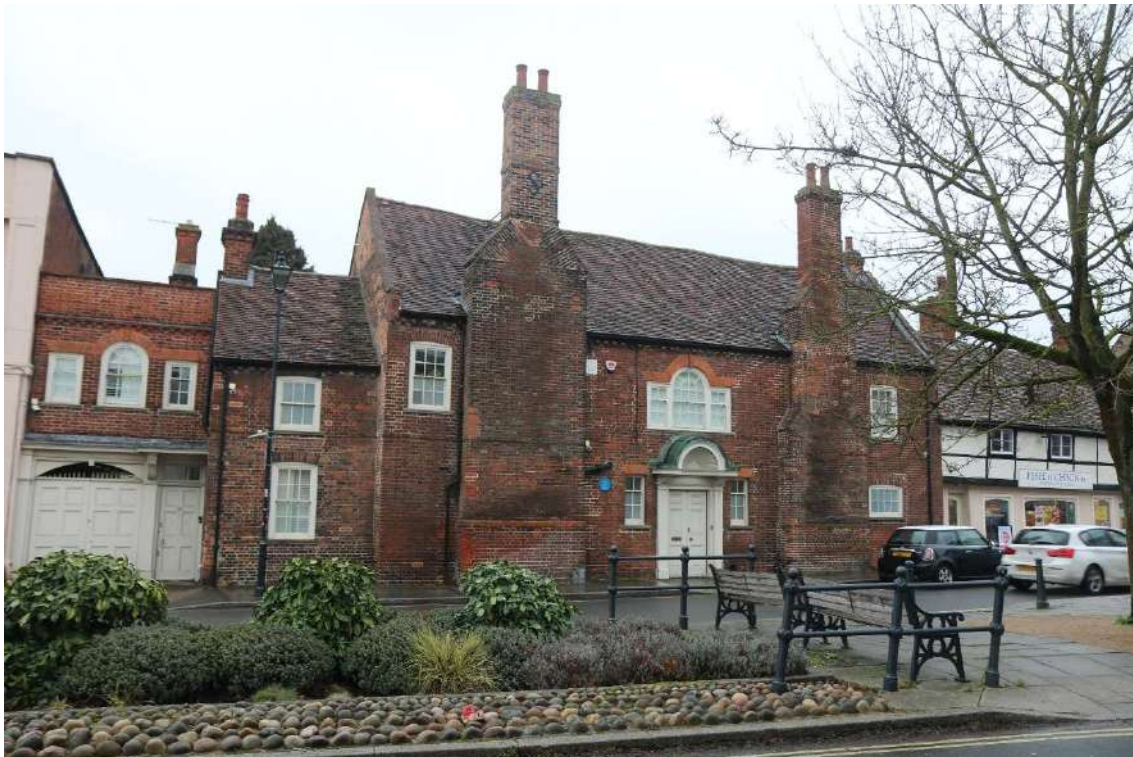
**Photograph 5** South-western elevation. Photograph taken facing east.

The south-western elevation of range 1 comprises red bricks (brick dimensions: 220 x 105 x 60mm) in a Flemish bonding pattern. Two large chimney breasts project from this elevation (Photographs 5, 6 & 7). The north-western chimney is the taller of the two, with a single set of shoulders, and comprises red brick, with occasional yellow bricks, (brick dimensions: 225 x 105 x 60mm) laid in Flemish bond. Several courses of oversailing bricks are present in the stack, while a chamfered course of bricks are located towards the base of the breast. Queen closers run up both edges of the chimney breast, and an S-shaped anchor plate is positioned towards the base of the stack. The south-eastern chimney is constructed from slightly smaller bricks (brick dimensions: 215-220 x 105 x 55mm) laid in a rough English bond. While this chimney breast has a chamfered course at the same height as the other, the stack is plainer with oversailing brickwork only used for the top courses. This breast also has two sets of shoulders as opposed to one.

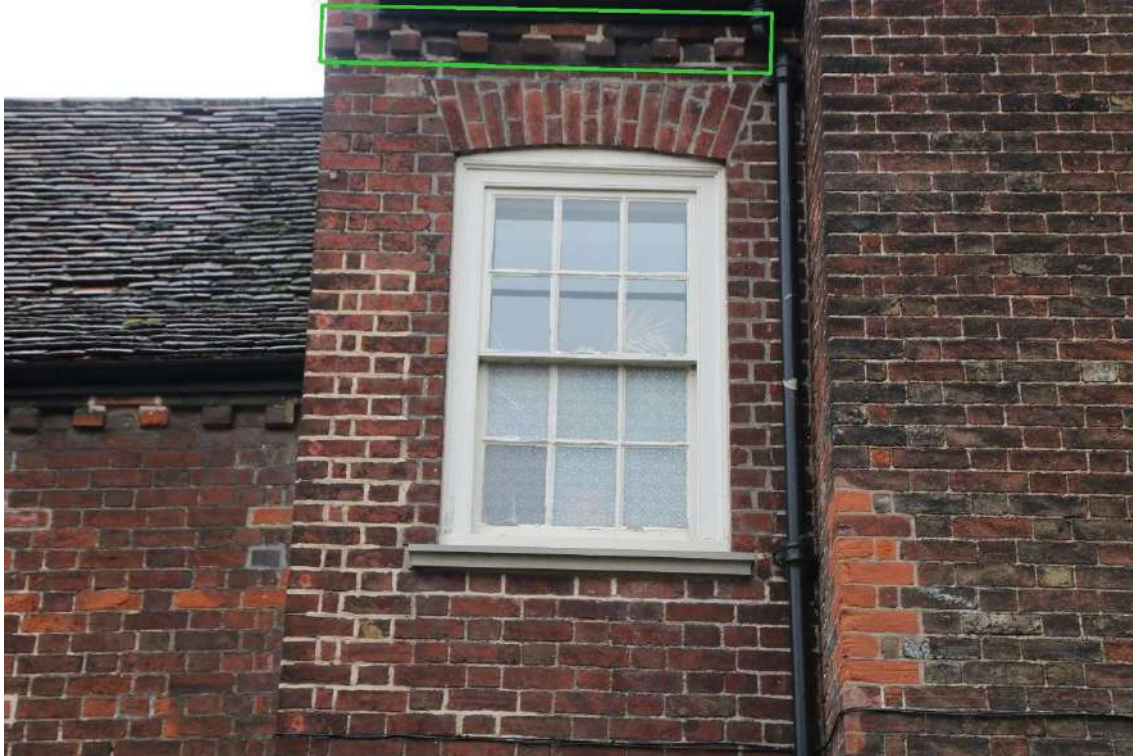
**Photograph 8** Detail of window in south-western elevation of range 1, first floor. Dentilled brickwork highlighted in green. Photograph taken facing north-east.

light sashes and one eight-light fixed window, with arched brick lintels. None of these windows are flanked by queen closers suggesting they have been inserted into the elevation (Photograph 8). Along the eaves of range 1 there is dentil pattern brickwork, with alternating protruding headers (Photograph 8). This decorative dentil detailing continues across ranges 2 and 3.

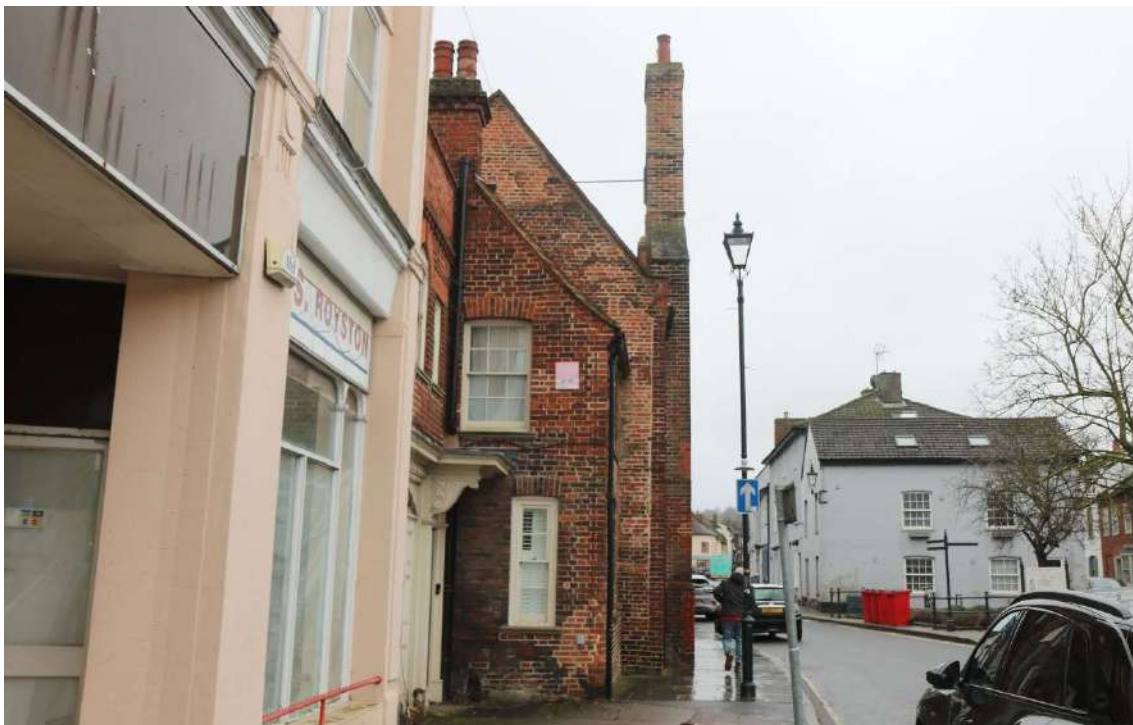
**Photograph 10** North-western elevation. Photograph taken facing south-east.

The north-western elevation is largely obscured by the neighbouring building (Photograph 10). There is an obvious change in the brick work on range 1 in this elevation, with the bricks used for the gable wall smaller (brick dimensions: 220-225 x 105 x 55mm) than those of the street-facing façade

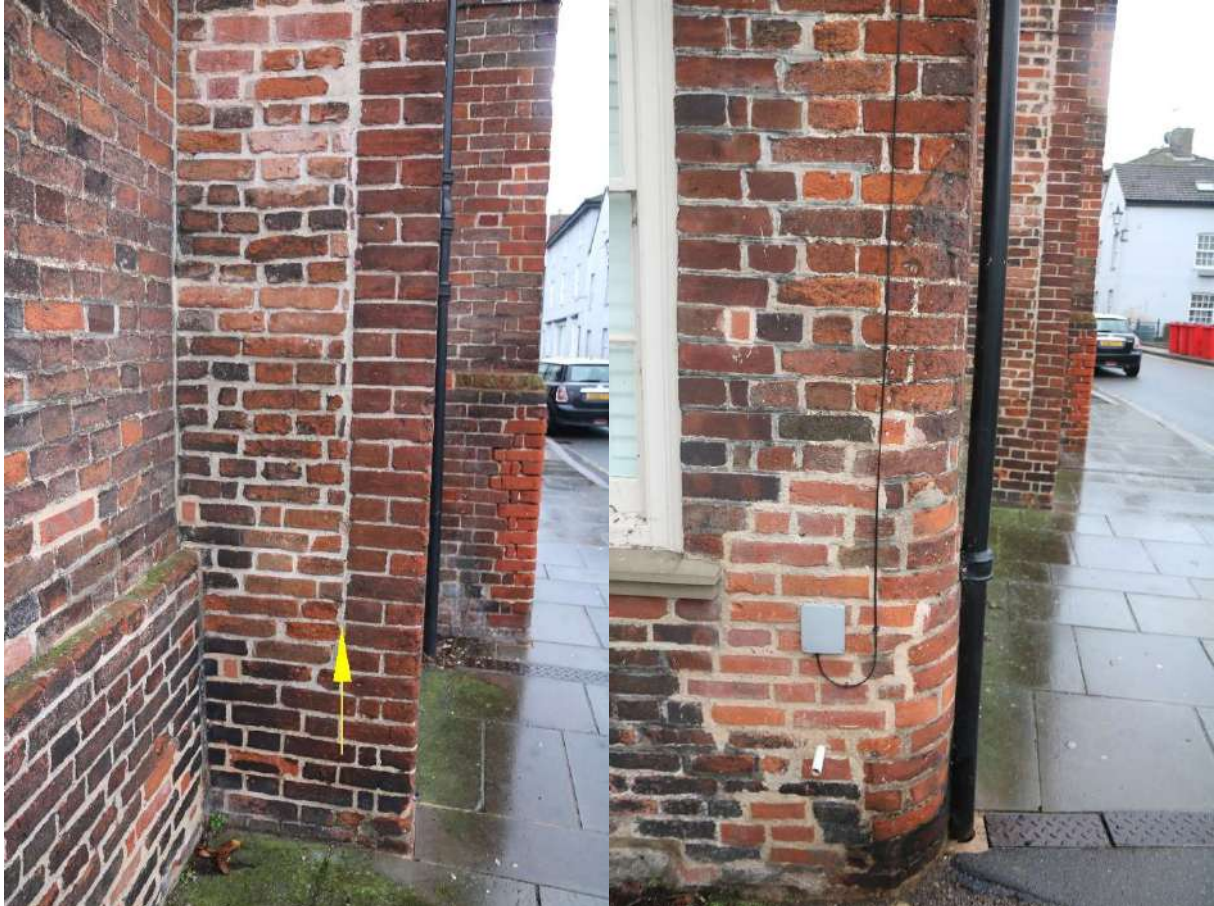
**Photograph 11** Detail in change in brickwork, highlighted by the yellow arrow, north-western elevation of range 1. Photograph taken facing south south-east.

(Photograph 11). Range 2 has two windows set into this elevation, both flanked by queen closers with arched brick lintels. The corner of range 2 has been rounded at ground level on this elevation (Photograph 12). Two sash windows and a fixed window are present on range 3, all surrounded by queen closers.

**Photograph 12** Detail of curved corner on north-western elevation of range 2. Photograph taken facing south-east.

The original brickwork of the palace can be observed in the north-western and south-eastern (although this elevation is largely obscured) elevations, from which it is evident that the street facing façade of the Old Palace has been rebuilt. The original bricks are smaller and laid in a rough English bond, which contrasts the regular Flemish bond of the south-western elevation. Both the bonding patterns and brick sizes are indicative of their respective periods of construction. English bond is accepted to be the first recognisable pattern in brickwork, emerging in the 16th century, with the thin bricks (~55mm thick) also typical of this period. Flemish bonding became the prevailing choice for brickwork by the end of the 17th century with bricks increasing in width (~60mm thick) from the middle of the century.

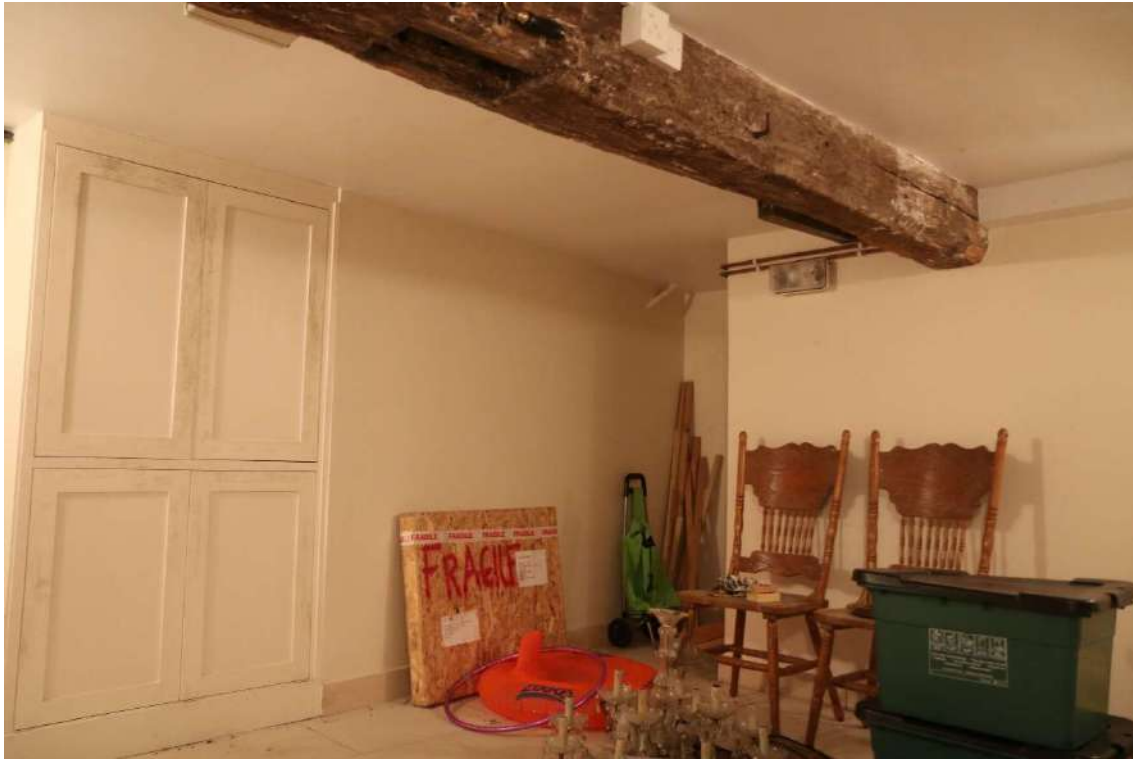
**Photograph 13** Interior of basement. Photograph taken facing south.

The basement of the Old Palace is located beneath range 1, accessed via a set of modern timber stairs. Although largely modernised, a large hand-sawn binding-beam is exposed in the ceiling of the basement (Photograph 13). An empty mortice is present in the underside of the beam, possibly an indication the timber is reused (Photograph 14). A small section of a second binding-beam is also exposed above the entrance from the stairs. An in-built cupboard is present in the south-eastern wall.

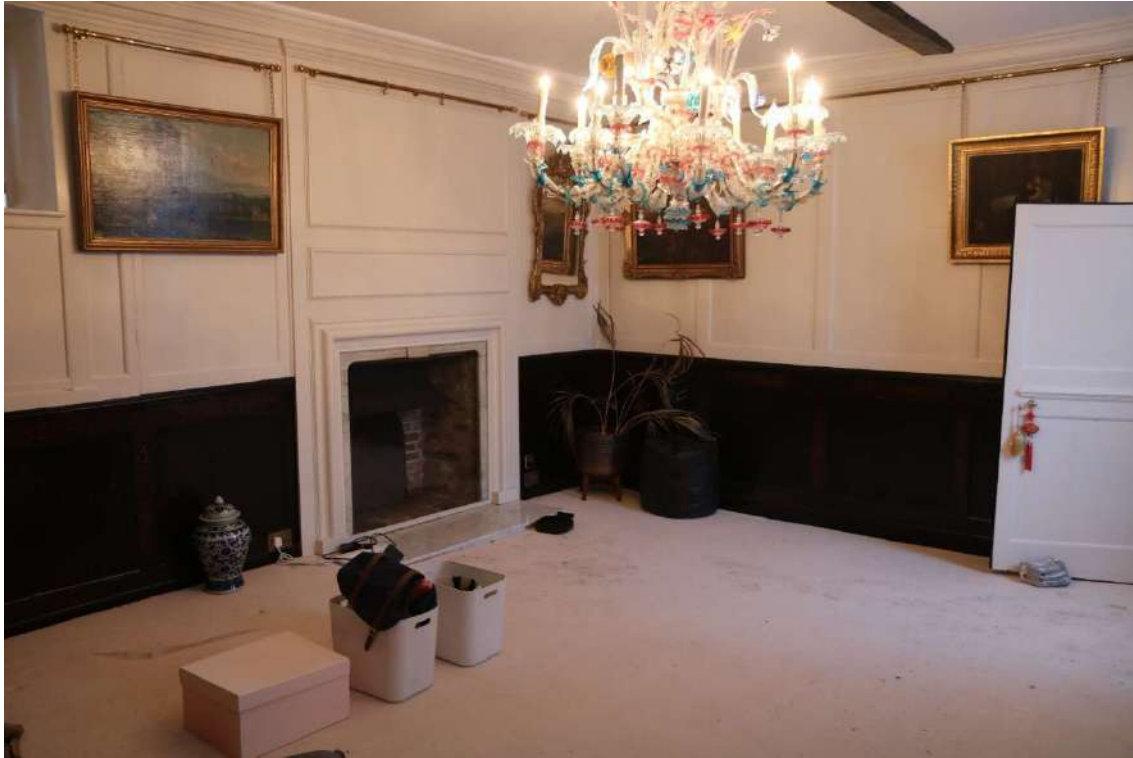
**Photograph 15** Interior of drawing room. Photograph taken facing west.

Occupying the south-eastern limit of the ground floor, the drawing room (Photograph 15) has several exposed beams in its ceiling, which are chamfered with lamb's tongue stops (Photograph 16). A large Murano glass chandelier hangs from the ceiling. The walls of the drawing room have ovolo panelling with a dado rail, the upper of which are painted white while the lower are stained dark with a foliage design. There is a door in the north-western, north-eastern and south-eastern walls. The north-western door is a simple two-panel door, with a brass lock case and H-hinges. There is a continuation of the dado rail across the central rail of the door and the same painted foliage pattern as the panelling is present (Photograph 17). The south-eastern door is the same style as the north-western, minus the foliage pattern and brass lock case. The north-eastern door is four-panel exterior door, the top two panels of which appear to form a shutter. It has a brass lock case and a plain surround. Two sash windows are present in the north-eastern wall with one fixed window in the south-western wall. A fireplace is in the south-western wall, with a timber surround, marble chimney piece and an iron fireback and hood. Hinges in the panelling adjacent to the fireplace suggest that a now blocked cupboard is located in the wall. Built into the south-eastern wall is a round-headed cupboard. It has panelled doors, with a moulded architrave, and a decorative faux keystone (Photograph 18).

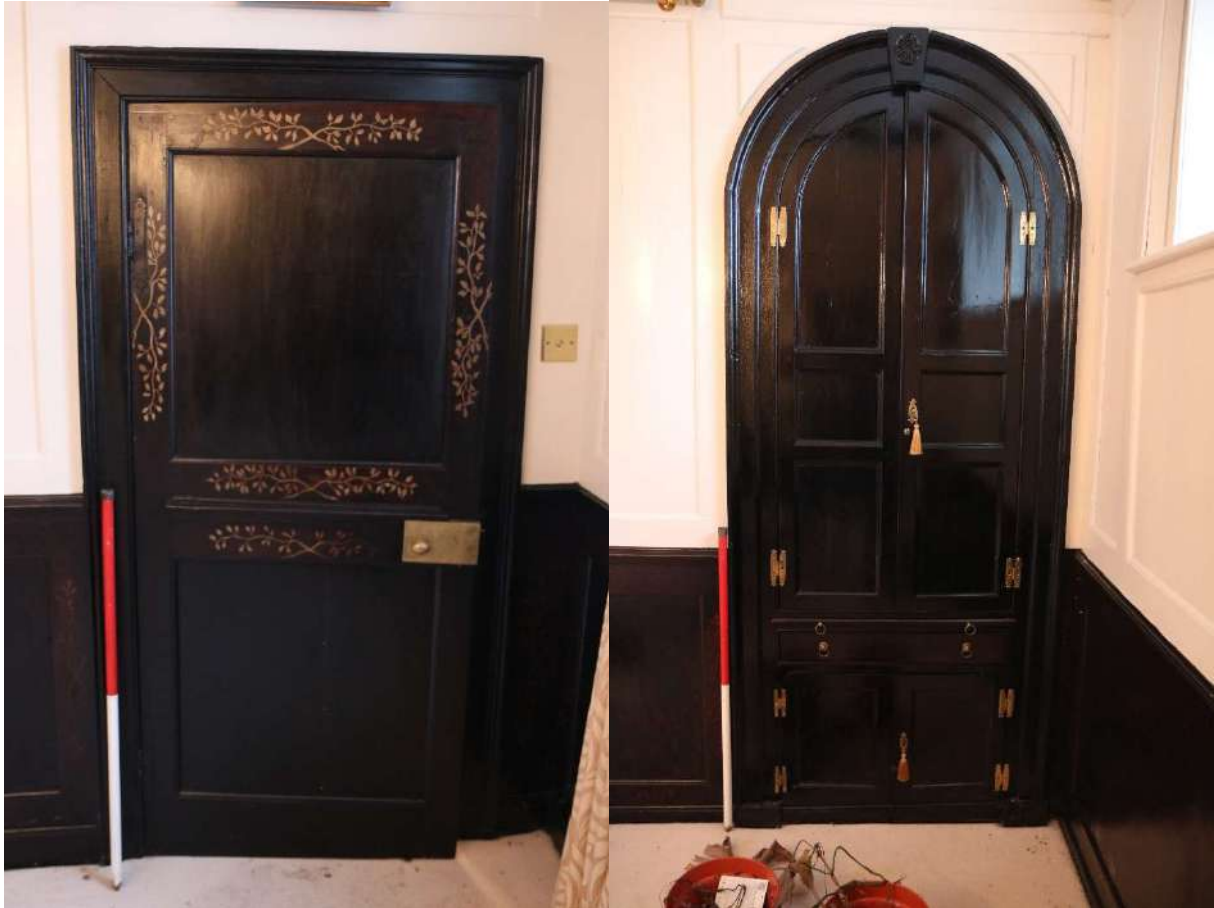
**Photograph 17** Detail of door in north-western wall of drawing room. Photograph taken facing north-west.

**Photograph 18** Detail of built-in cupboard in south-eastern wall of drawing room. Photograph taken facing south-east.

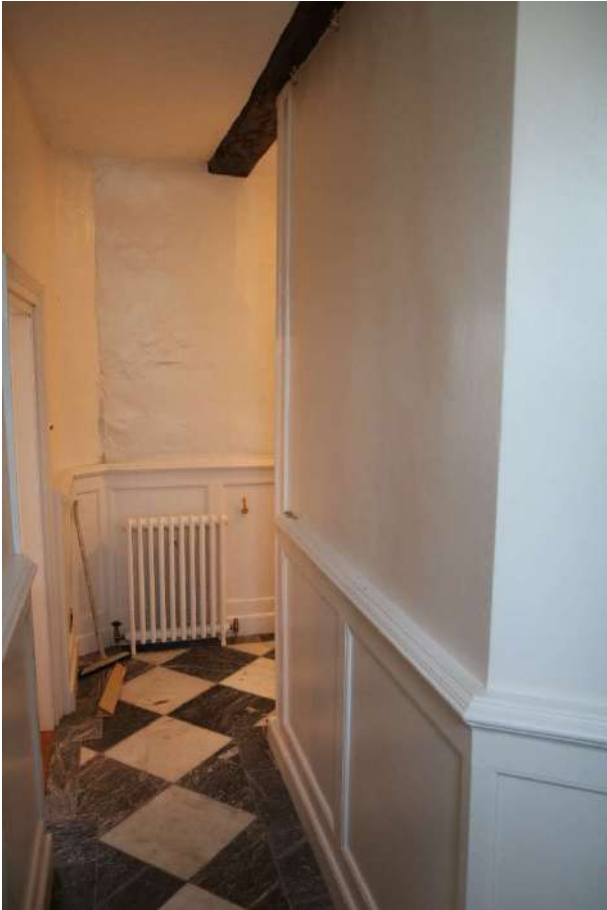
**Photograph 19** Interior of entrance hall 1.  
Photograph taken facing east.

Entrance hall 1 (Photograph 19) is a C-shaped room, adjacent to the drawing room. Several hand-sawn beams are exposed in the ceiling, some of which display curved lamb's tongue stops and have chamfered edges. The lower half of the wall is panelled, with a moulded dado rail. Doors are present in four walls. In opposing walls are a two-panel door and a six-panel door, both of which have small brass knobs. The final two doors comprise pairs of modern three-panel doors. Two small windows flank the door in the south-western wall.

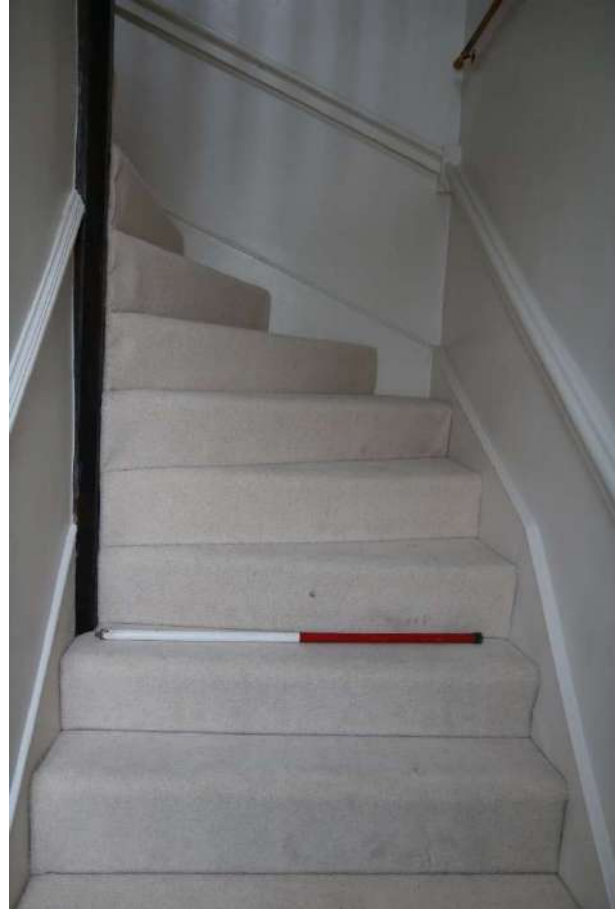
**Photograph 20** Detail of staircase 1. The  
hand-carved newel post  
visible to the left. Photograph  
taken facing south-west.

In the centre of entrance hall 1 is staircase 1 (Photograph 20), which continues from the ground floor to the attic. It has a central hand-sawn newel post, that extends for the entire height of the staircase. The stairs are of a dog-leg type with a winder. Along the outer wall of the stairs is a round-topped handrail with corner anchor points while the inner wall has a moulded dado rail.

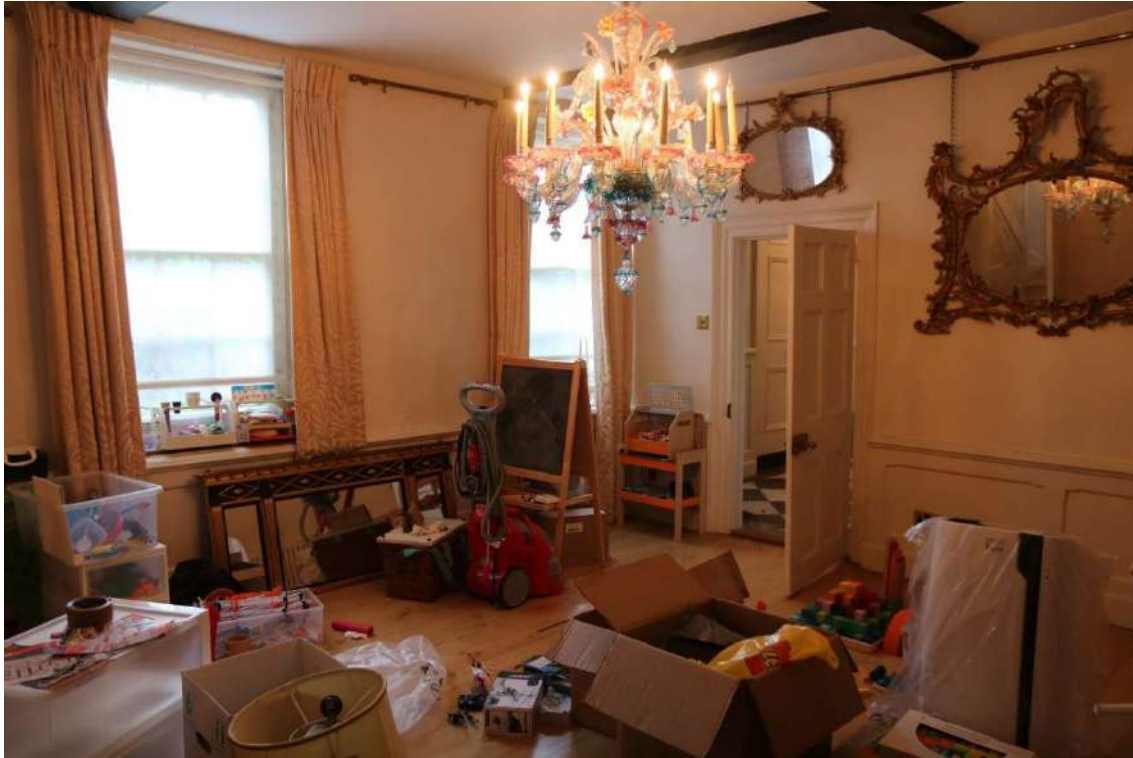
**Photograph 21** Interior of dining room. Photograph taken facing east.

The dining room (Photograph 21) also has exposed hand-sawn beams in the ceiling with lamb's tongue carved stops, between which hangs a large Murano glass chandelier. Timber panelling lines the lower portion of the walls, which is topped with a moulded dado rail. There is a four-panel door in the north-western wall and a six-panel one in south-eastern wall. Both have brass lock cases and concealed butt-hinges. Two sash windows are set into the north-eastern wall. A large fireplace is in the south-western wall, which has a timber surround and a stone chimney piece (Photograph 22). A number of pieces of iron fireplace furniture are within the large opening, which has been lined with modern tiles, along with a small wooden door in the back.

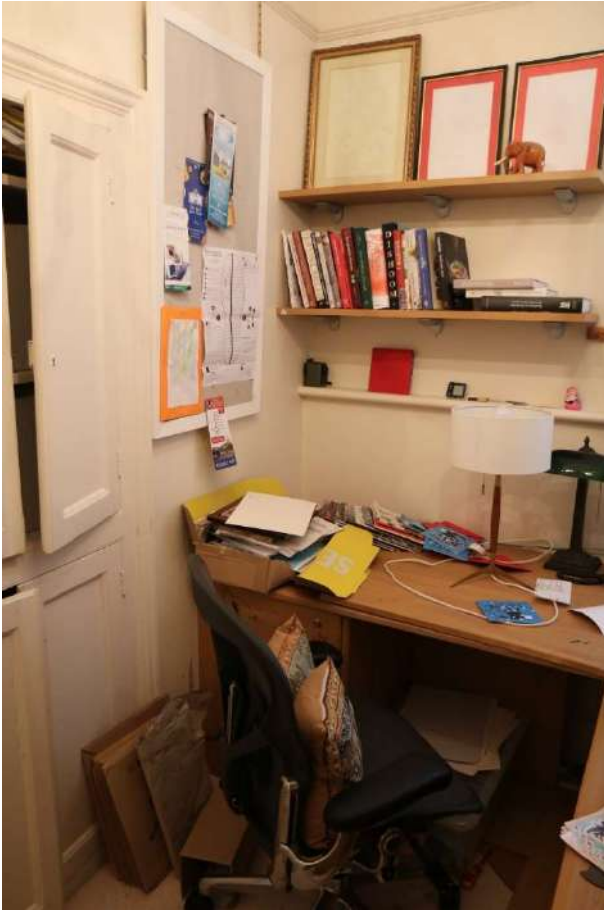
**Photograph 23** Interior of study. Photograph taken facing south.

In the study (Photograph 23), which dominates much of the ground floor of range 2, there is a moulded picture rail along each wall, which is interrupted by a shuttered sash window in the south-western wall, and a moulded skirting board. An in-built cupboard is present in the south-eastern wall, which has two sets of double doors and is surrounded by a decorative architrave. The door in the south-eastern wall has four-panels. Adjacent to the study is a modern restroom which has a four-panel door.

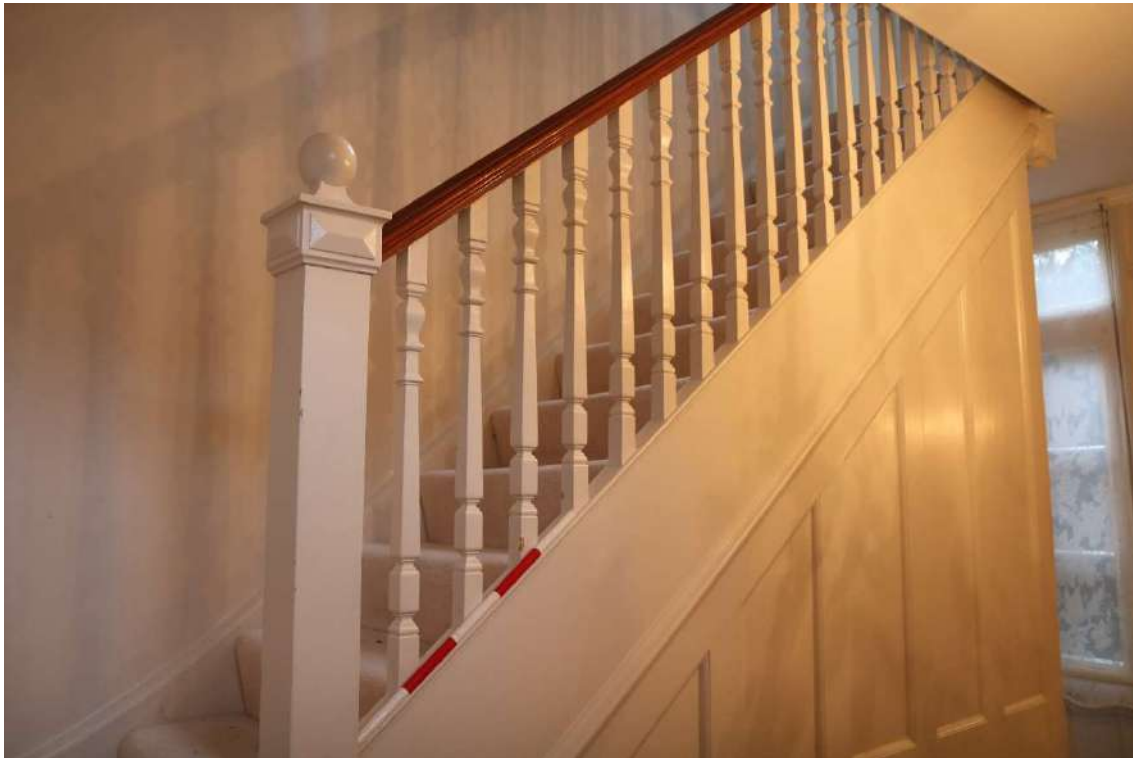
**Photograph 24** Detail of newel post, handrail and balusters of staircase 2. Photograph taken facing east.

Entrance hall 2 straddles ranges 2 and 3. Cornicing is present at the top of each wall, below which is a picture rail, with a skirting board along the base. The sash window in the north-western wall interrupts both the cornicing and picture rail. Multiple doors are located in the three walls, largely comprising four-panel doors with brass knobs and decorative key plate covers, except the main entrance which is a modern six-panel door. Above the doorway between entrance hall 1 and the kitchen is a pair of servant bell boards (Photograph 25). Staircase 2 is against the north-eastern wall of the entrance hall. The stairs are a straight flight with a winder at ground floor level and have a closed stringer along with a panelled spandrel (Photograph 24). The balustrade has a tall newel post, topped with a ball finial, moulded decorative balusters and a round-topped handrail. At the top of the stairs hangs a simple domed pendant.

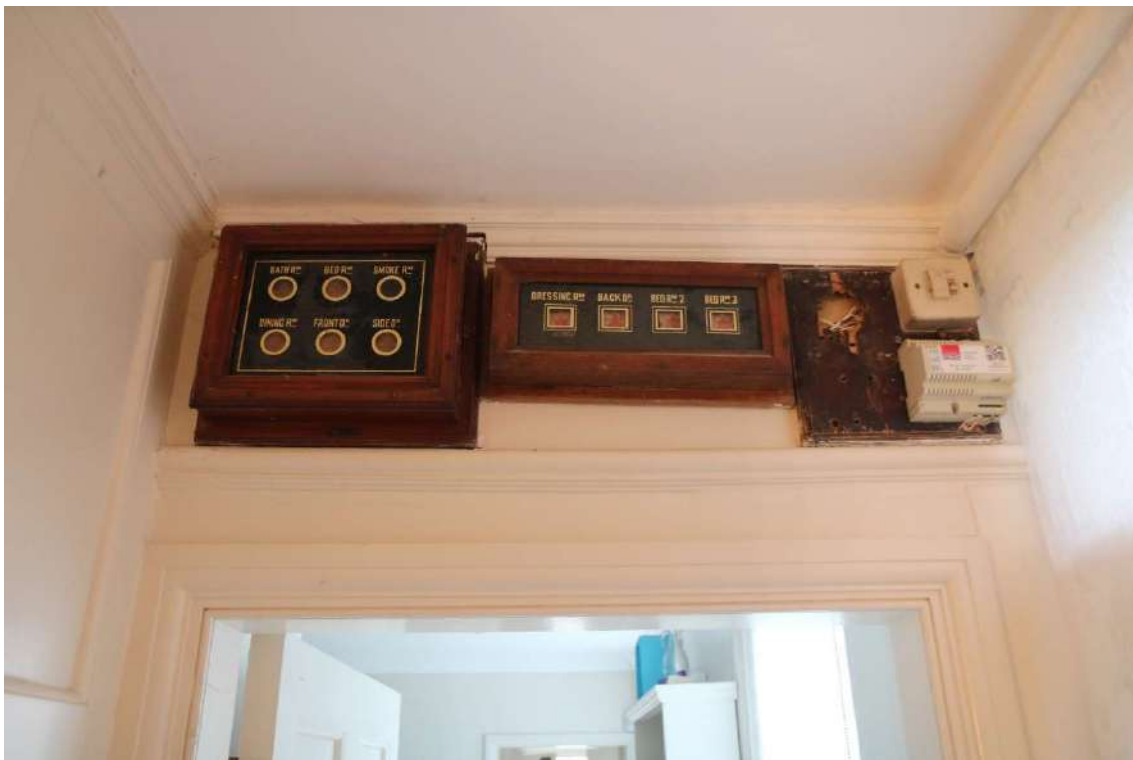
**Photograph 25** Detail of butler's bell boxes on north-eastern wall of entrance hall 2. Photograph taken facing north-east.

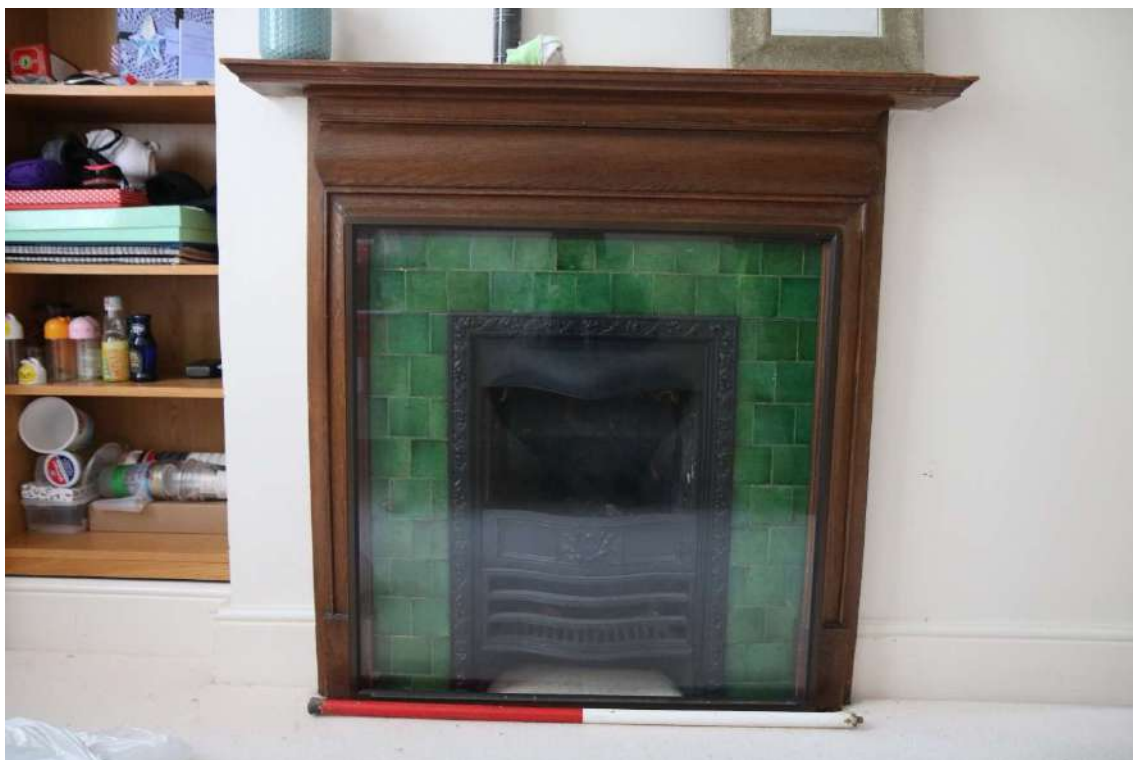
**Photograph 27** Detail of fireplace in south-eastern wall of bedroom 1. Photograph taken facing south-east.

Bedroom 1, located in range 3, has decorative cornicing and picture rail with a simple skirting board. There is a single sash window, which interrupts the picture rail, in the north-eastern wall and a four-panel door in the opposite wall. A chimney breast projects from the south-eastern wall with an Arts and Crafts style fireplace, which has a timber surround, green-glazed tiles and an iron fire grate (Photograph 27).

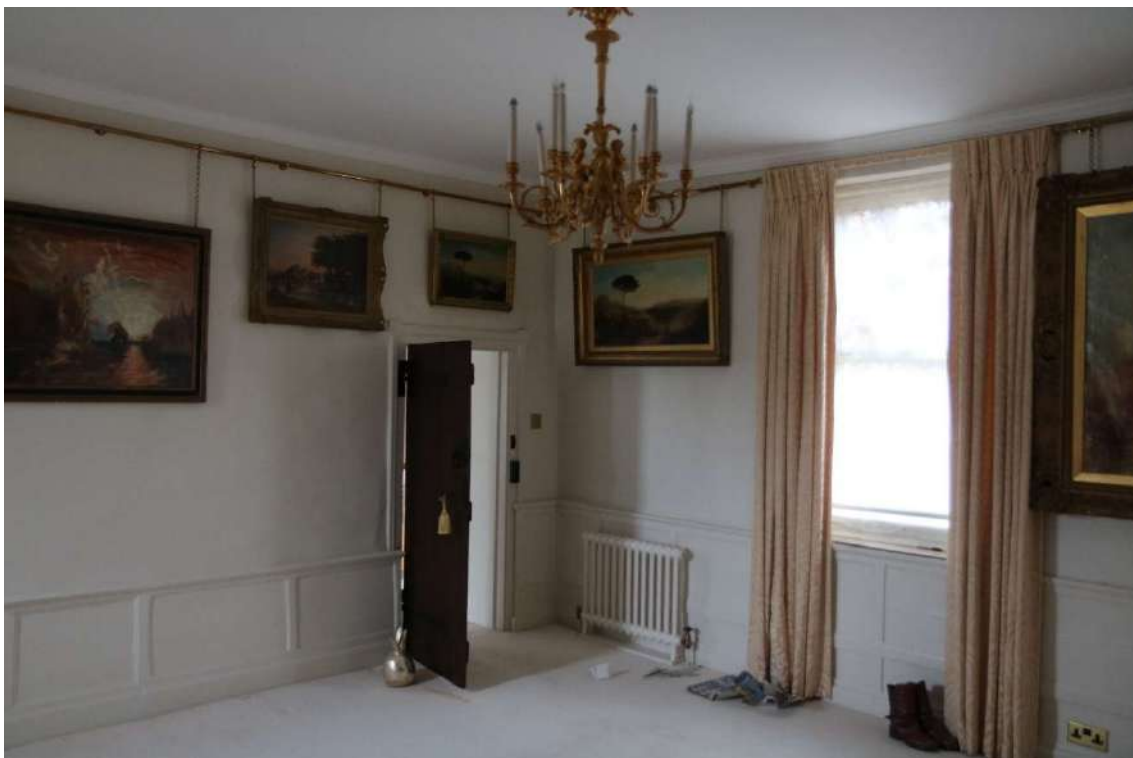
**Photograph 30** Interior of bedroom 4. Photograph taken facing north.

Around the top of the walls of bedroom 4 is moulded cornicing, while the lower portion of the walls are covered with panelling (Photograph 30). A decorative frieze is present along the south-eastern wall, with a geometric pattern. Two sash windows are present in the north-eastern wall while a single

window is in the south-western wall, which has timber shutters. The fireplace, in the north-western wall, has a moulded timber surround with a marble chimney piece and Delft tiles depicting coastal scenes. There is a cast iron grate in the fireplace and a marble hearth.

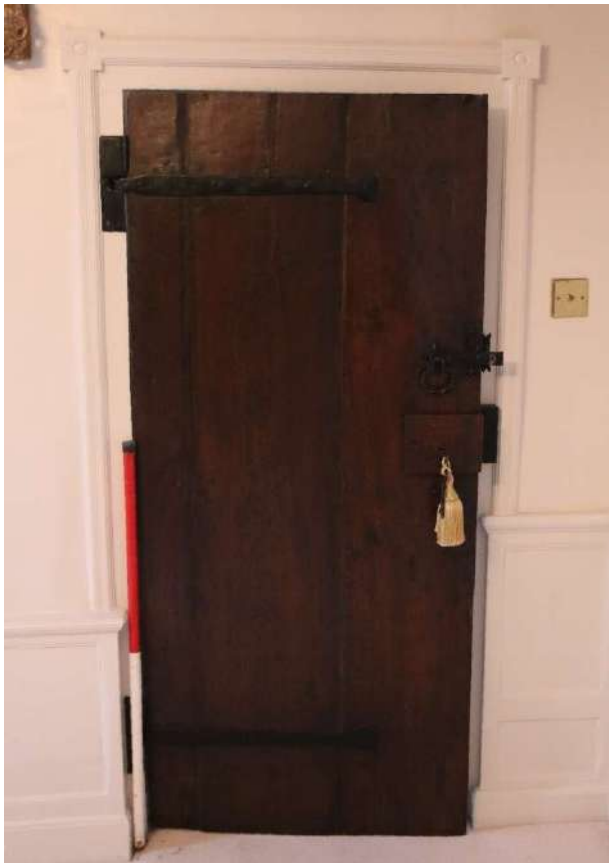
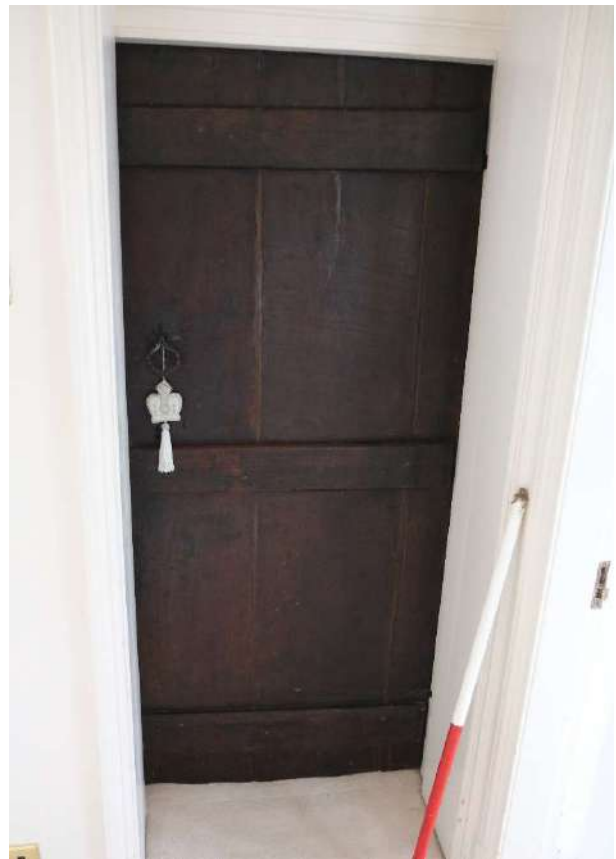
**Photographs 31 & 32** Detail of door in north-western wall of bedroom 4. Photographs taken facing north-west (31) and south-east (32).

Directly opposite one another, there are doors in the north-western and south-eastern walls. The north-western door is a plank and batten door (Photographs 31 & 32), which is formed from three irregular sized planks secured with three battens that have chamfered edges. It is hung with iron strap hinges with round ends. There is a bar-type door latch, with a barley twist drop handle and star-shaped backplate, which is a later replacement. The door also has a timber lock case beneath the door latch. The south-eastern door is a double-thickness plank door, with the outer face comprising three roughly equal width vertical planks, separated by crease mouldings, while the inner face has six horizontal planks (Photographs 33 & 34). Decorative ended strap hinges secure the door; a later architrave has been fixed over the base plate of the hinges (Photograph 35). There is a door latch, the same style as the other door, and a timber lock case.

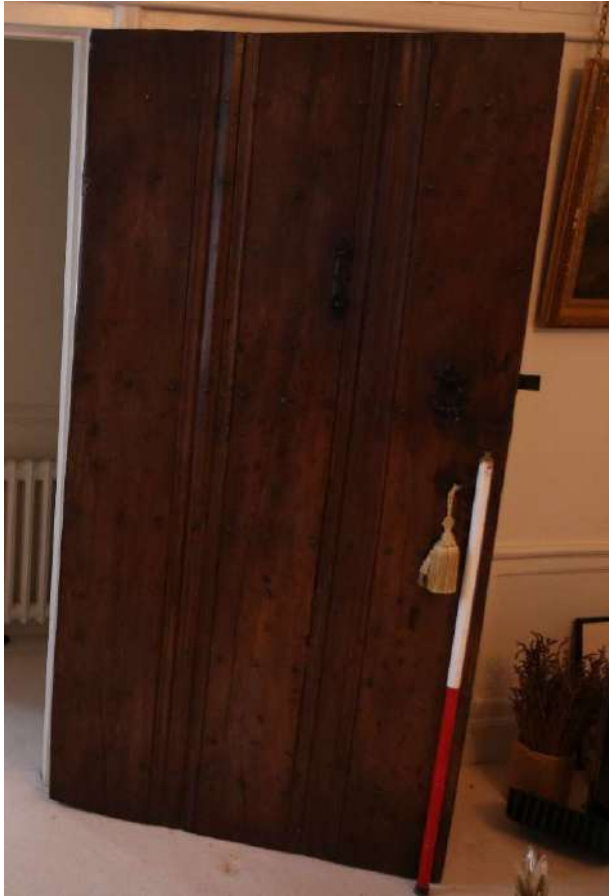
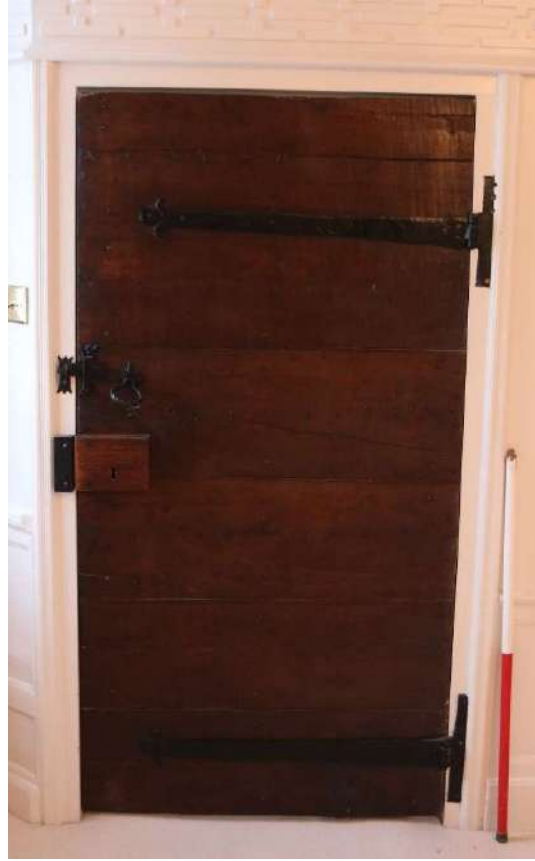
**Photograph 33 & 34** Detail of door in south-eastern wall of bedroom 4. Photograph taken facing south-east.

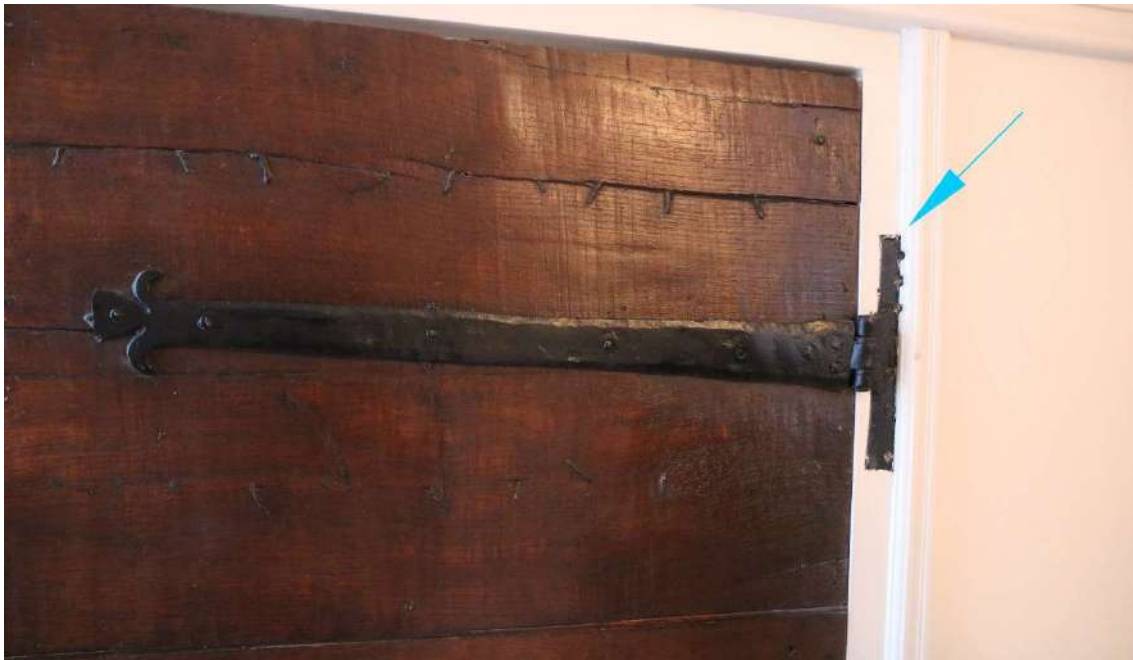
**Photograph 35** Detail of strap hinge on door in south-eastern wall of bedroom 4. Blue arrow highlighting the architrave sealing the plate of the hinge Photograph taken facing south-east.

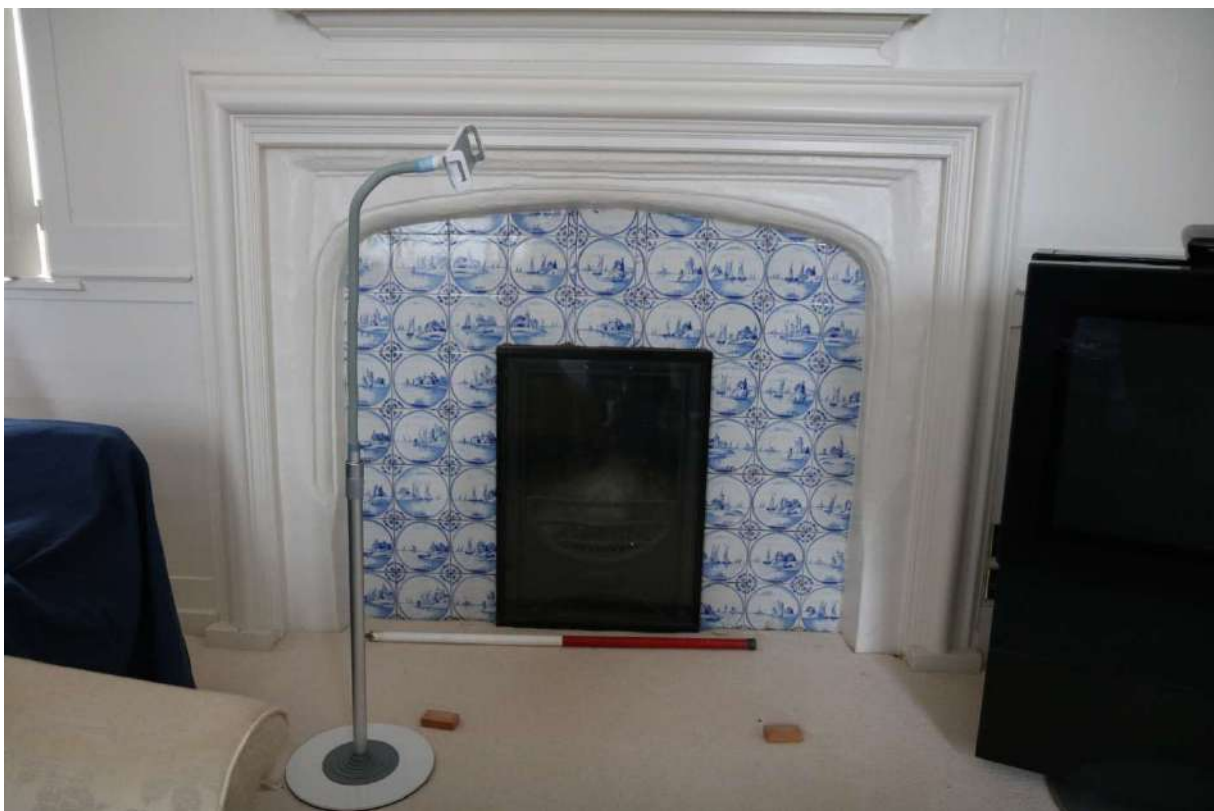
**Photograph 37** Detail of fireplace in south-western wall of bedroom 5. Photograph taken facing south-west.

The walls of bedroom 5 are panelled with sash windows in the north-eastern and south-western walls, one of which has shutters. Two two-panel doors are located in the north-western wall. In-built cupboards project from the south-eastern wall. In the centre of the south-western wall is a fireplace, which comprises a carved surround with an iron fire grate and Delft tiles (Photograph 37).
