**CAT Report 2257  
Issued March 2026**

**Historic building recording of  
The Old Palace, 23 Kneesworth Street, Royston,  
Hertfordshire, SG8 5AB**

**CAT project ref.: 2025/12g  
CAT Report 2257  
OASIS id: colchest3-540229**

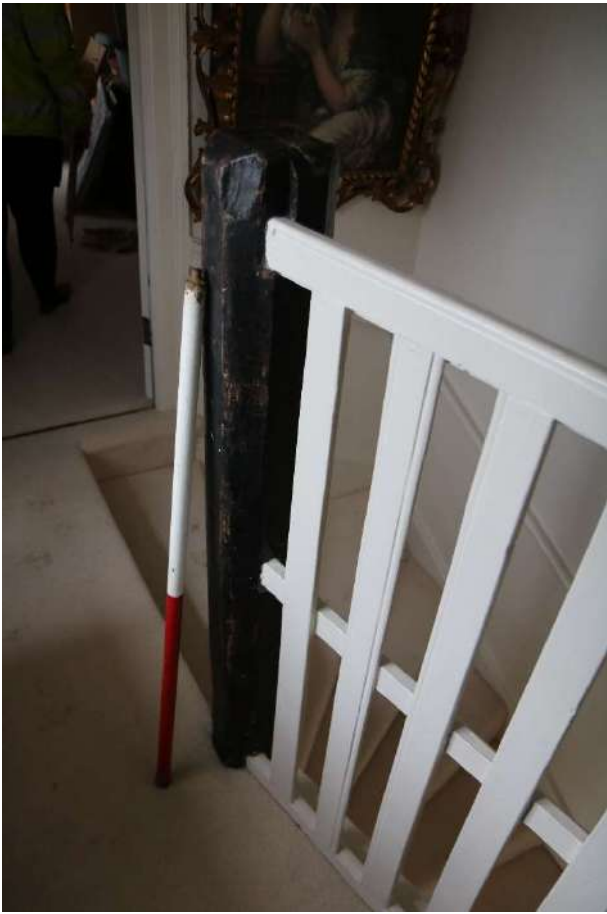
**Photograph 39** Detail of hand-carved newel post in staircase 1 (second floor). Photograph taken facing south.

In the centre of the attic is landing 3, flanked by bedrooms 6 and 7, all of which have a dormer window in the north-eastern wall. There is a simple balustrade around staircase 1, which utilises the central hand-sawn newel post with plain, flat balusters and handrail (Photograph 39).

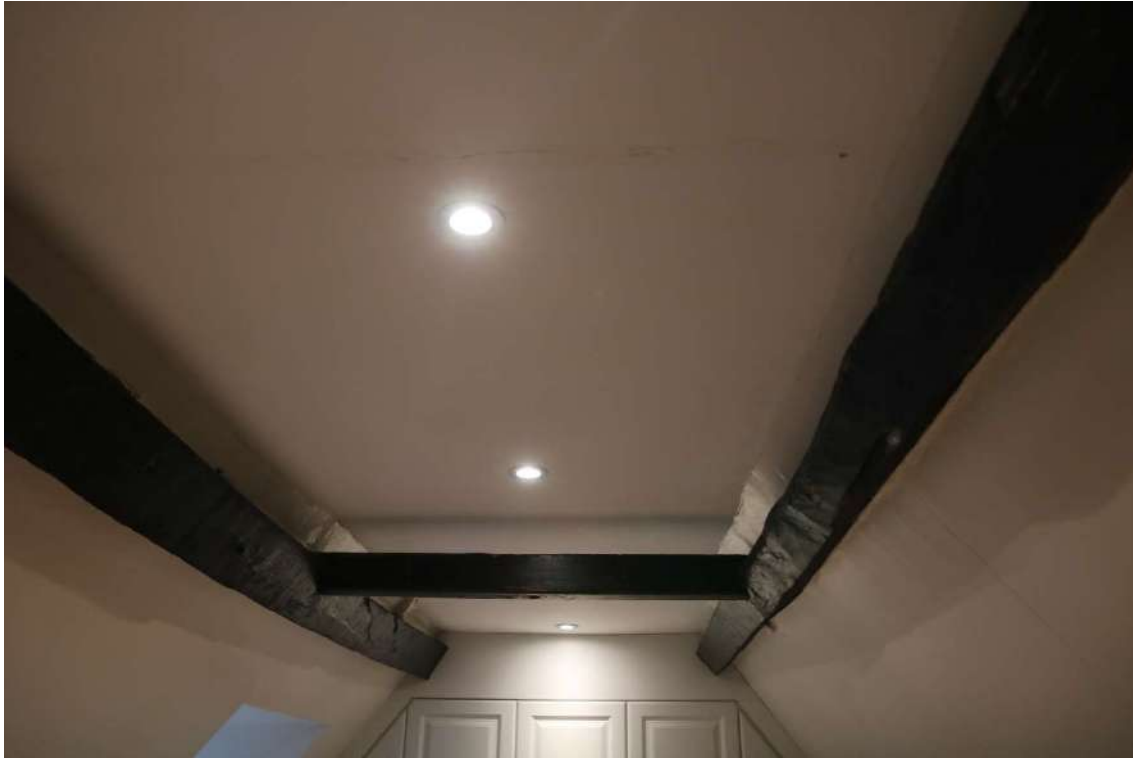
**Photograph 40** Detail of exposed purlins in ceiling of bedroom 7. Photograph taken facing south-east.

Purlins are exposed in the ceiling of bedroom 7, which appear to be hand-sawn with modern machine-cut repairs (Photograph 40). A possible scarf-joint is present in the south-western purlin, but its type was not discernible at the time of recording.

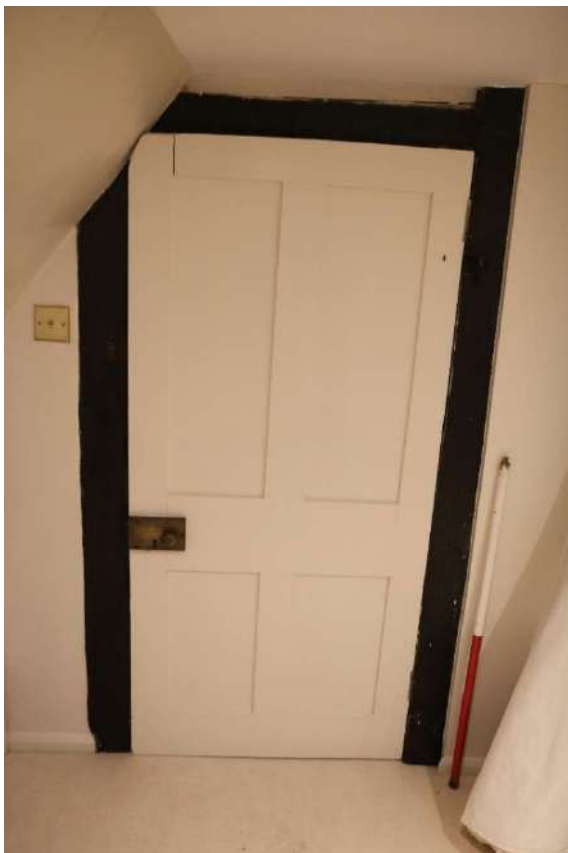
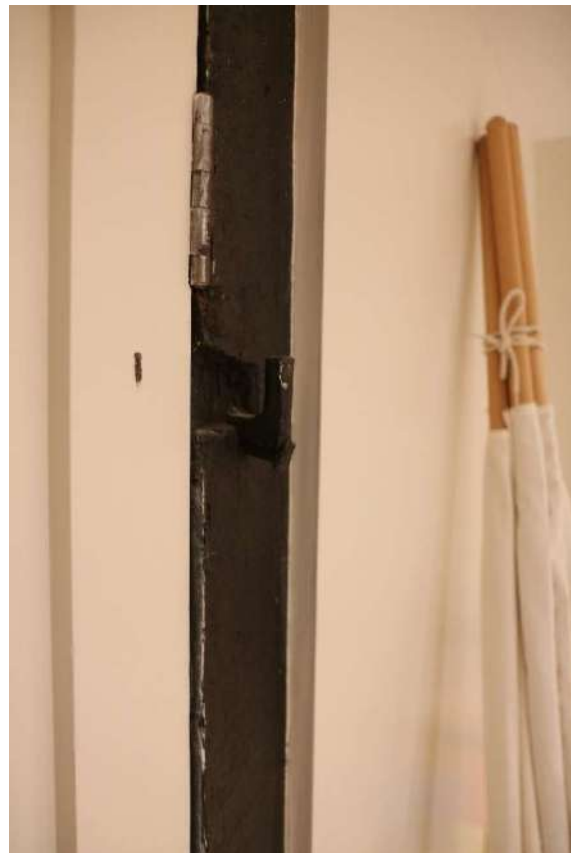
**Photograph 41 & 42** Detail of door in south-eastern wall of bedroom 6, with detail of pintle.  
Photograph taken facing south-east (41) and south (42).

The door between landing 3 and bedroom 6 (Photograph 41) is a four-panel door with a brass doorknob and lock case. A doorframe, comprising hand-sawn timbers, is visible from in bedroom 6. Small, iron pintles project from the doorframe (Photograph 42). The door between landing 3 and bedroom 7 is the same style, also with a hand-sawn doorframe.

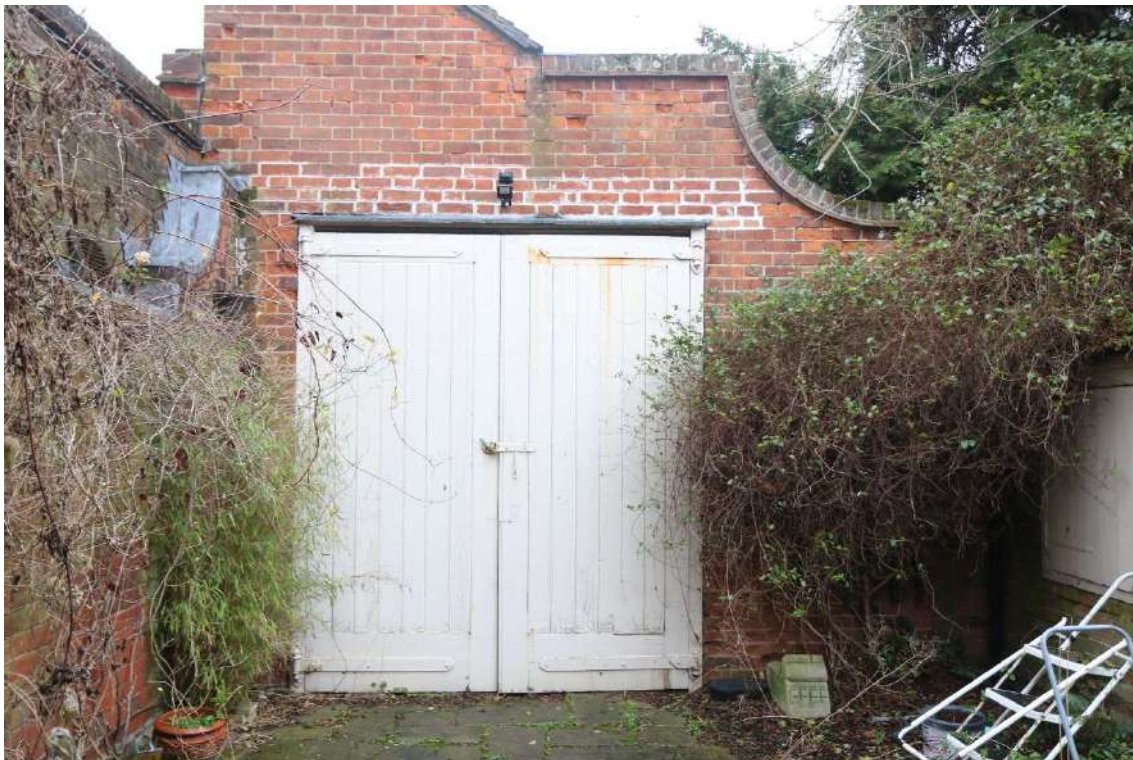
**Photograph 43** South-western elevation of studio. Photograph taken facing north-east.

Both the studio and storage shed have a mono-pitched roof covered with peg-tiles, with three roof lights inserted into the roof of the studio. At the north-western end, the studio has a half-width, curved parapet (Photograph 43). Both structures are brick built in Flemish bond, with the studio comprising red brick (brick dimensions: 225 x 110 x 60mm) while the storage shed is a mixture of red (brick dimensions: 225 x 110 x 65mm) and yellow (brick dimensions: 225 x 110 x 65mm) brick. The courtyard is enclosed with brick walls, which comprise a combination of red (brick dimensions: 225 x 110 x 65mm) and yellow (brick dimensions: 225 x 110 x 65mm) bricks. In the south-eastern wall of the courtyard, the bricks have been laid in checkerboard pattern (Photograph 45).

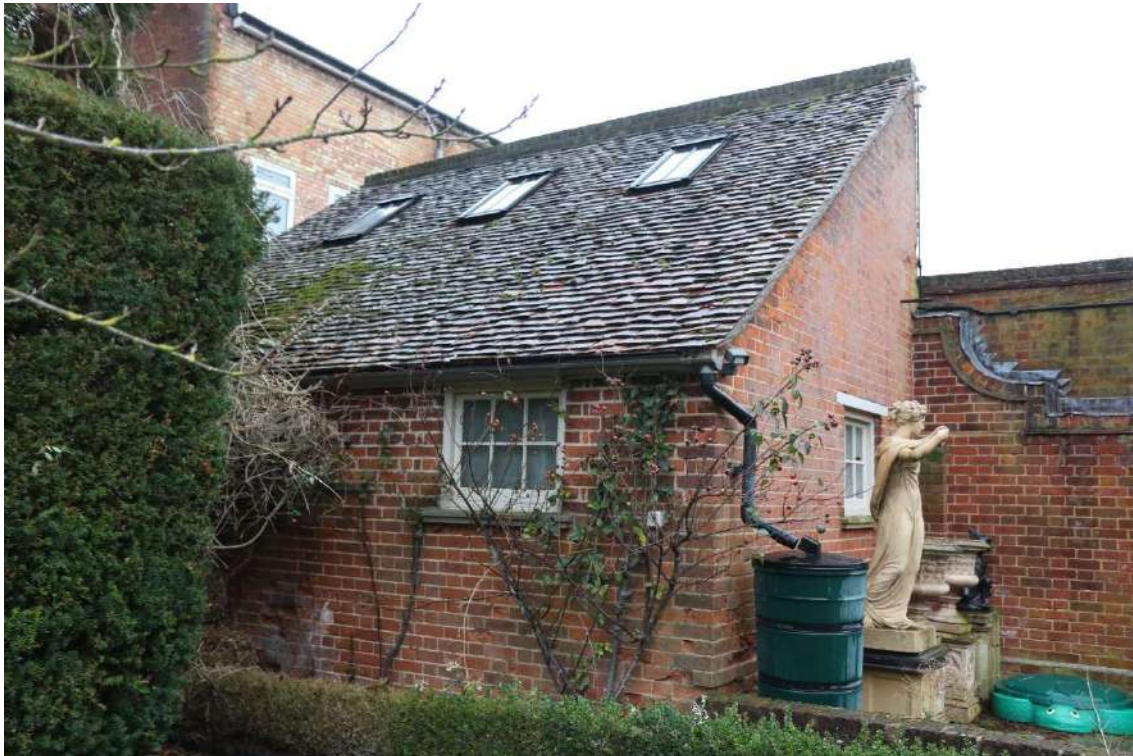
**Photograph 44** South-eastern elevation of studio. Photograph taken facing west.

The studio has windows in the north-eastern and south-eastern elevations, all of which have been blocked from the interior of the building. They are all six-lights with a timber lintel and stone still. Each window is surrounded by queen closers. A set of replacement double doors is present in the north-western elevation of the studio, which are also flanked by queen closers. The north-western elevation of the storage shed is largely composed of yellow bricks, suggesting it has been rebuilt at some point. This is further evidence by the door in the elevation, which does not appear to have been inserted but

is not surrounded by queen closers, unlike the window in the north-western elevation. The window has a vertically planked door as a shutter.

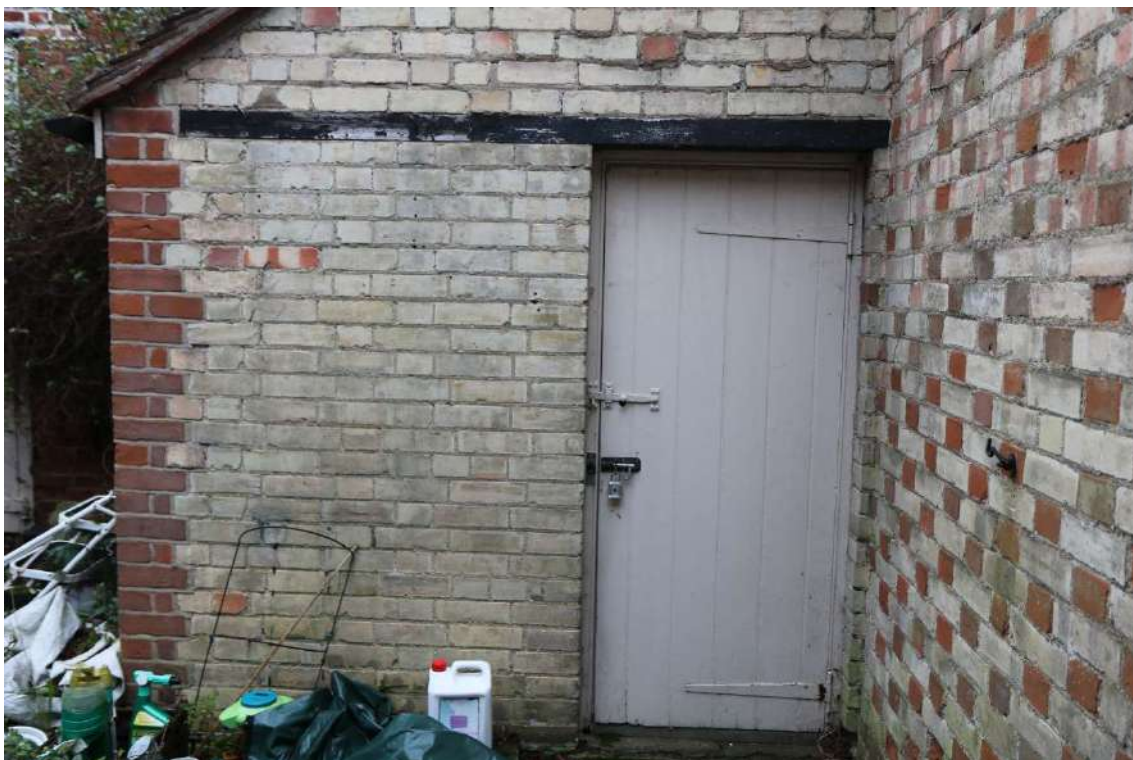
**Photograph 45** South-western elevation of storage shed. Checkerboard brickwork visible to the right. Photograph taken facing north-east.

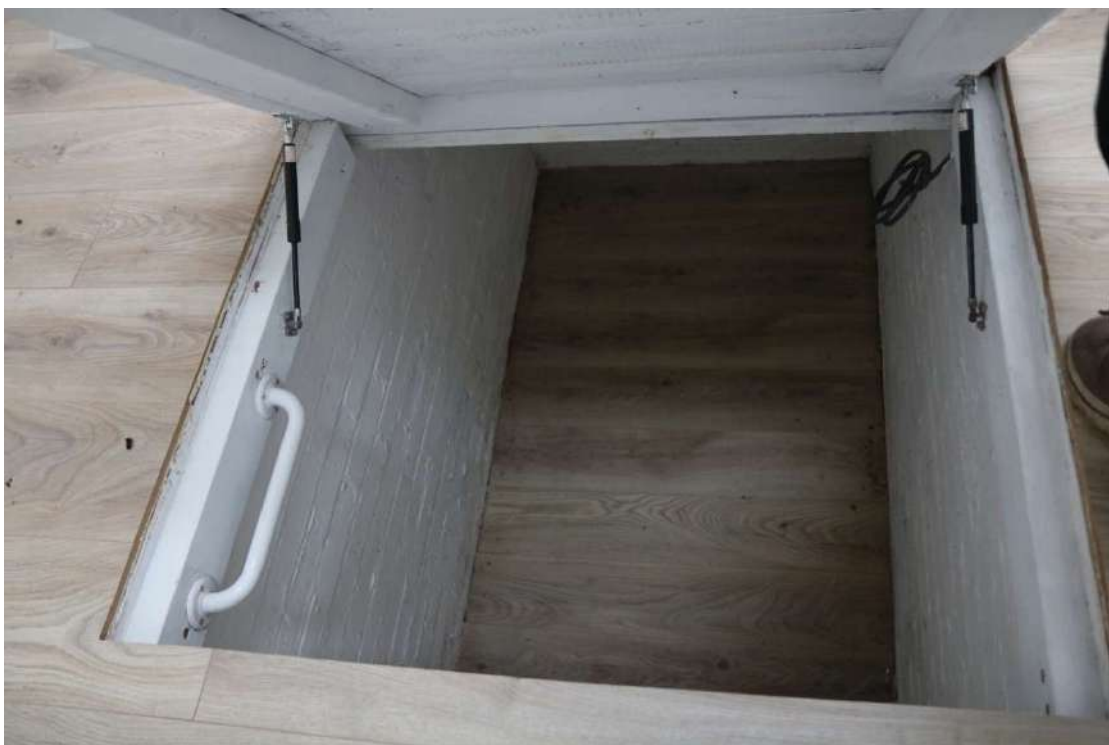
**Photograph 47** Pit in floor of studio. Photograph taken facing south-west.

The interior of both buildings has been modernised, with plain plaster walls and ceilings and modern floor coverings (Photograph 46). There is a brick lined pit in the centre of the studio's floor, which is accessed by a hatch (Photograph 47).

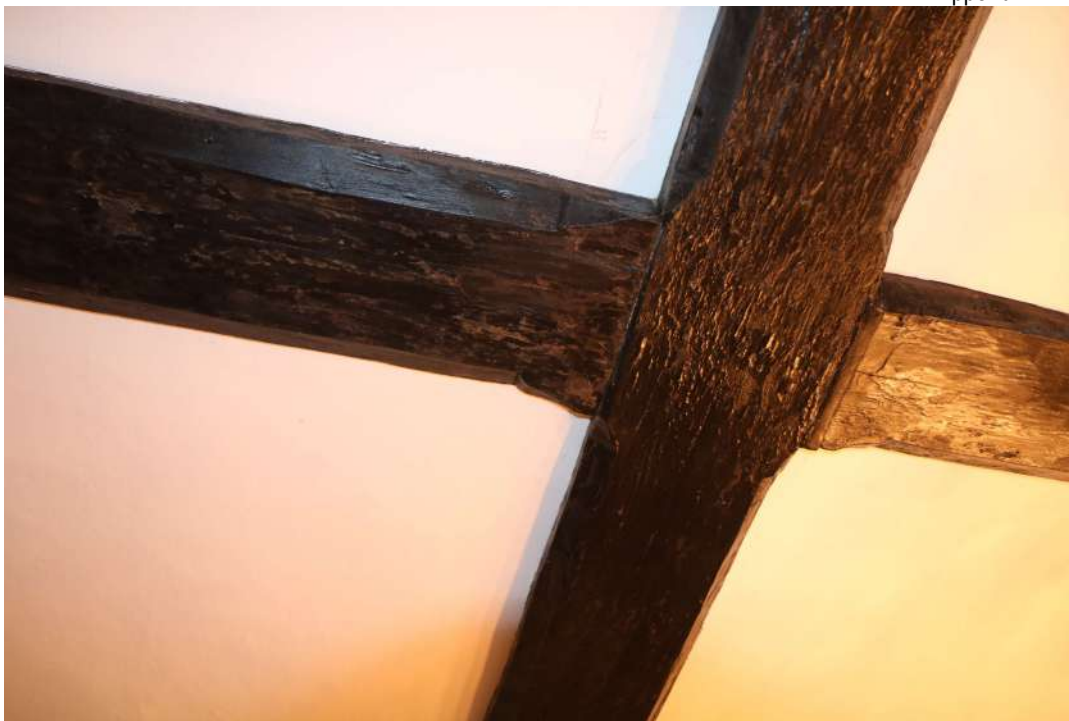
2025.12g\_Photograph\_005  
Detail of carved stops in binding beam and bridging joists in ceiling of drawing room. Photograph taken facing west.

Occupying the south-eastern limit of the ground floor, the drawing room (Photograph 15) has several exposed beams in its ceiling, which are chamfered with lamb's tongue stops (Photograph 16). A large Murano glass chandelier hangs from the ceiling. The walls of the drawing room have ovolo panelling with a dado rail, the upper of which are painted white while the lower are stained dark with a foliage design. There is a door in the north-western, north-eastern and south-eastern walls. The north-western door is a simple two-panel door, with a brass lock case and H-hinges. There is a continuation of the dado rail across the central rail of the door and the same painted foliage pattern as the panelling is present (Photograph 17). The south-eastern door is the same style as the north-western, minus the foliage pattern and brass lock case. The north-eastern door is four-panel exterior door, the top two panels of which appear to form a shutter. It has a brass lock case and a plain surround. Two sash windows are present in the north-eastern wall with one fixed window in the south-western wall. A fireplace is in the south-western wall, with a timber surround, marble chimney piece and an iron fireback and hood. Hinges in the panelling adjacent to the fireplace suggest that a now blocked cupboard is located in the wall. Built into the south-eastern wall is a round-headed cupboard. It has panelled doors, with a moulded architrave, and a decorative faux keystone (Photograph 18).

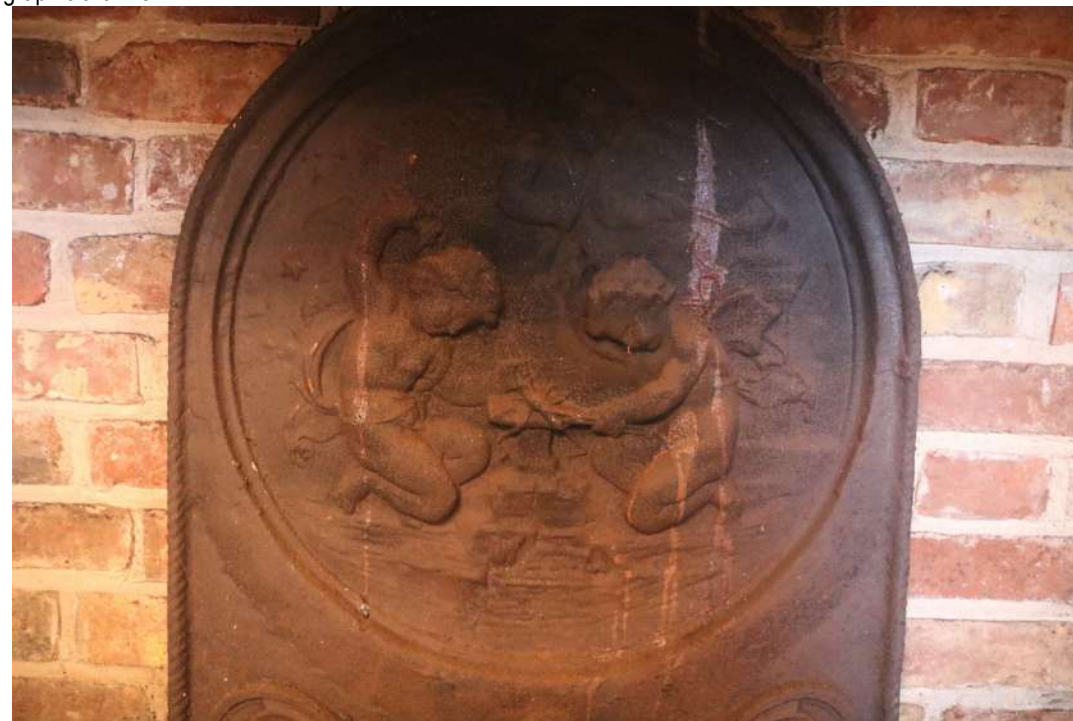
2025.12g\_Photograph\_006  
Detail of decorative fireback in drawing room fireplace. Photograph taken facing south-west.

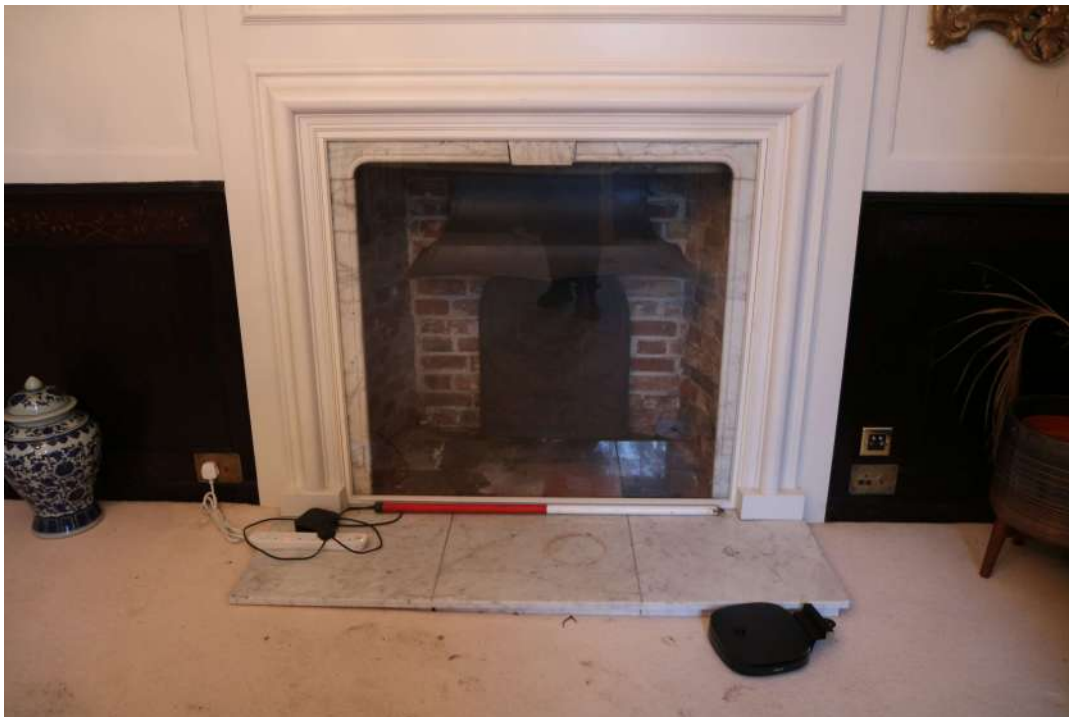
2025.12g\_Photograph\_007  
Detail of fireplace in south-western wall of drawing room. Photograph taken facing south-west.

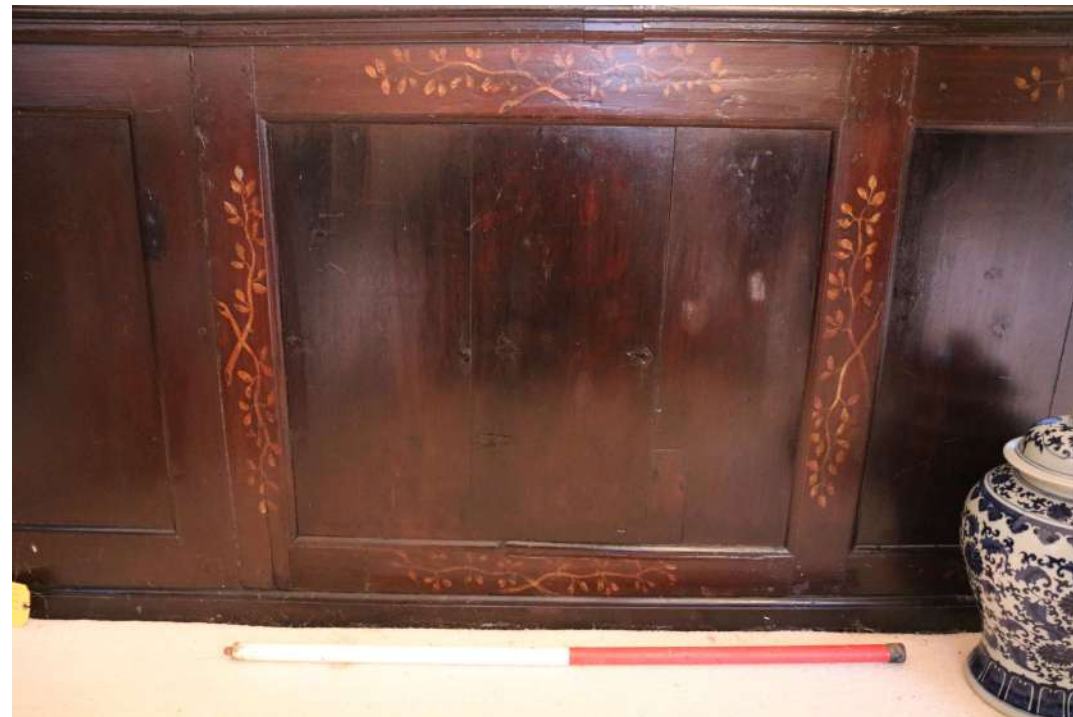
2025.12g\_Photograph\_008  
Detail of panelling in drawing room (north-western wall). Photograph taken facing north-west.

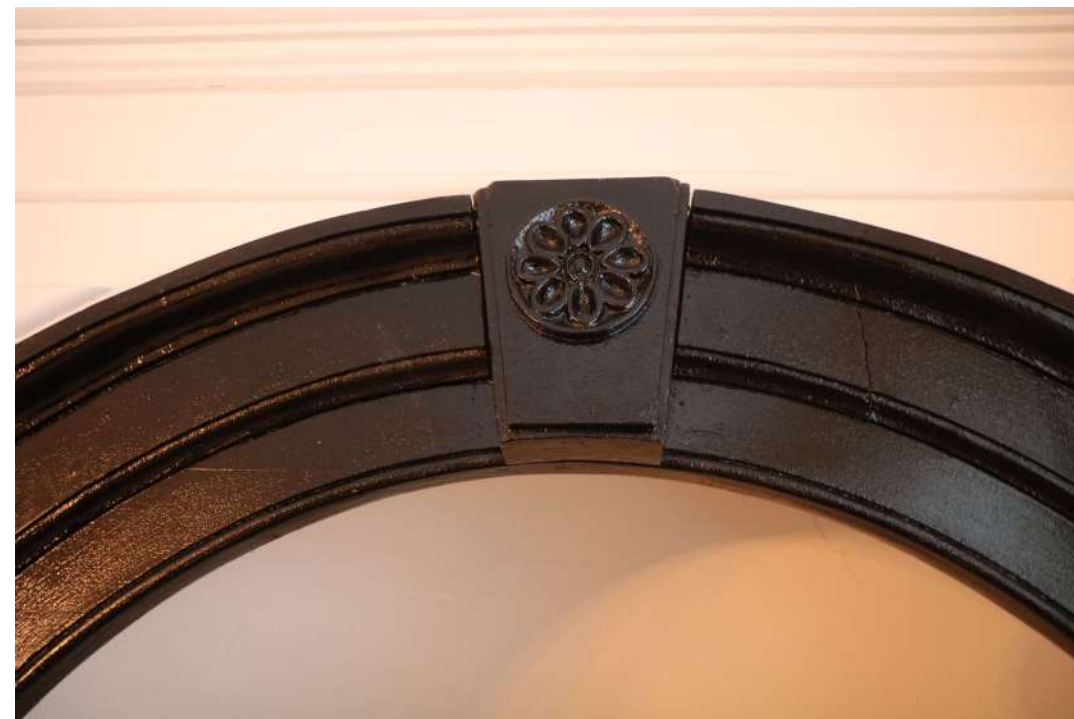
2025.12g\_Photograph\_012  
Detail of decorative carving on arch of built-in cupboard in south-eastern wall of drawing room. Photograph taken facing south-east.

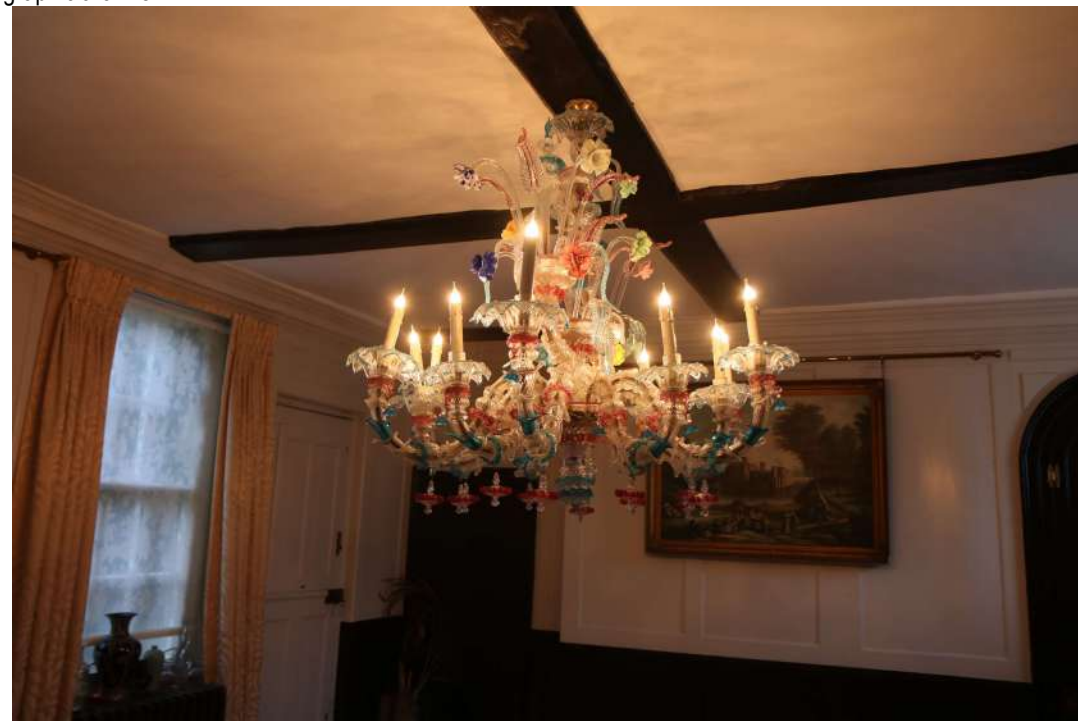
2025.12g\_Photograph\_018  
Detail of light fitting in drawing room. Photograph taken facing east.

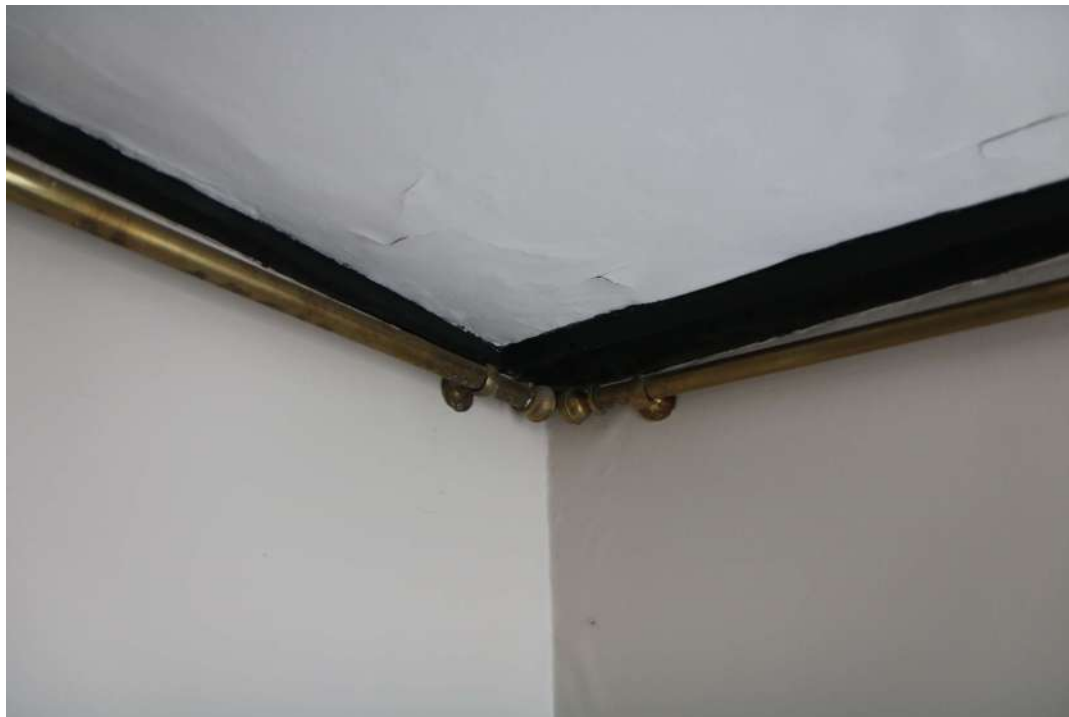
2025.12g\_PhotoGraph\_027  
Detail of exposed timber in ceiling of entrance hall 1. Photograph taken facing east.

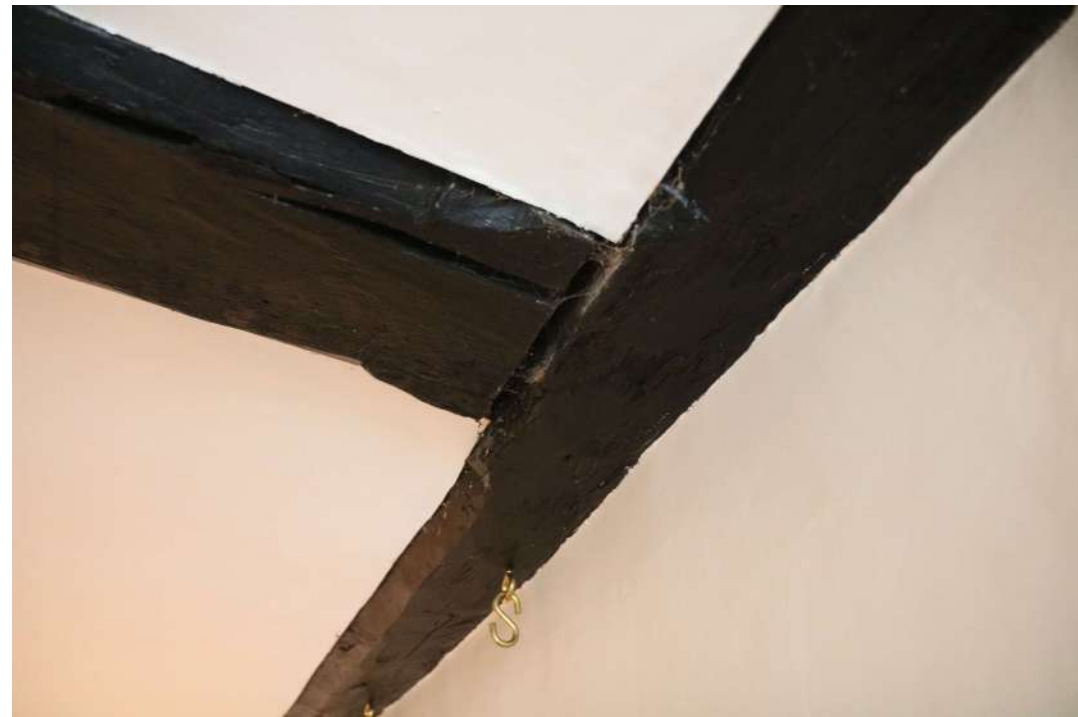
2025.12g\_PhotoGraph\_028  
Detail of carved stops in ceiling of entrance hall 1. Photograph taken facing north.

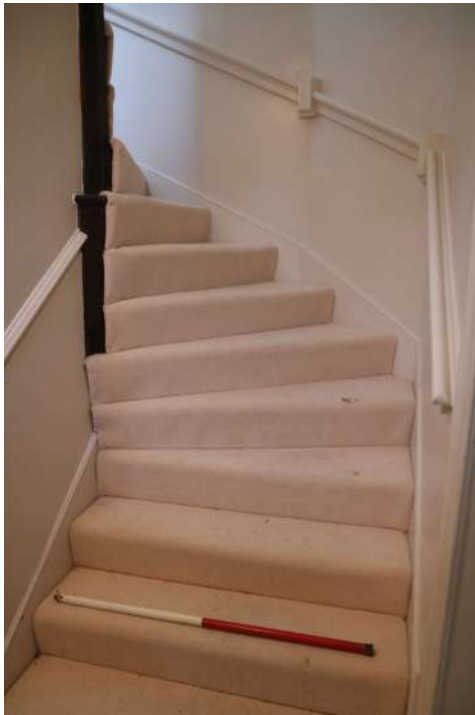
2025.12g\_Photograph\_031  
Detail of staircase 1. Photograph taken facing south-west.

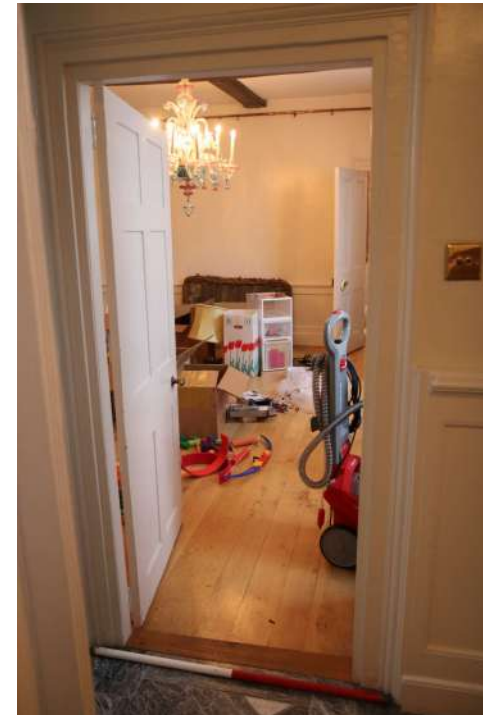
2025.12g\_Photograph\_032  
Detail of door in north-western wall of entrance hall 1. Photograph taken facing north-west.

Directly opposite one another, there are doors in the north-western and south-eastern walls. The north-western door is a plank and batten door (Photographs 31 & 32), which is formed from three irregular sized planks secured with three battens that have chamfered edges. It is hung with iron strap hinges with round ends. There is a bar-type door latch, with a barley twist drop handle and star-shaped backplate, which is a later replacement. The door also has a timber lock case beneath the door latch. The south-eastern door is a double-thickness plank door, with the outer face comprising three roughly equal width vertical planks, separated by crease mouldings, while the inner face has six horizontal planks (Photographs 33 & 34). Decorative ended strap hinges secure the door; a later architrave has been fixed over the base plate of the hinges (Photograph 35). There is a door latch, the same style as the other door, and a timber lock case.

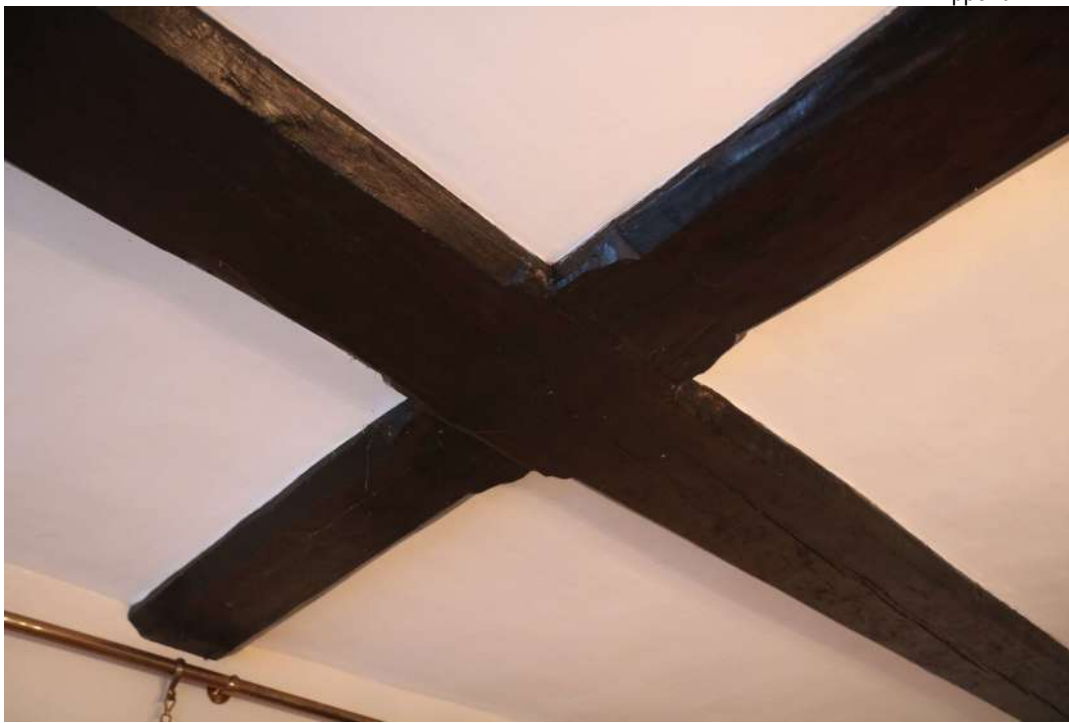
2025.12g\_Photograph\_037

Detail of carved stops in binding beam and bridging joist in ceiling of dining room. Photograph taken facing south.

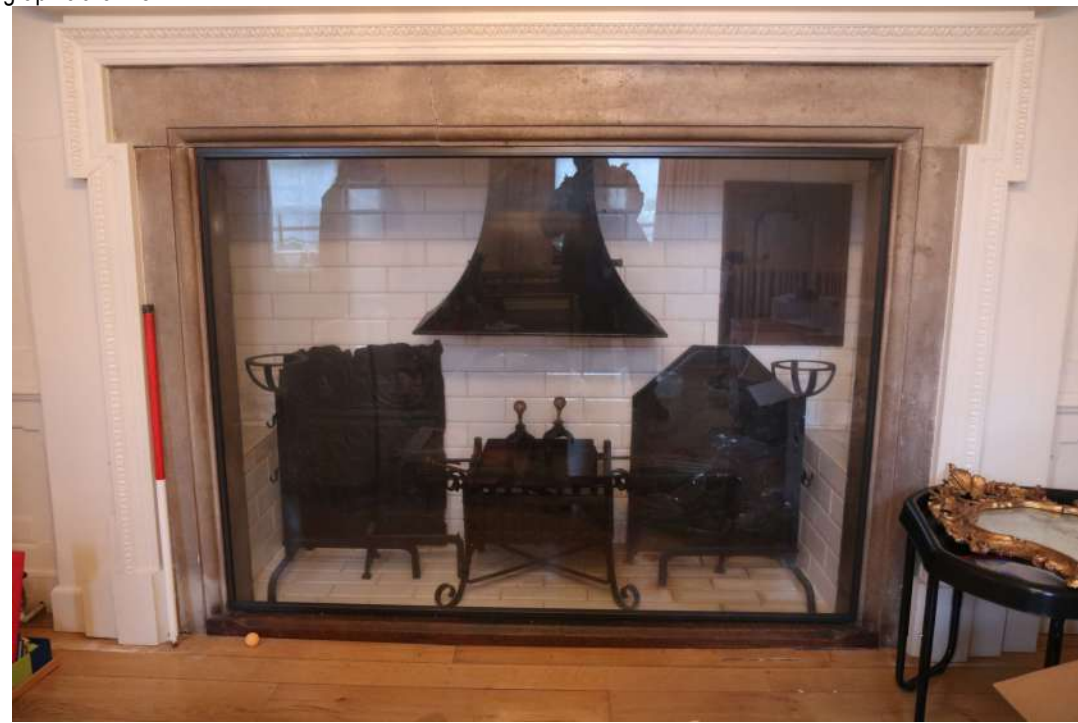
2025.12g\_Photograph\_038

Detail of fireplace in south-western wall of dining room. Photograph taken facing south-west.

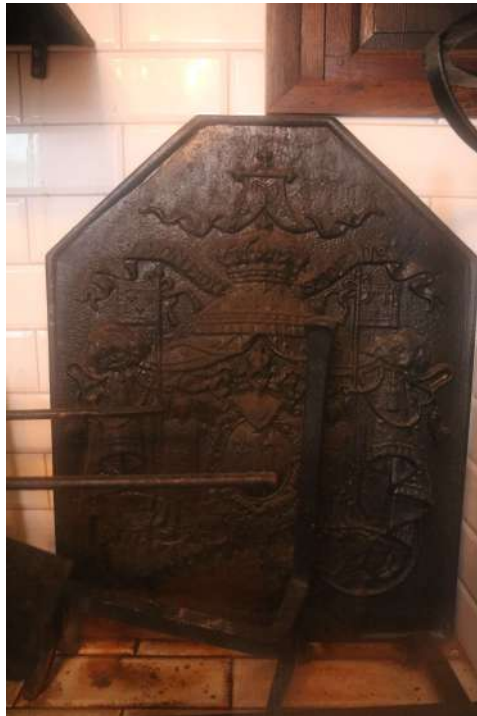
2025.12g\_Photograph\_039

Detail of decorative fireback in fireplace in south-western wall of dining room. Photograph taken facing south-west.

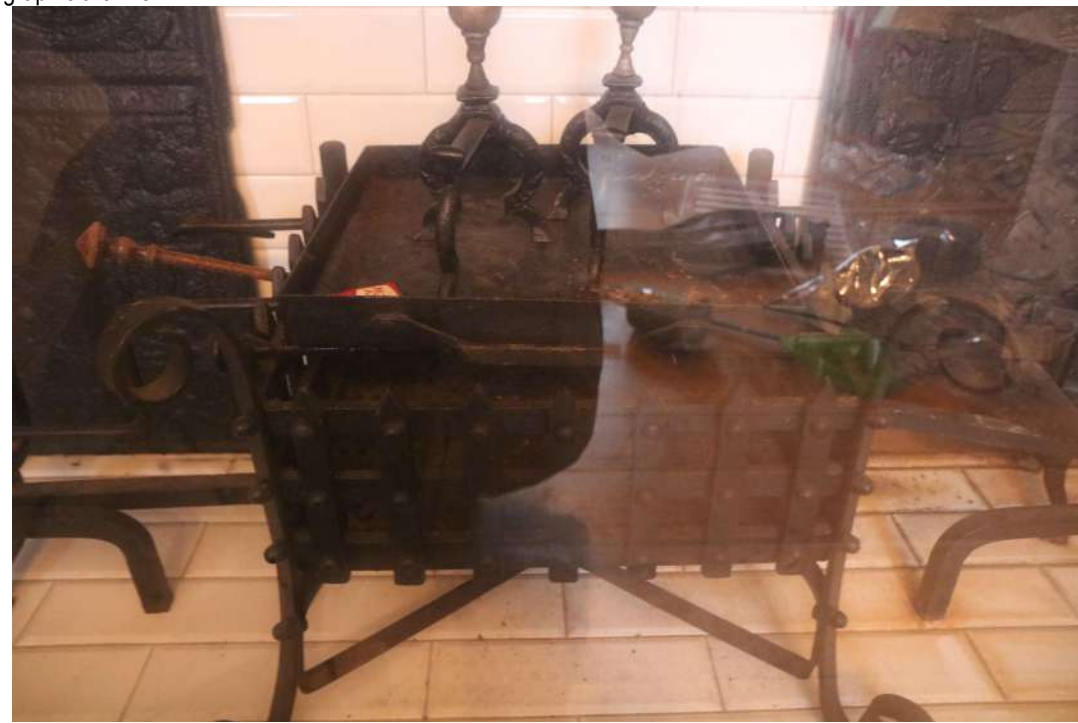
2025.12g\_Photograph\_042

Detail of firegrate in fireplace in south-western wall of dining room. Photograph taken facing south-west.

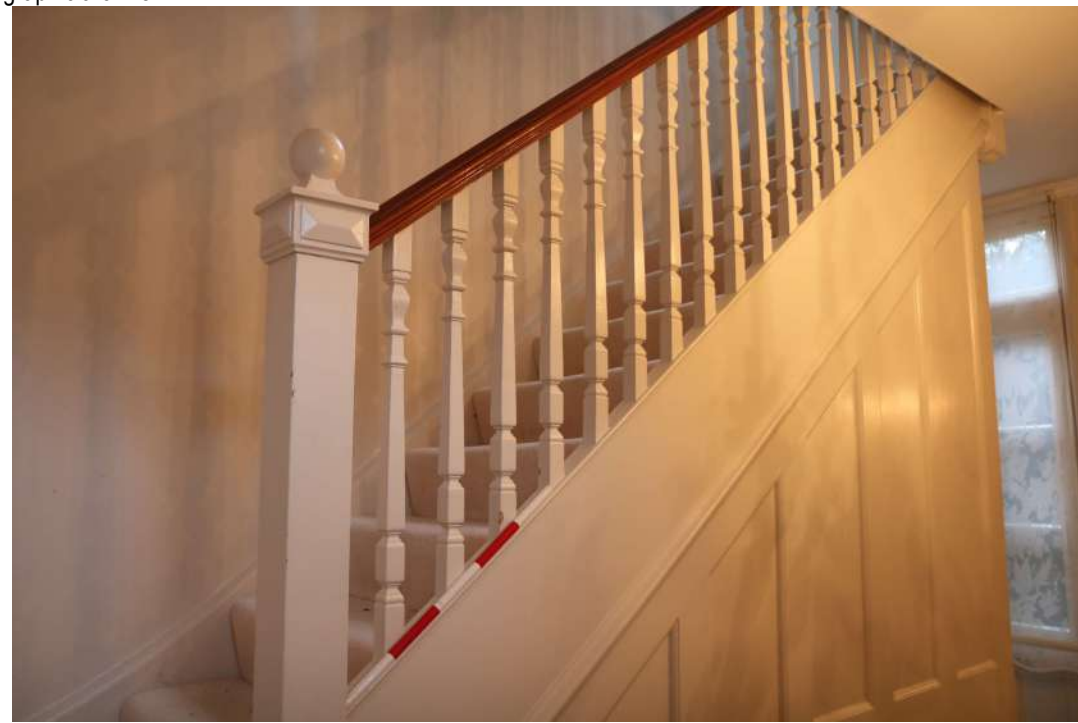
2025.12g\_Photograph\_057  
Detail of staircase 2. Photograph taken facing north-east.

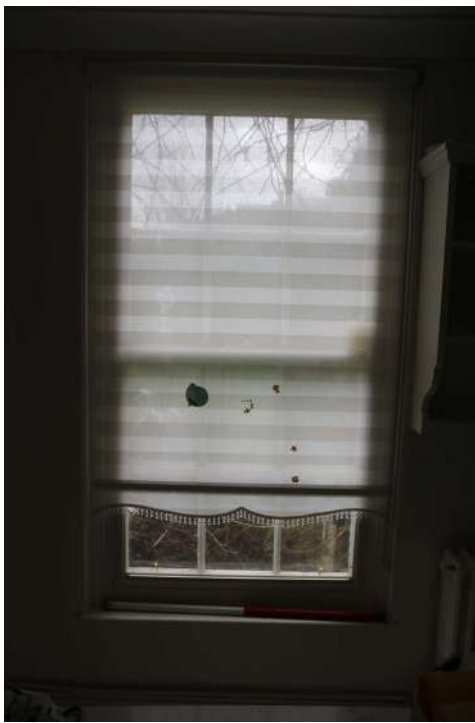
2025.12g\_PhotoGraph\_072  
Detail of window in south-eastern wall of kitchen. Photograph taken facing south-east.

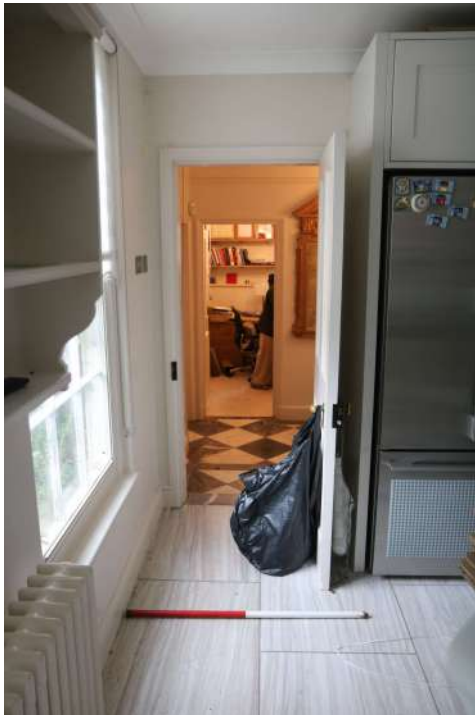
2025.12g\_Photograph\_074  
Detail of door in north-eastern wall of kitchen. Photograph taken facing north-east.

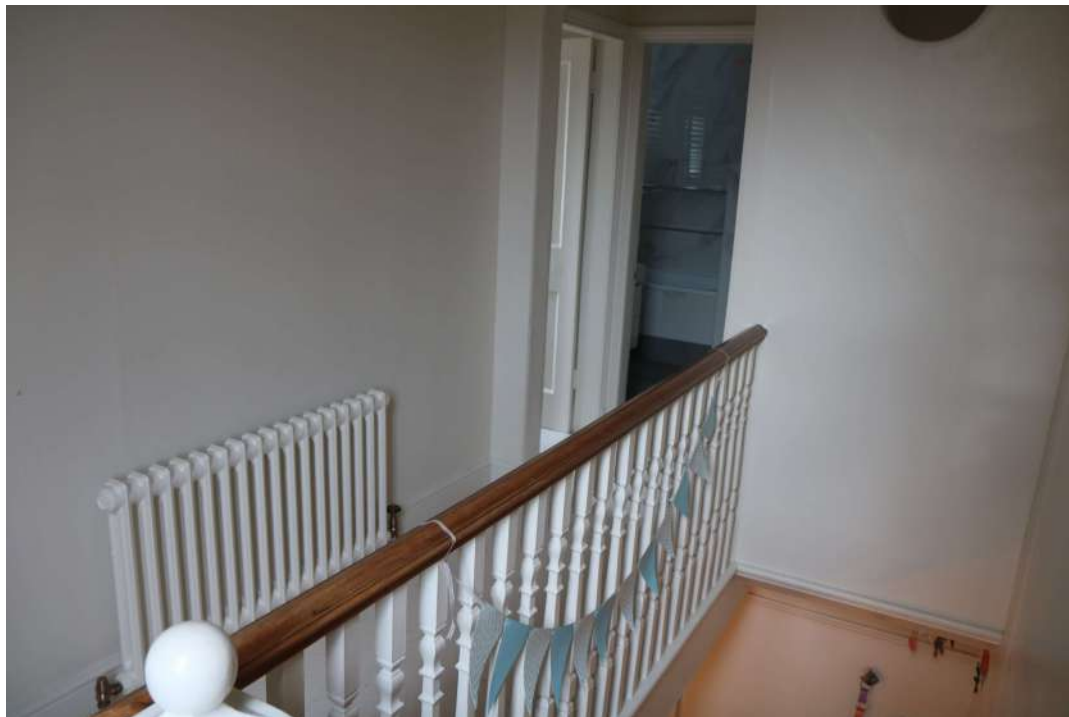
2025.12g\_Photograph\_082  
Detail of staircase 2. Photograph taken facing north-west.

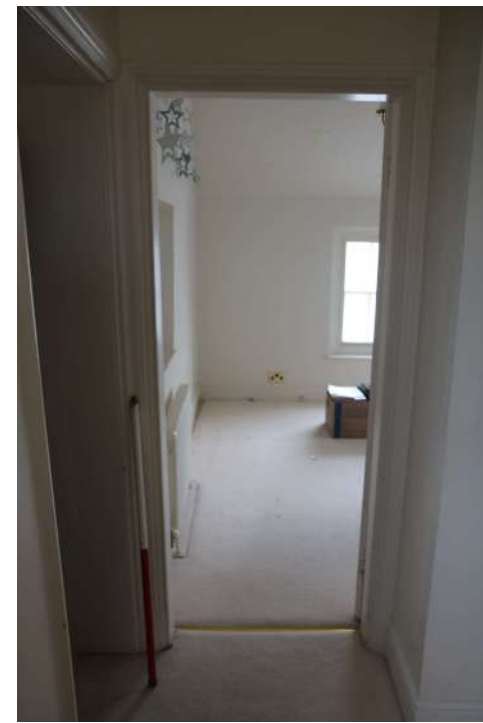
2025.12g\_Photograph\_089  
Detail of door in south-eastern wall of landing 2. Photograph taken facing south-west.

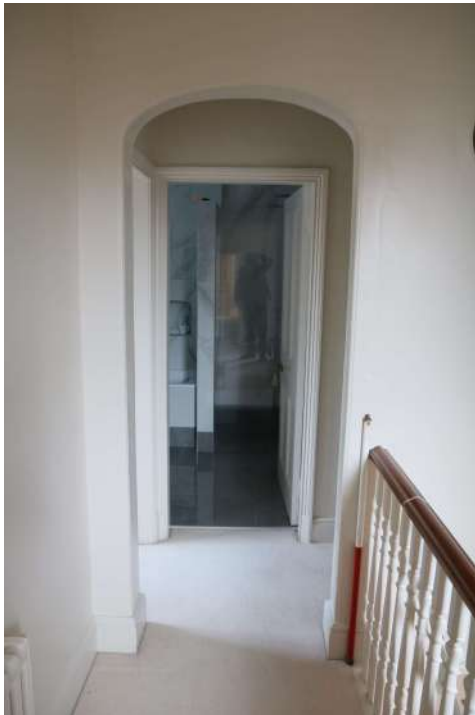
2025.12g\_Photograph\_090  
Detail of door in south-western wall of landing 2. Photograph taken facing south-west.

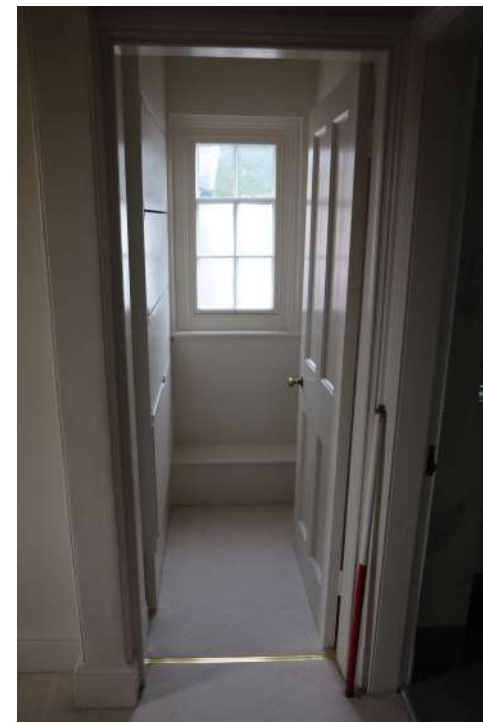
2025.12g\_Photograph\_093  
Detail of door in north-western wall of landing 2. Photograph taken facing north-west.

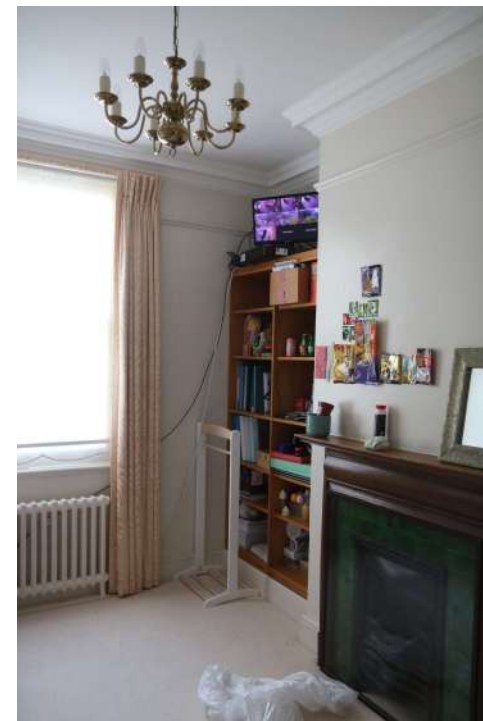
2025.12g\_Photograph\_098  
Interior of bedroom 1. Photograph taken facing east.

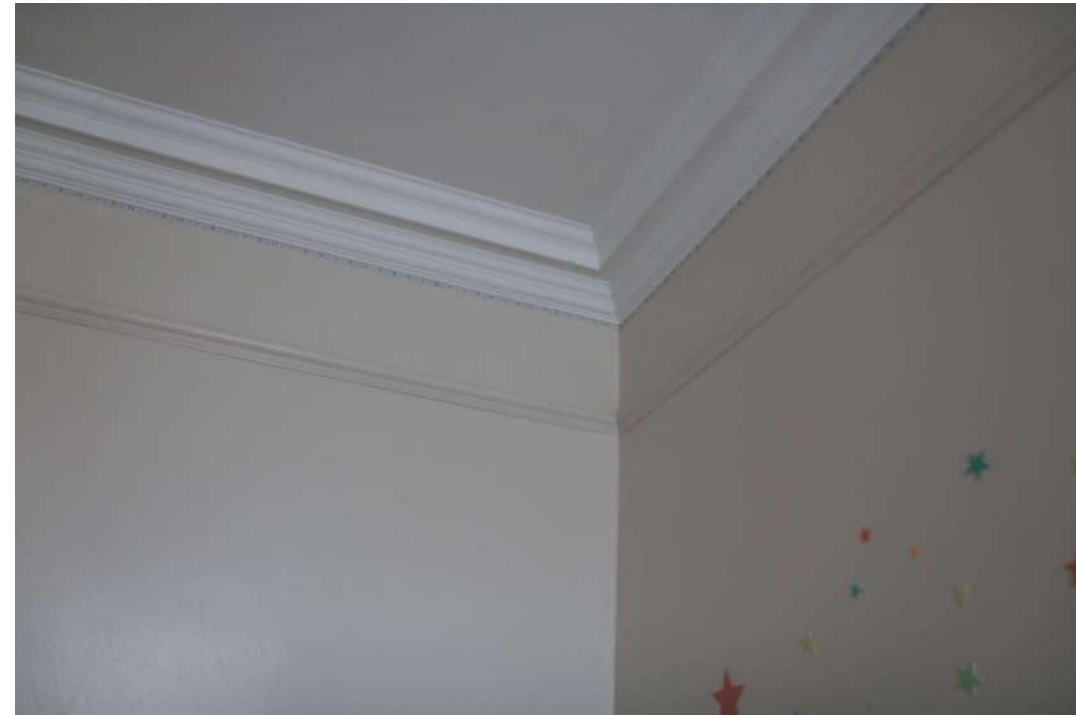
2025.12g\_Photograph\_100  
Detail of picture rail and cornicing in bedroom 1. Photograph taken facing west.

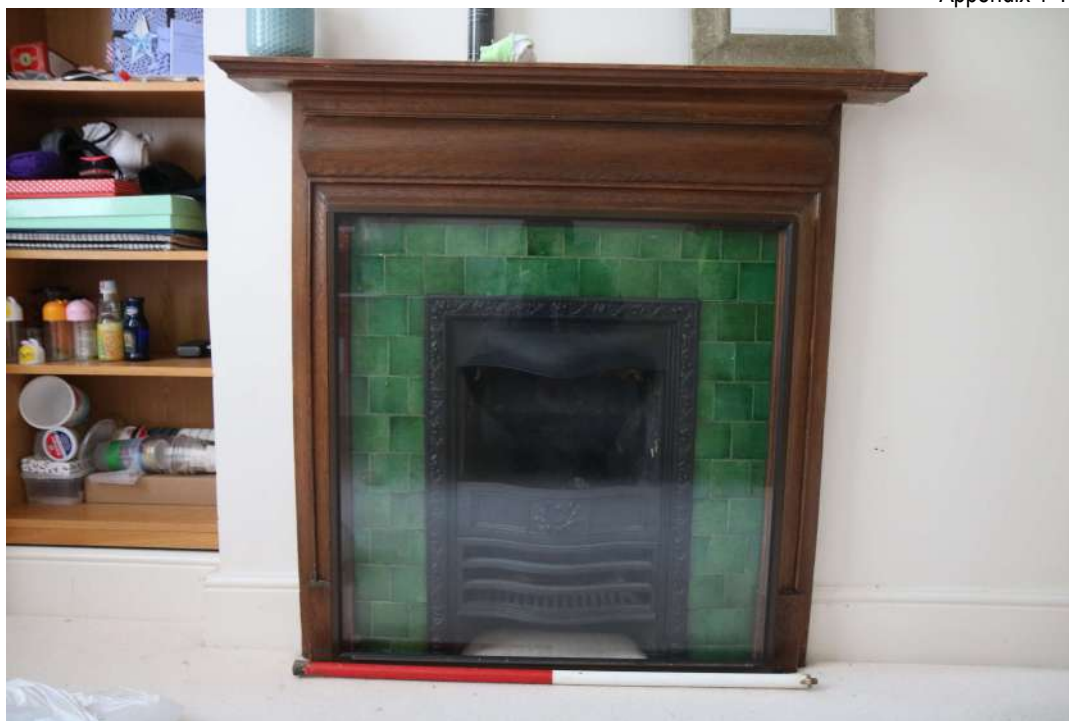
2025.12g\_Photograph\_101  
Detail of fireplace in south-eastern wall of bedroom 1. Photograph taken facing south-east.
