**CAT Report 2257  
Issued March 2026**

**Historic building recording of  
The Old Palace, 23 Kneesworth Street, Royston,  
Hertfordshire, SG8 5AB**

**CAT project ref.: 2025/12g  
CAT Report 2257  
OASIS id: colchest3-540229**

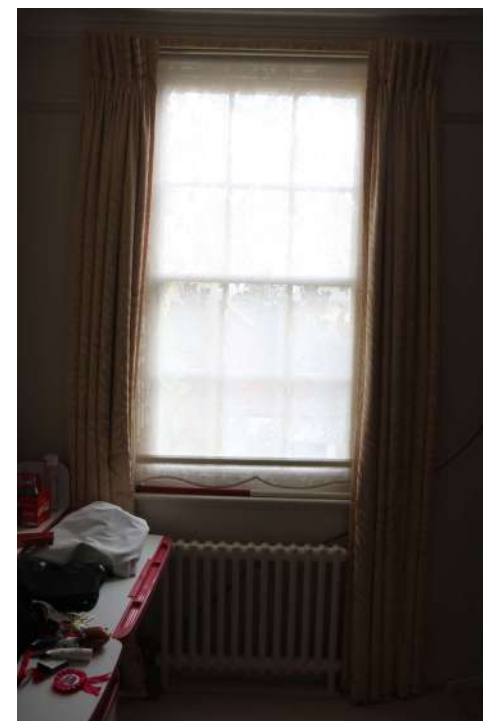
2025.12g\_Photograph\_102  
Detail of window in north-eastern wall of bedroom 1. Photograph taken facing north-east.

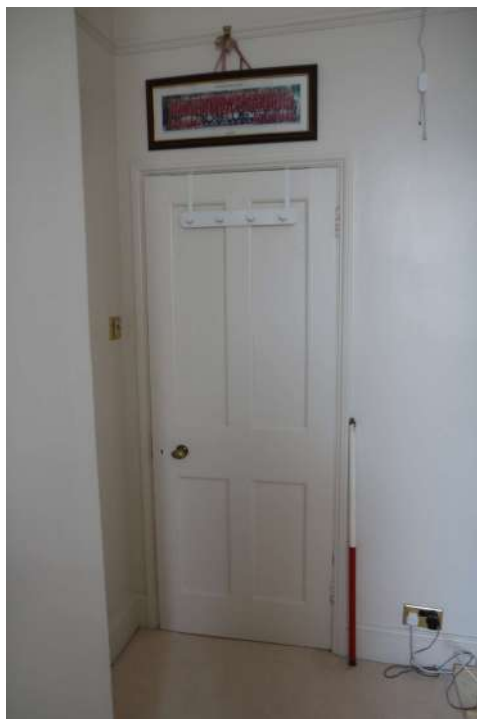
2025.12g\_Photograph\_103  
Detail of door in south-western wall of bedroom 1. Photograph taken facing south south-west.

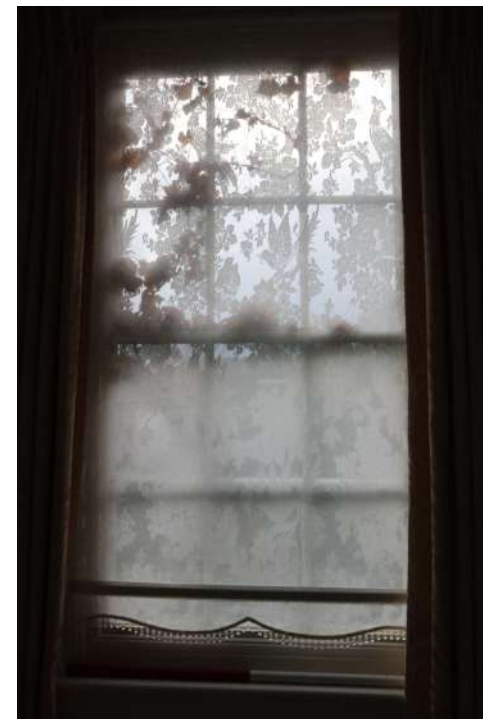
2025.12g\_Photograph\_110  
Detail of window in south-eastern wall of bedroom 2. Photograph taken facing south-east.

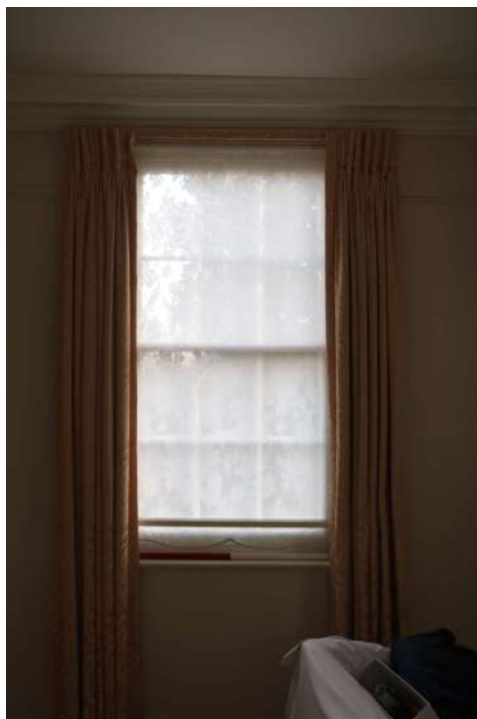
2025.12g\_Photograph\_111  
Detail of window in north-eastern wall of bedroom 2. Photograph taken facing north-east.

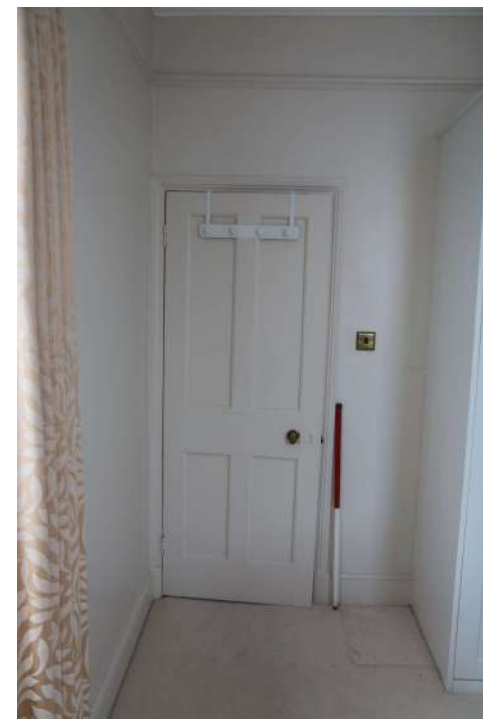
2025.12g\_Photograph\_112  
Detail of door in south-western wall of bedroom 2. Photograph taken facing south-west.

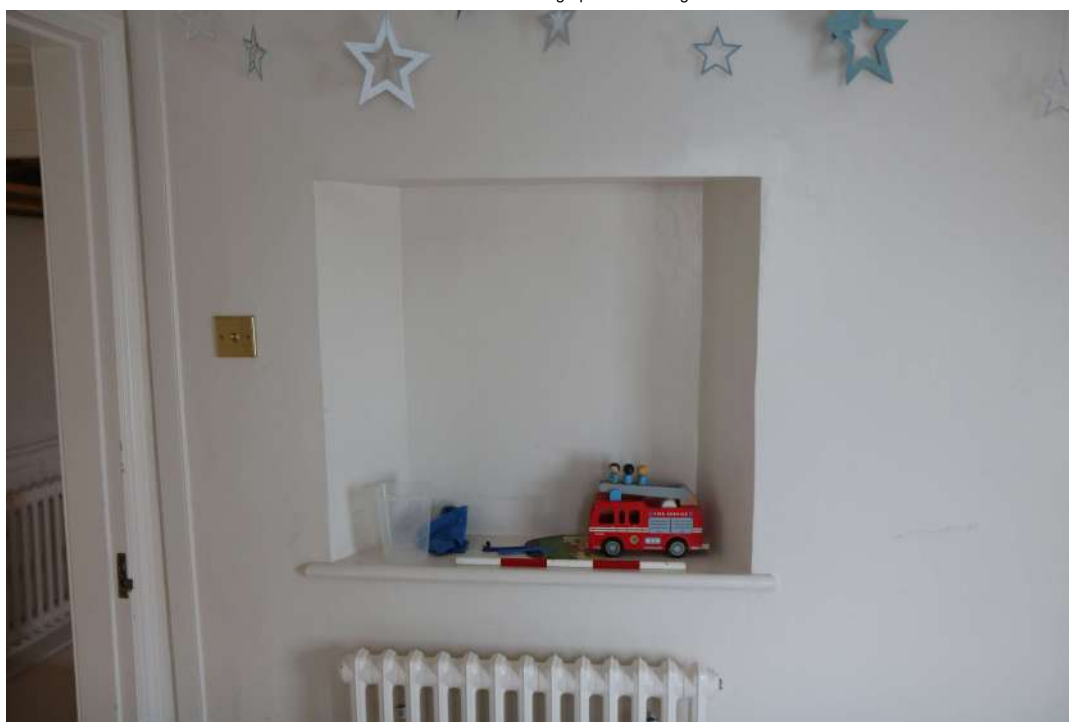
2025.12g\_Photograph\_115  
Detail of niche in south-eastern wall of bedroom 3. Photograph taken facing south-east.

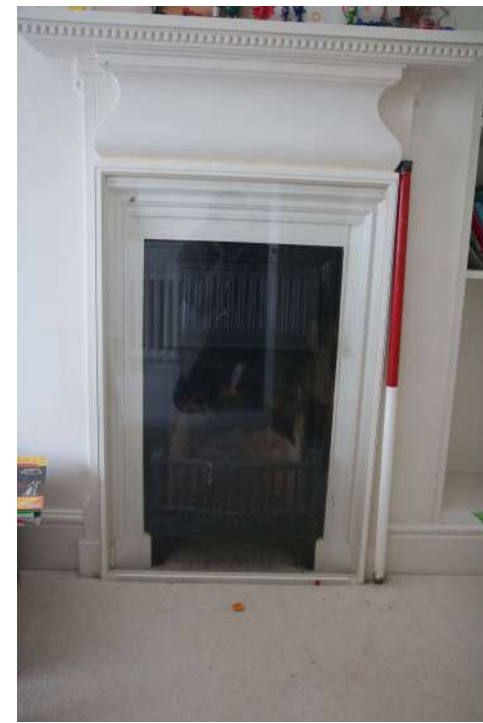
2025.12g\_Photograph\_118  
Detail of fireplace in north-western wall of bedroom 3. Photograph taken facing north-west.

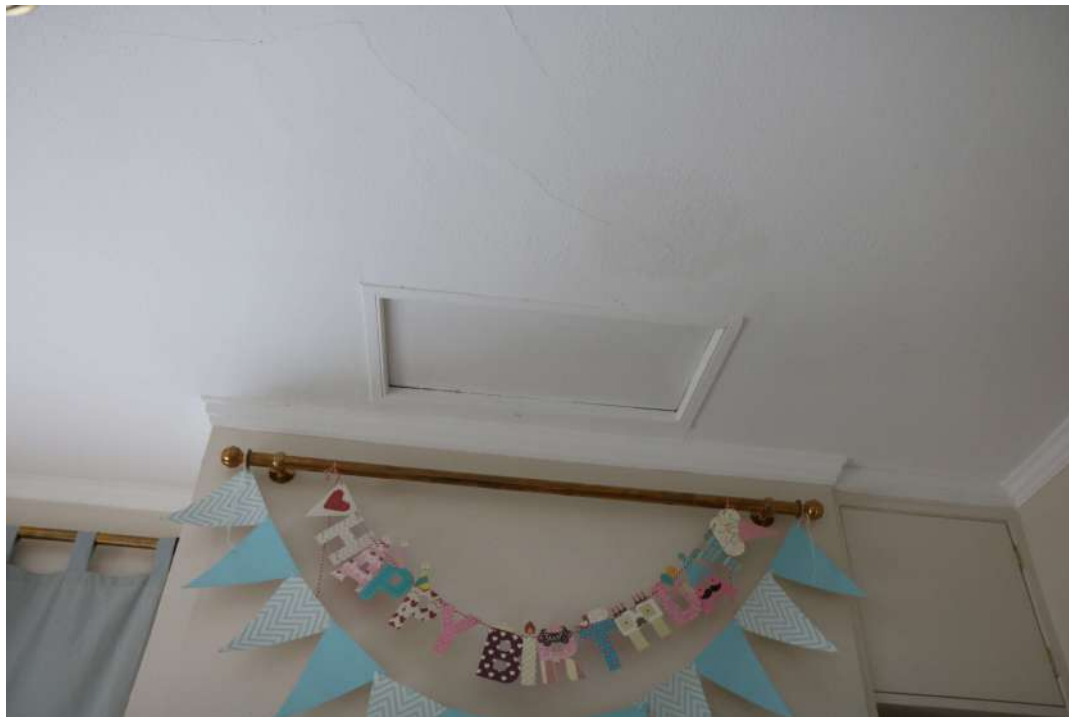
2025.12g\_Photograph\_119  
Detail of opening in ceiling of bedroom 3. Photograph taken facing north-west.

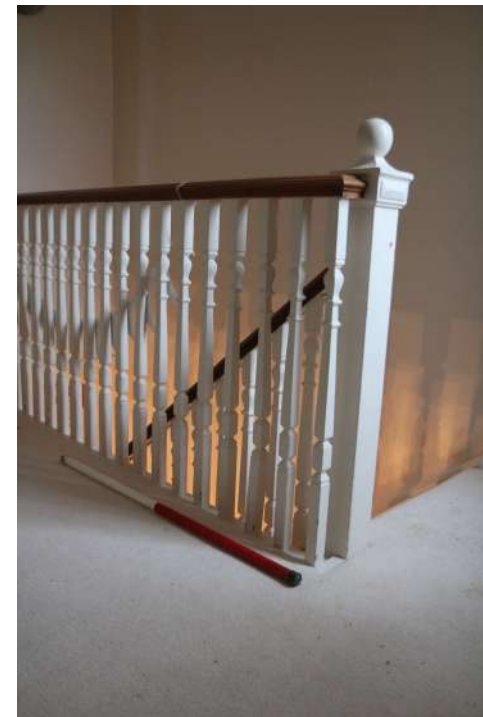
2025.12g\_Photograph\_120  
Detail of balustrade and newel post of staircase 2. Photograph taken facing north.

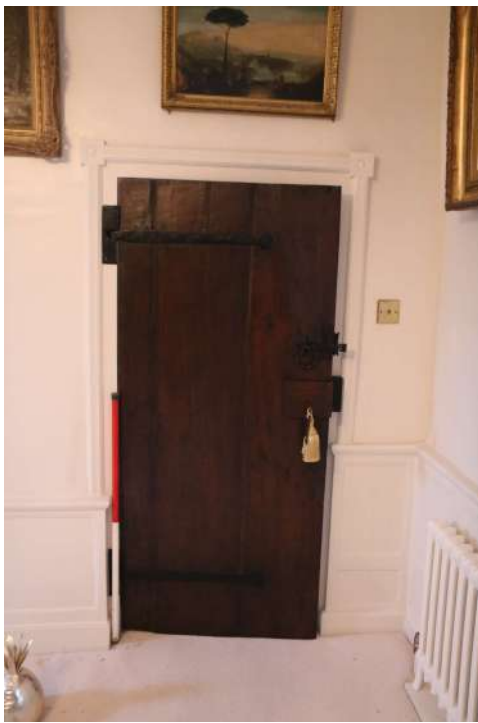
2025.12g\_Photograph\_125  
Detail of door in north-western wall of bedroom 4. Photograph taken facing north-west.

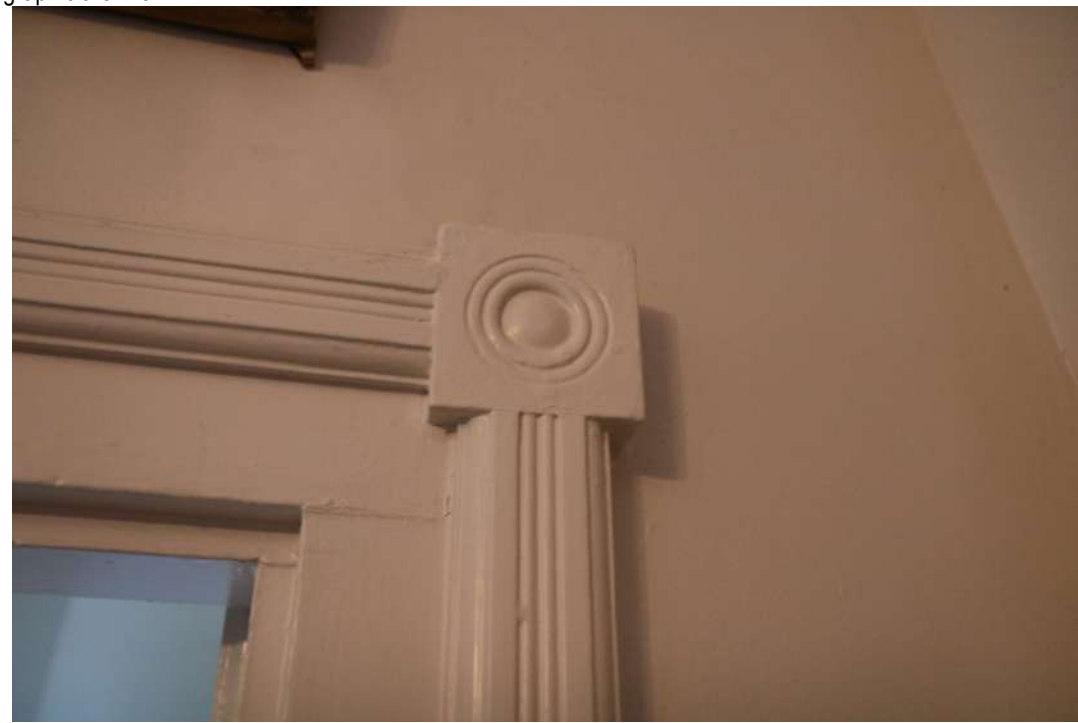
2025.12g\_Photograph\_126  
Detail of decorative doorframe in north-western wall of bedroom 4. Photograph taken facing north-west.

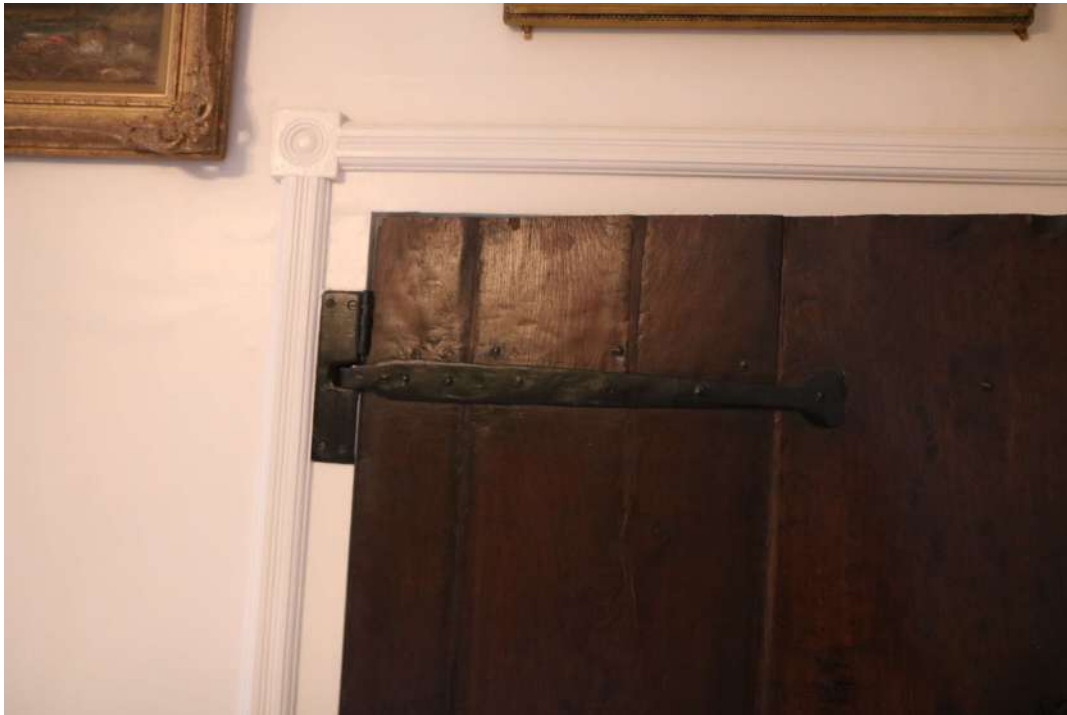
2025.12g\_Photograph\_127  
Detail of strap hinge on door in north-western wall of bedroom 4. Photograph taken facing north-west.

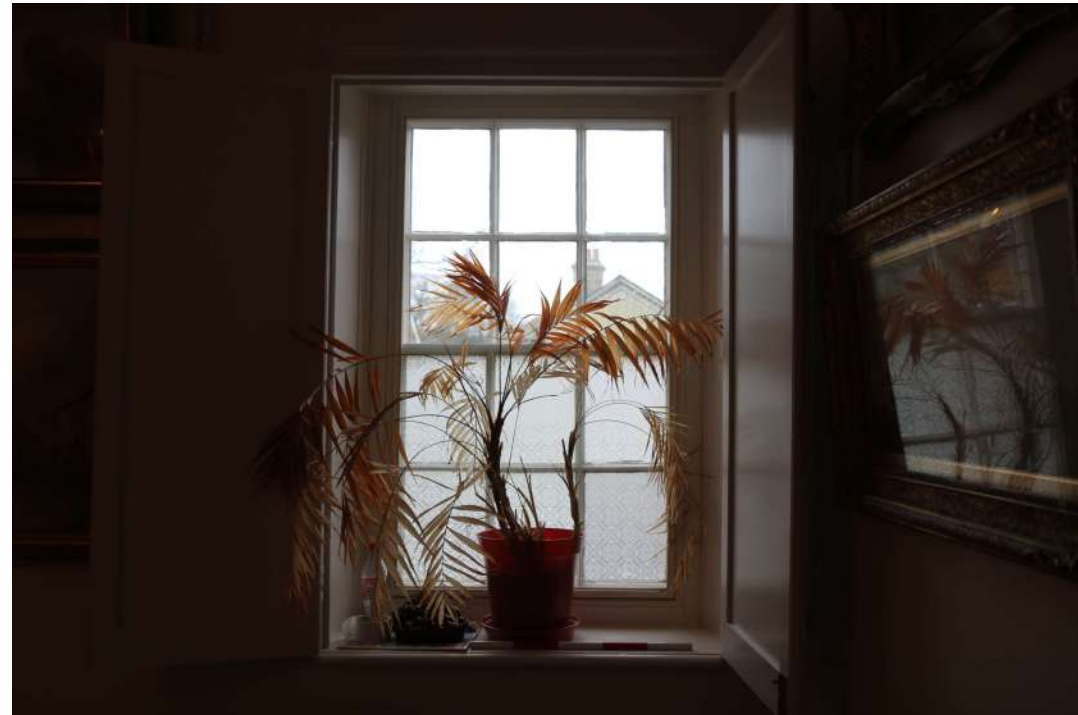
2025.12g\_Photograph\_128  
Detail of window in south-western wall of bedroom 4. Photograph taken facing south-west.

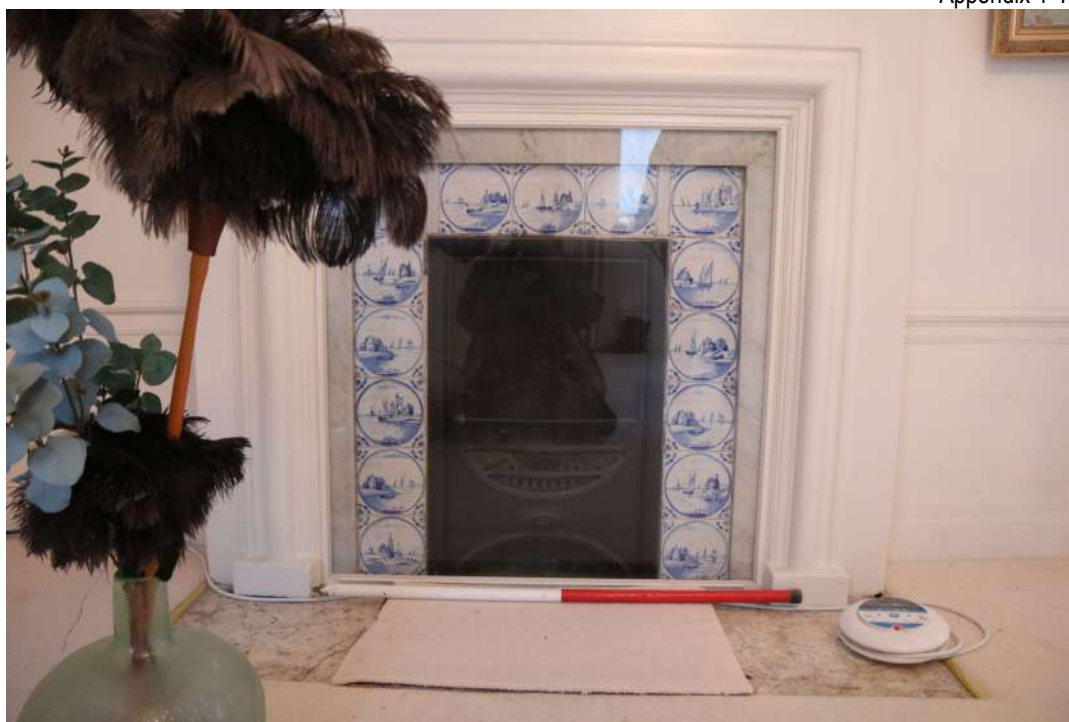
2025.12g\_Photograph\_129  
Detail of fireplace in south-western wall of bedroom 4. Photograph taken facing south-western.

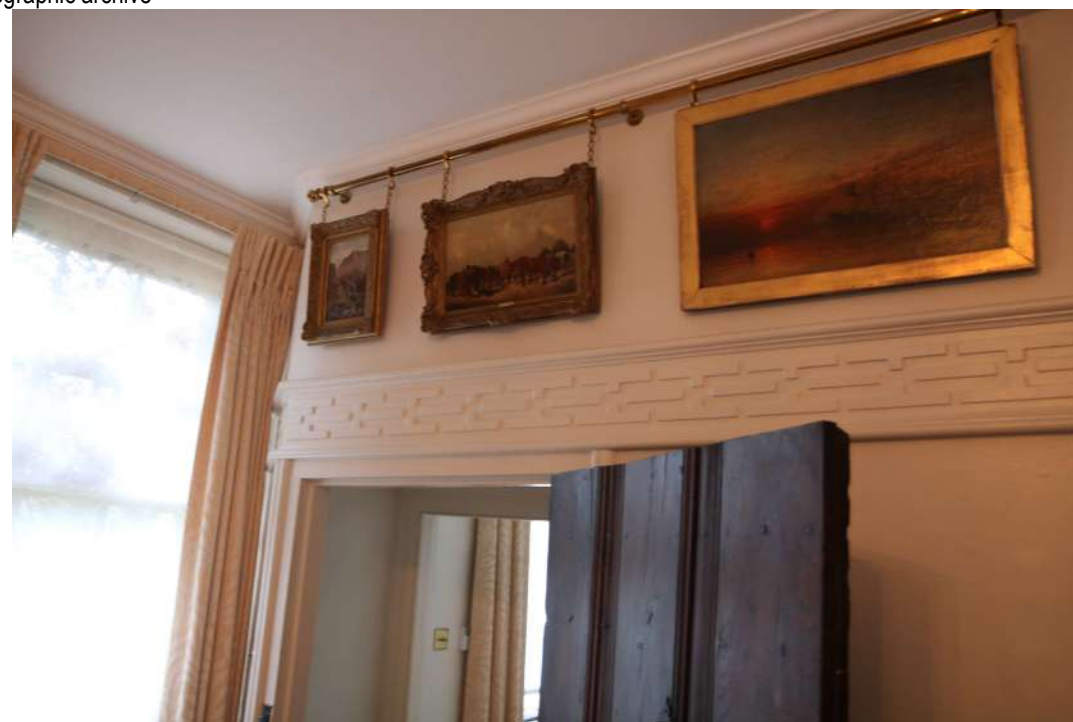
2025.12g\_Photograph\_130  
Detail of decorative frieze on south-eastern wall of bedroom 4. Photograph taken facing south south-east.

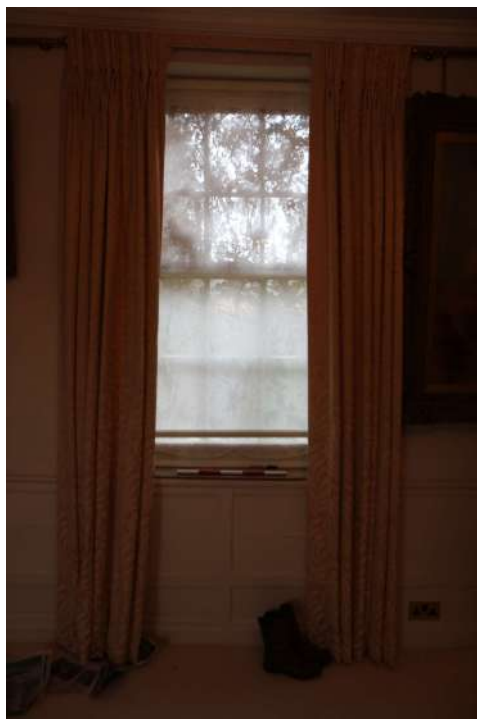
2025.12g\_Photograph\_131  
Detail of window in north-eastern wall of bedroom 4. Photograph taken facing north-east.

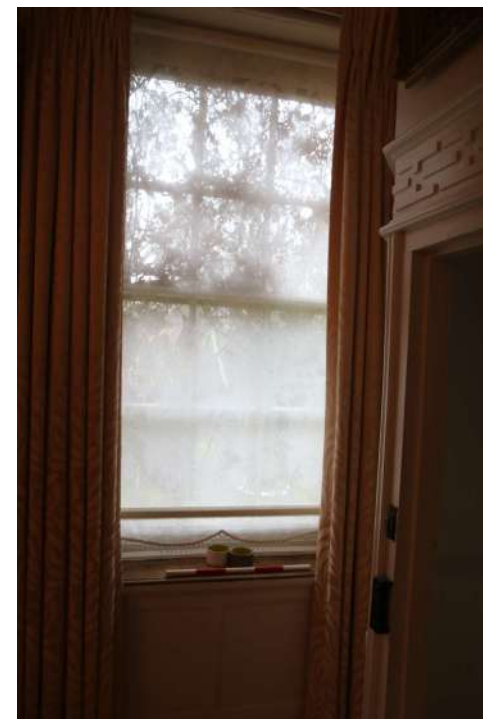
2025.12g\_Photograph\_132  
Detail of window in north-eastern wall of bedroom 4. Photograph taken facing north-east.

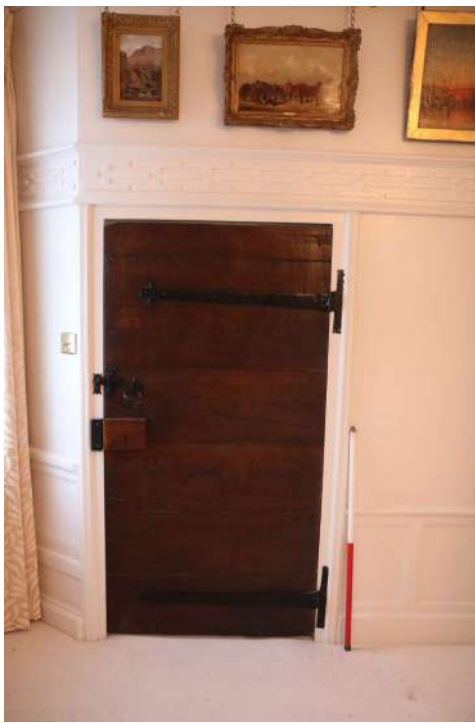
2025.12g\_PhotoGraph\_133  
Detail of door in south-eastern wall of bedroom 4. Photograph taken facing south-east.

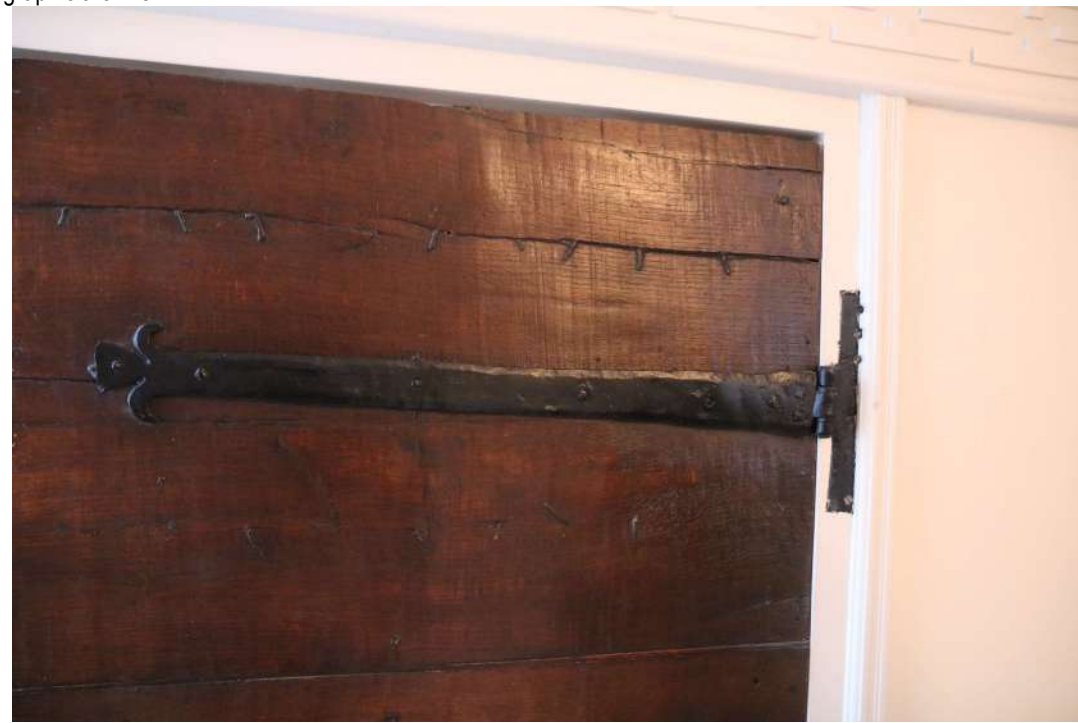
2025.12g\_PhotoGraph\_134  
Detail of strap hinge on door in south-eastern wall of bedroom 4. Photograph taken facing south-east.

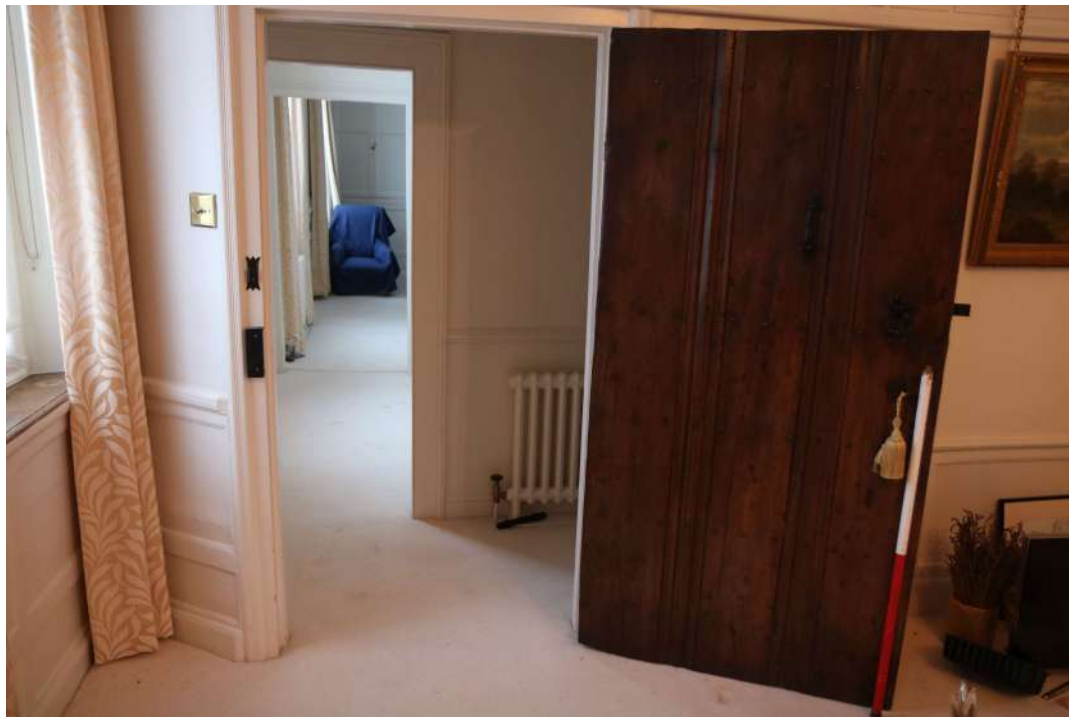
2025.12g\_PhotoGraph\_135  
Detail of door in south-eastern wall of bedroom 4. Photograph taken facing south-east.

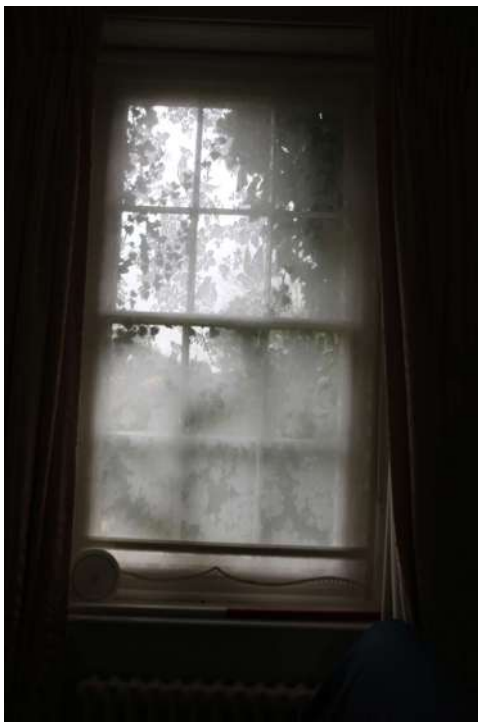
2025.12g\_Photograph\_144  
Detail of window in north-eastern wall of bedroom 5. Photograph taken facing north-east.

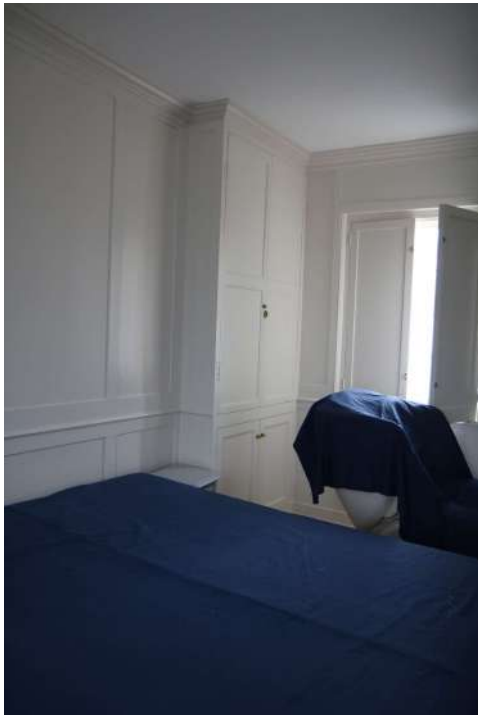
2025.12g\_Photograph\_146  
Detail in built-in cupboard in south-eastern wall of bedroom 5. Photograph taken facing south-east.

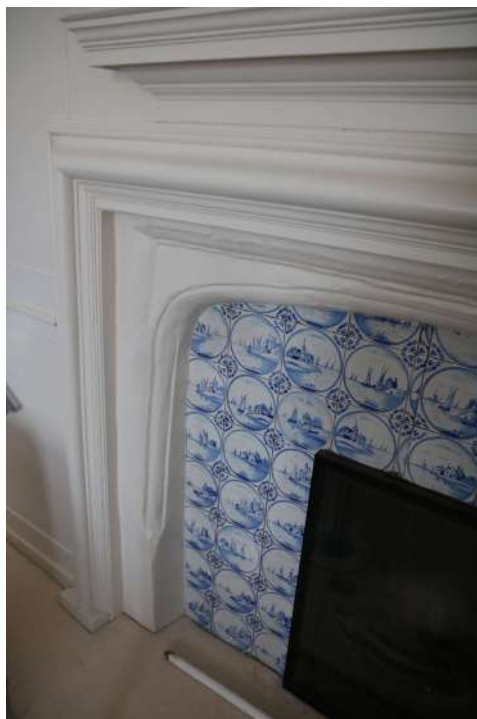
2025.12g\_Photograph\_150

Detail of fireplace in south-western wall of bedroom 5. Photograph taken facing south-west.

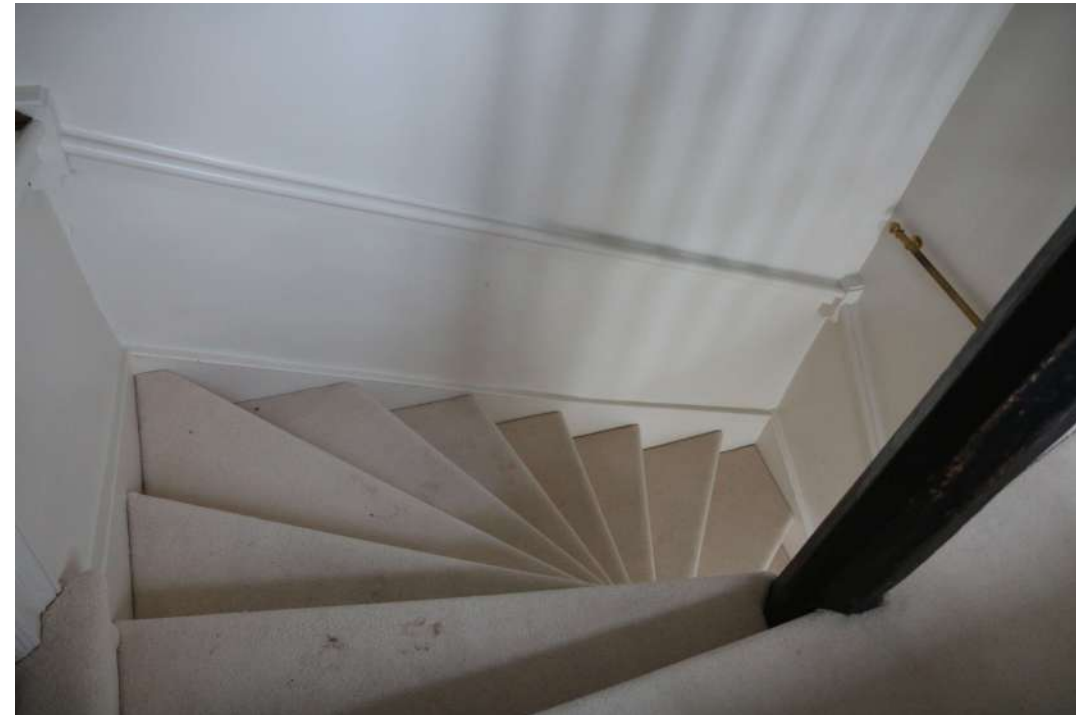
2025.12g\_Photograph\_155  
Detail of hand-carved post in staircase 1. Photograph taken facing south.

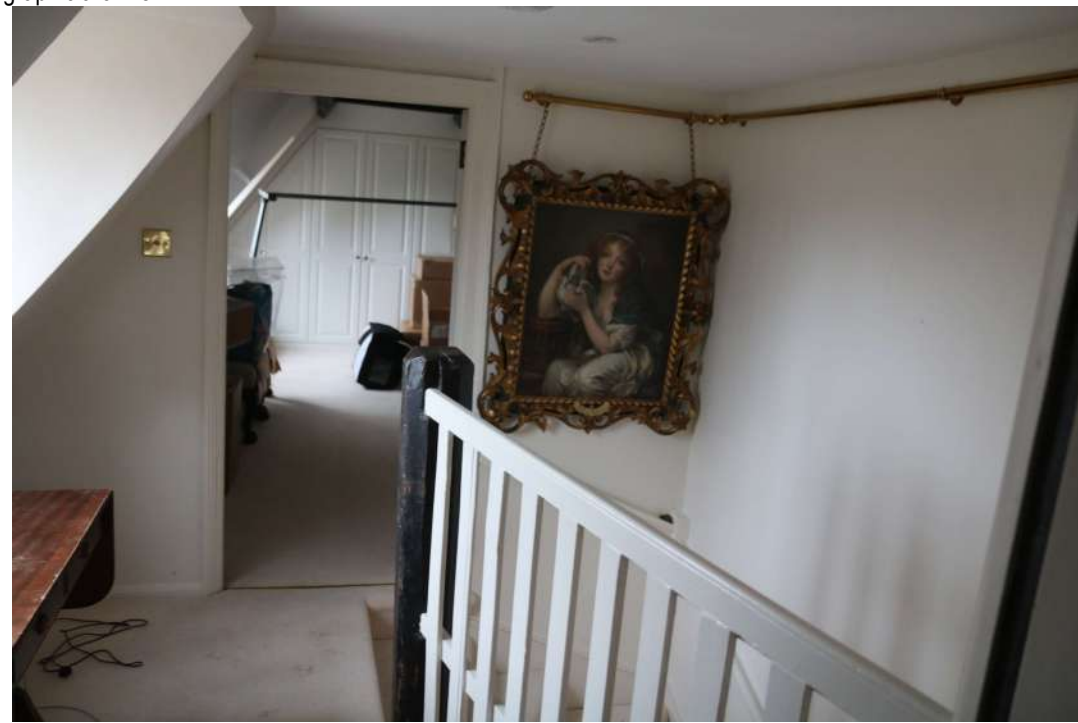
2025.12g\_Photograph\_157  
Detail of hand-carved newel post in staircase 1 (second floor). Photograph taken facing south.

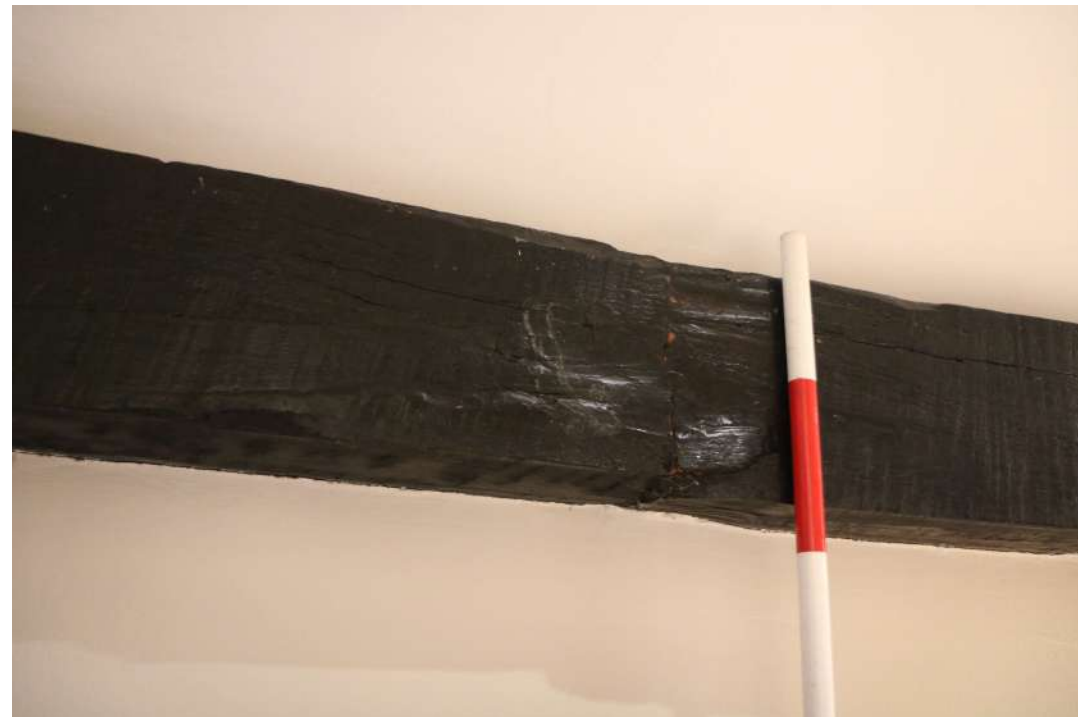
2025.12g\_PhotoGraph\_167  
Detail of exposed purlins in ceiling of bedroom 7. Photograph taken facing south-east.

The roof structure of range 1 is largely obscured by modern plaster. It is presumably a later replacement and comprises pairs of rafters, with a purlin on each roof pitch, as can be seen in the ceiling of bedroom 7 (discussed below). Range 2 has a gabled roof formed from pairs of rafters, which

Purlins are exposed in the ceiling of bedroom 7, which appear to be hand-sawn with modern machine-cut repairs (Photograph 40). A possible scarf-joint is present in the south-western purlin, but its type was not discernible at the time of recording.

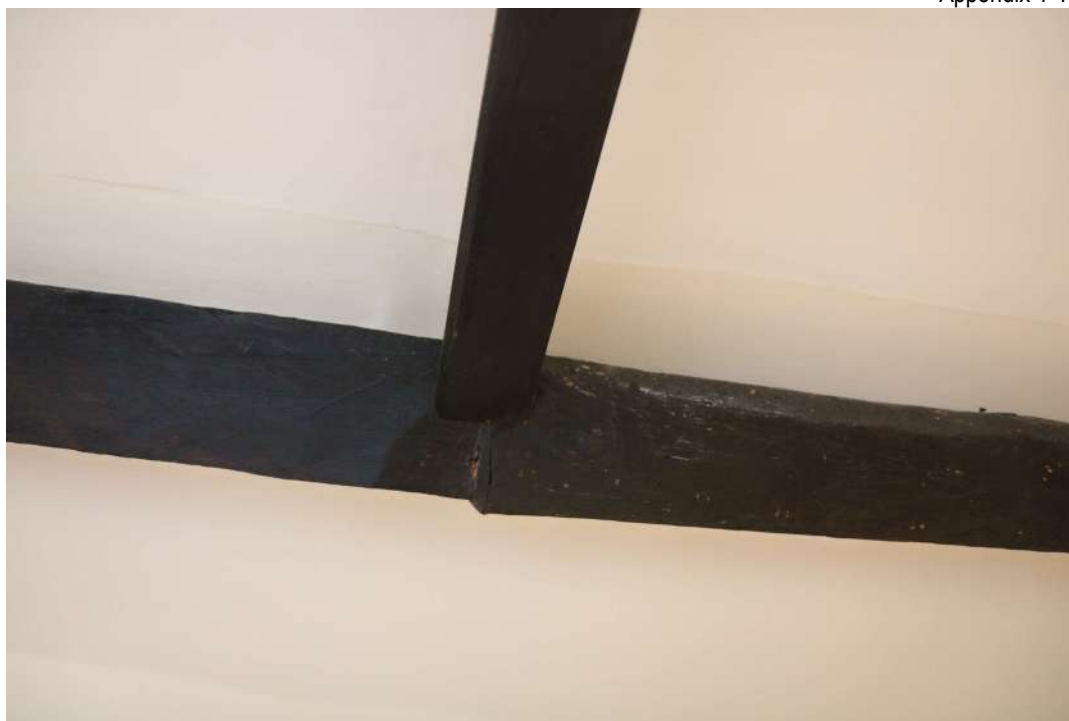
2025.12g\_PhotoGraph\_168  
Detail of possible scarf-joint in south-western purlin in bedroom 7. Photograph taken facing west.

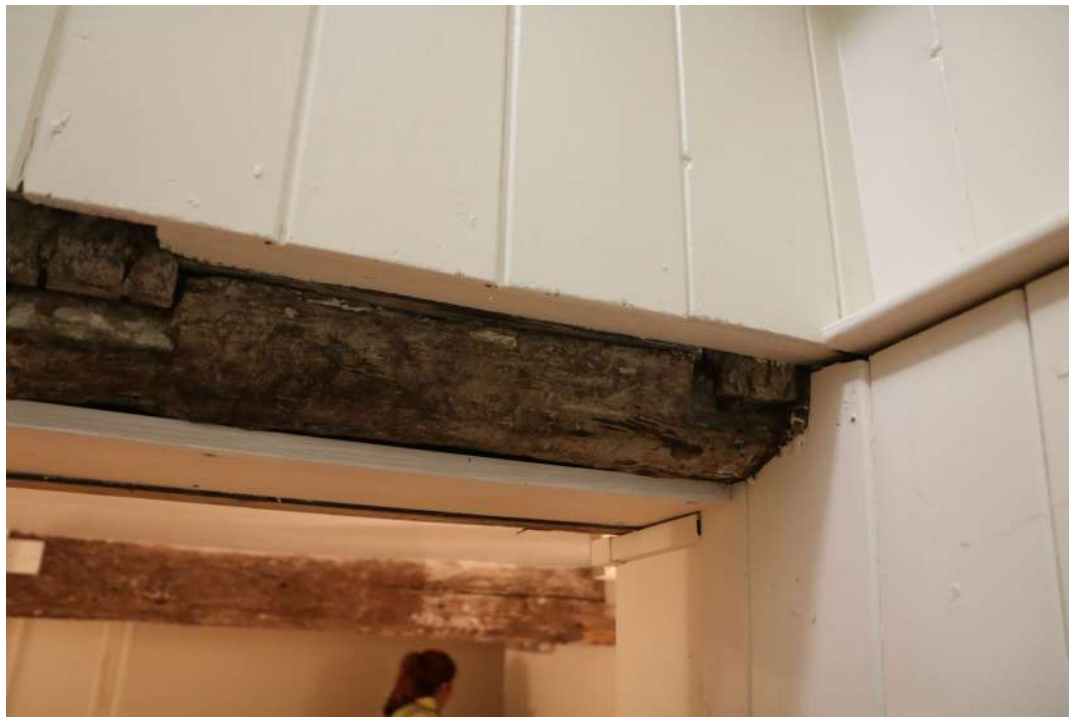
2025.12g\_PhotoGraph\_178  
Detail of exposed timber in basement ceiling. Photograph taken facing south-east.

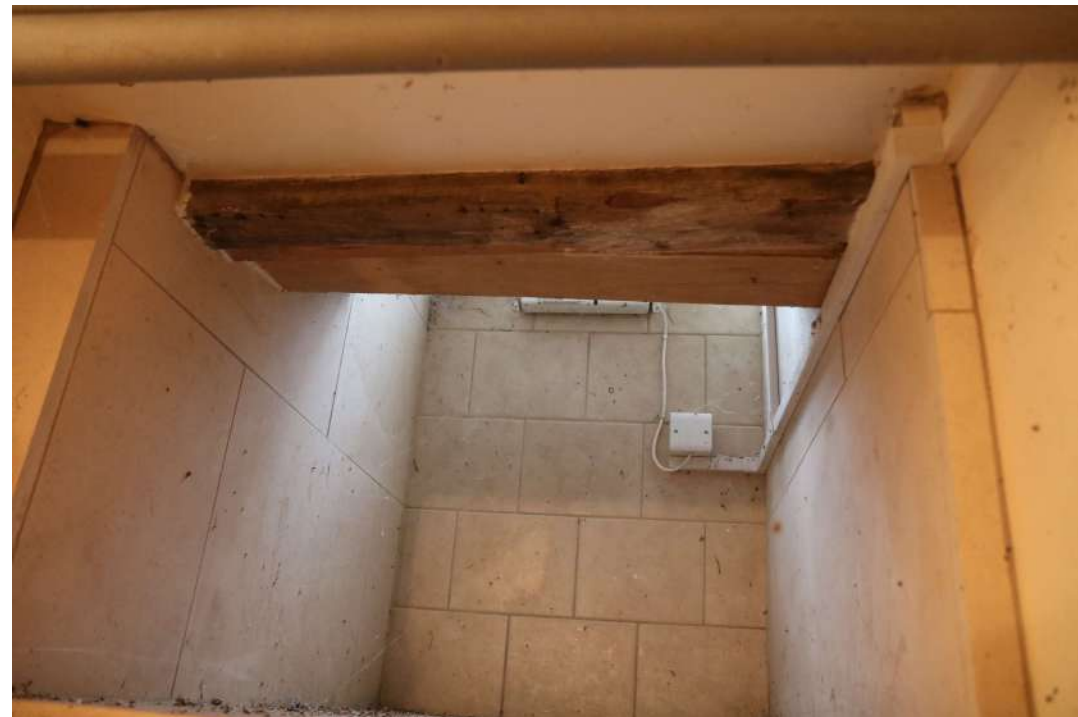
2025.12g\_PhotoGraph\_179  
Detail of exposed timber in basement ceiling. Photograph taken facing south.

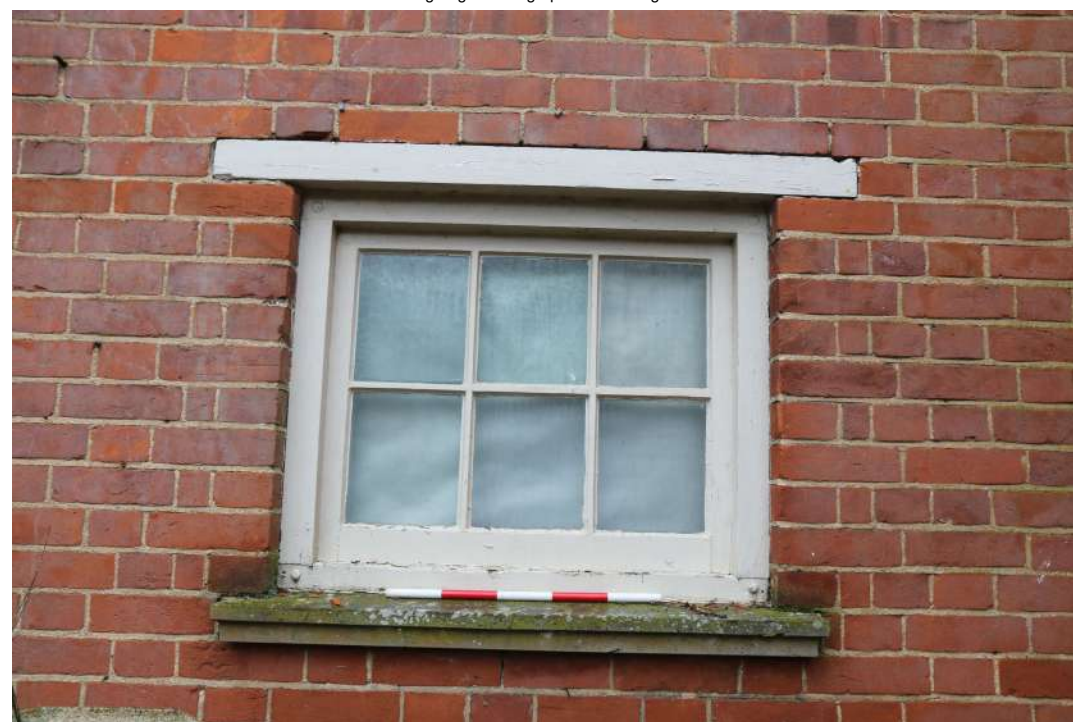
2025.12g\_PhotoGraph\_195  
North-eastern elevation of studio (range 4). Photograph taken facing south-west.

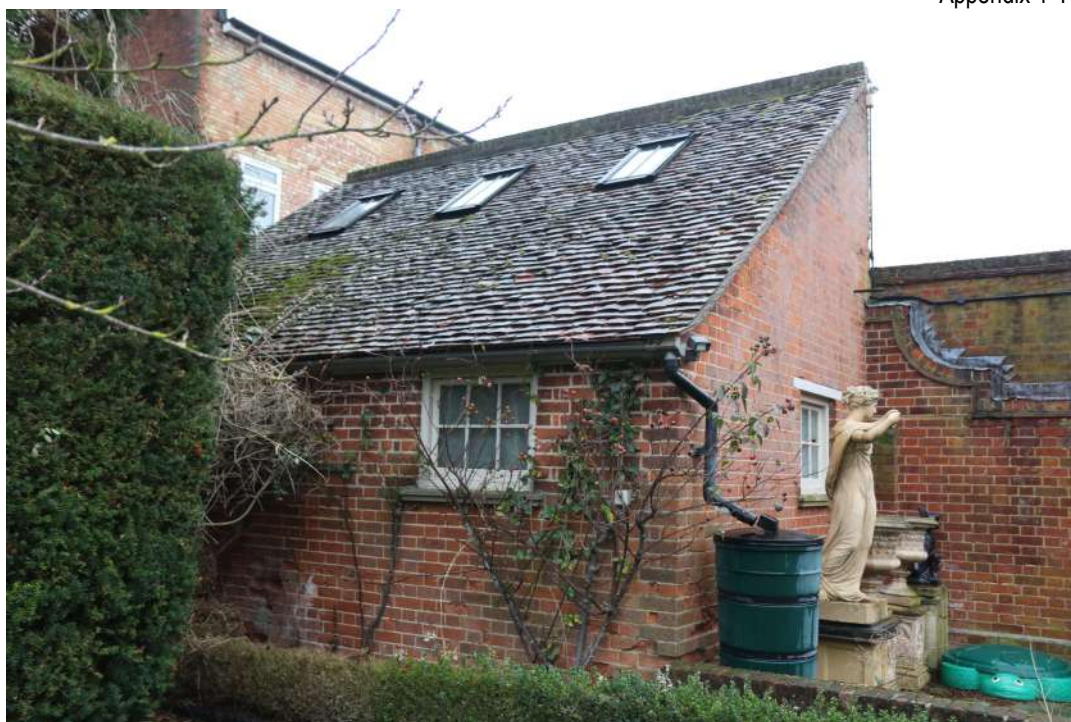
2025.12g\_PhotoGraph\_196  
Detail of window in north-eastern elevation of studio (range 4). Photograph taken facing south-west.

The studio has windows in the north-eastern and south-eastern elevations, all of which have been blocked from the interior of the building. They are all six-lights with a timber lintel and stone still. Each window is surrounded by queen closers. A set of replacement double doors is present in the north-western elevation of the studio, which are also flanked by queen closers. The north-western elevation of the storage shed is largely composed of yellow bricks, suggesting it has been rebuilt at some point. This is further evidence by the door in the elevation, which does not appear to have been inserted but

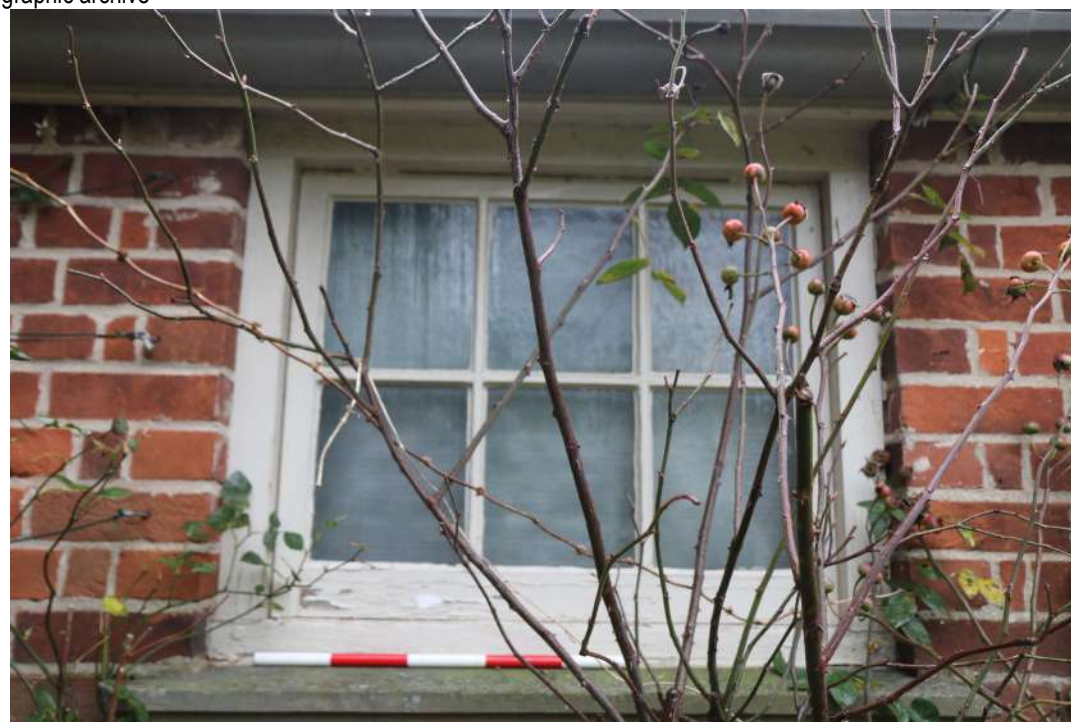
2025.12g\_Photograph\_197  
South-eastern elevation of studio (range 4). Photograph taken facing west.

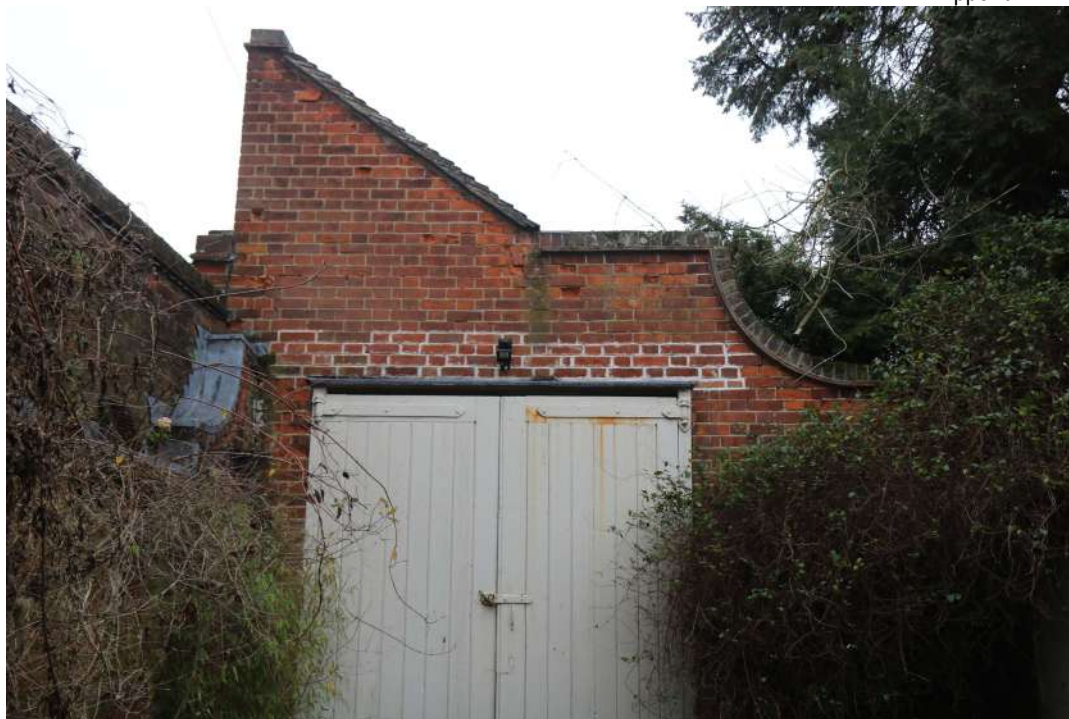
2025.12g\_Photograph\_200  
South-western elevation of studio (range 4). Photograph taken facing north-east.

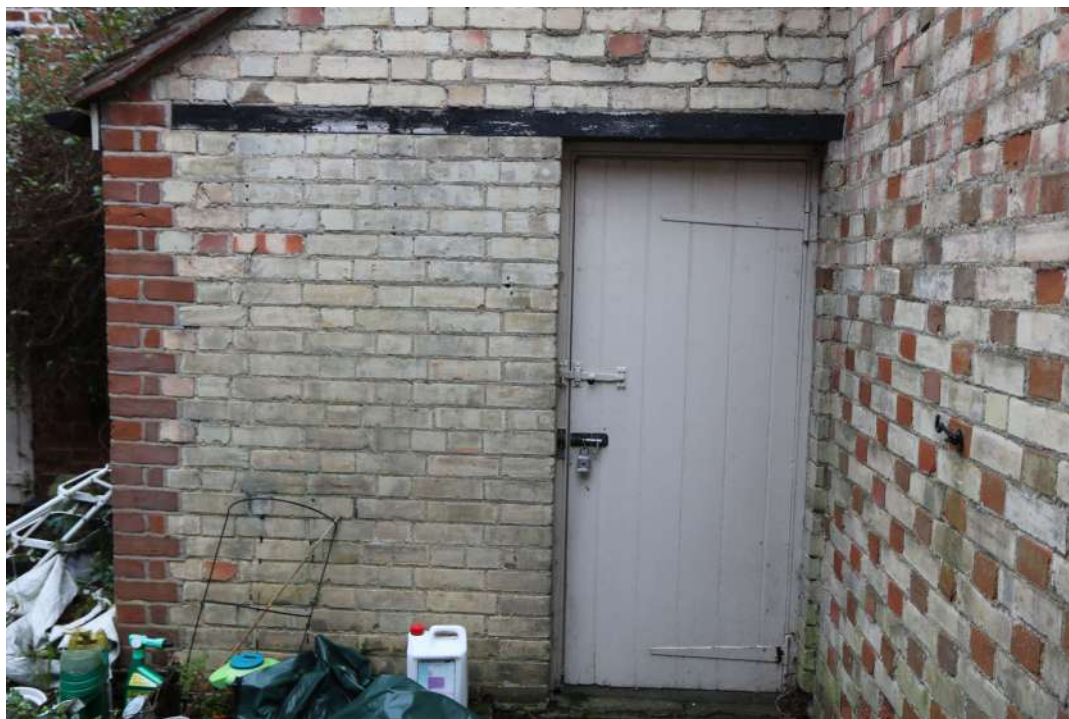
2025.12g\_Photograph\_202

Detail of doors on south-western elevation of studio (range 4). Photograph taken facing north-east.

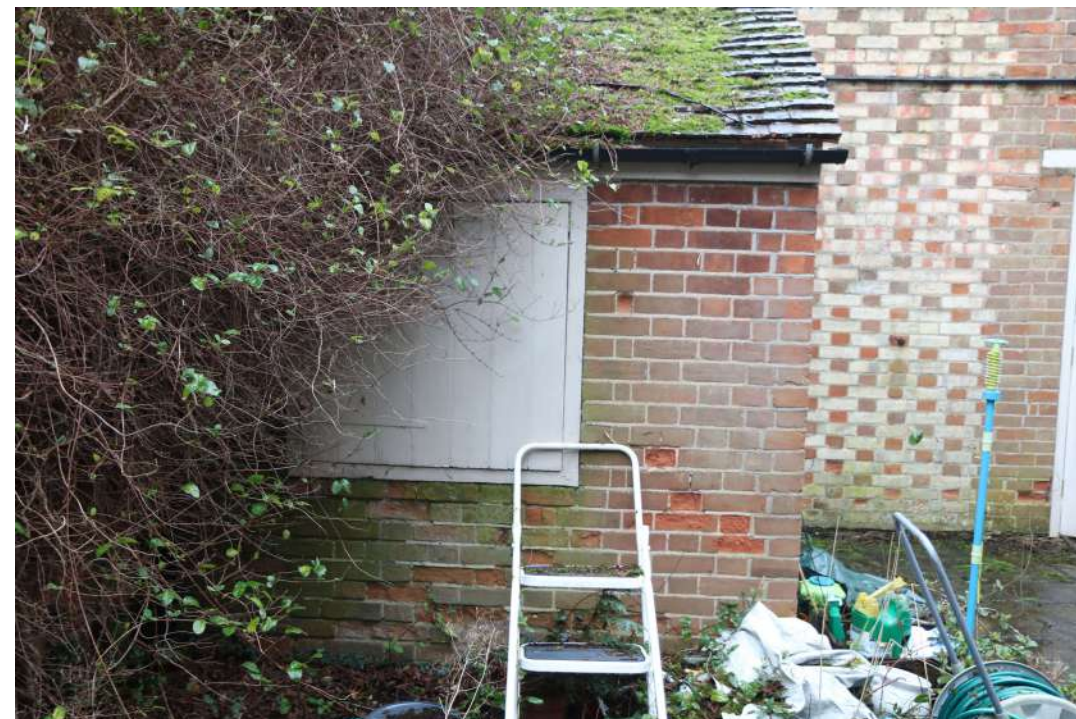
2025.12g\_Photograph\_203

South-western elevation of storage shed (range 4). Photograph taken facing north-east.
