**CAT Report 2257  
Issued March 2026**

**Historic building recording of  
The Old Palace, 23 Kneesworth Street, Royston,  
Hertfordshire, SG8 5AB**

**CAT project ref.: 2025/12g  
CAT Report 2257  
OASIS id: colchest3-540229**

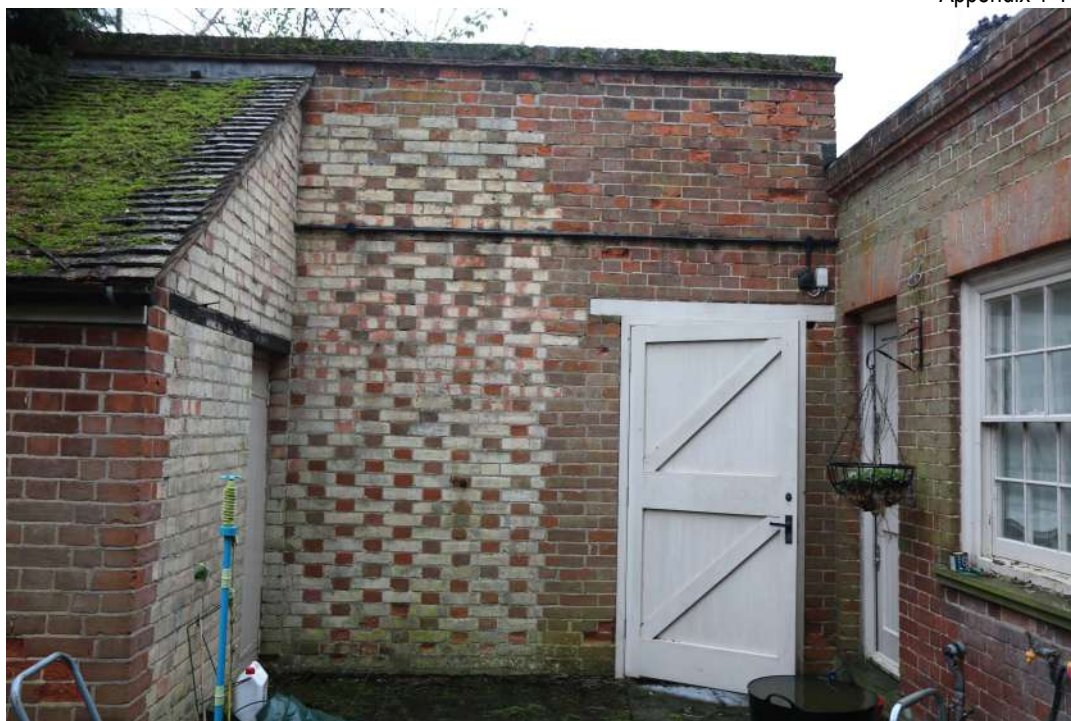
2025.12g\_Photograph\_204

North-western elevation of storage shed (range 4). Photograph taken facing south-east.

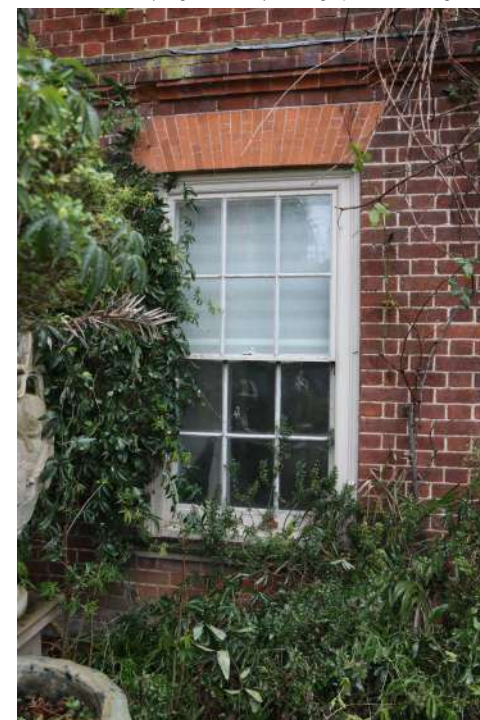
2025.12g\_Photograph\_207  
Detail of window in south-eastern elevation, ground floor (range 3). Photograph taken facing north-west.

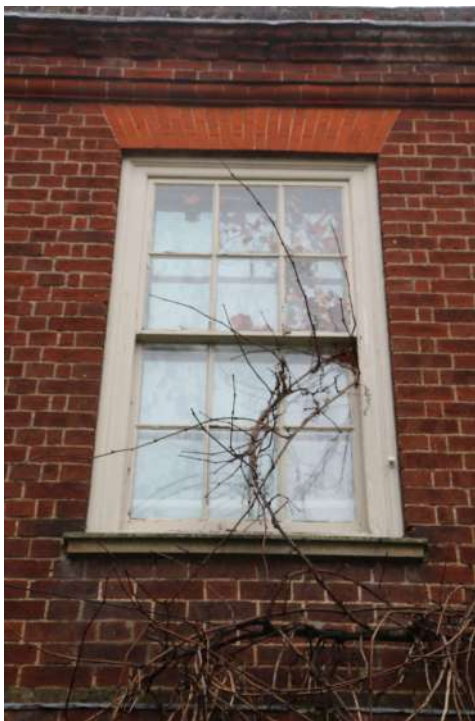
2025.12g\_Photograph\_208  
Detail of window in south-eastern elevation, ground floor (range 3). Photograph taken facing west north-west.

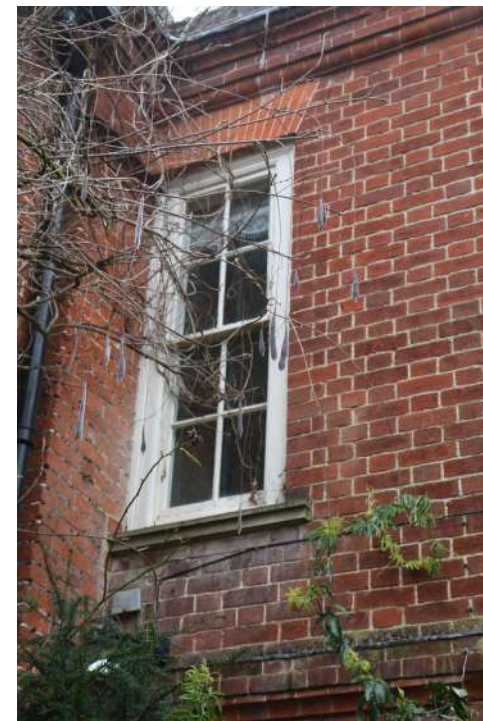
2025.12g\_Photograph\_209

Detail of window on south-eastern elevation, first floor (range 3). Photograph taken facing north-west.

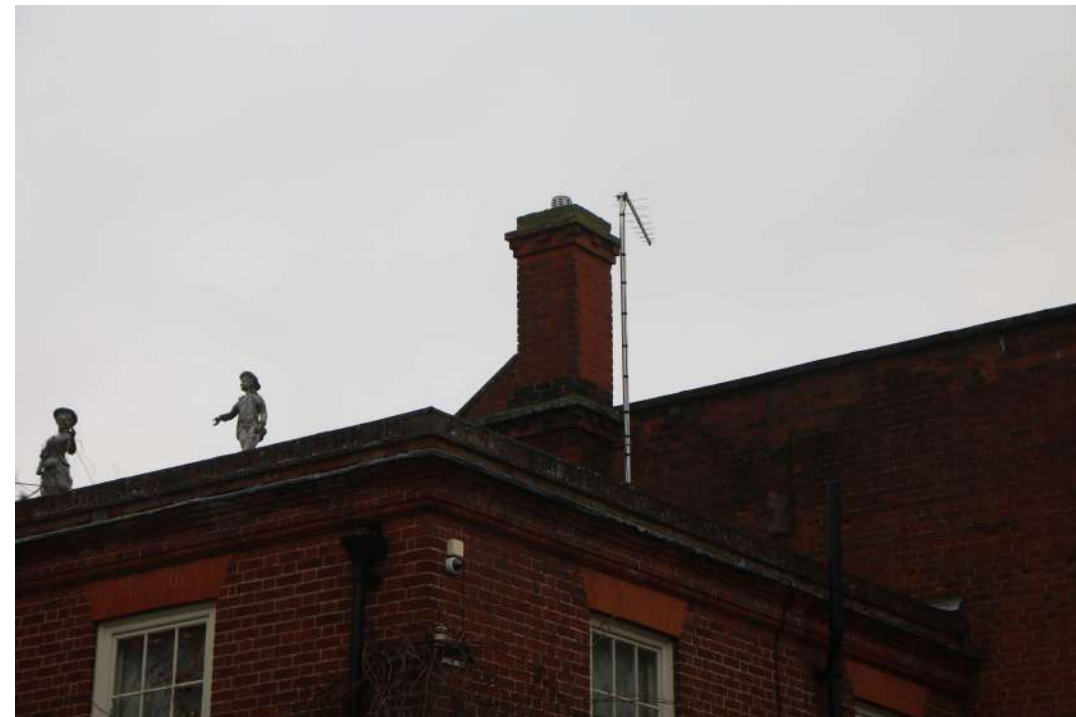
2025.12g\_Photograph\_211

North-eastern and south-eastern elevation (ranges 1, 3 and 4). Photograph taken facing west.

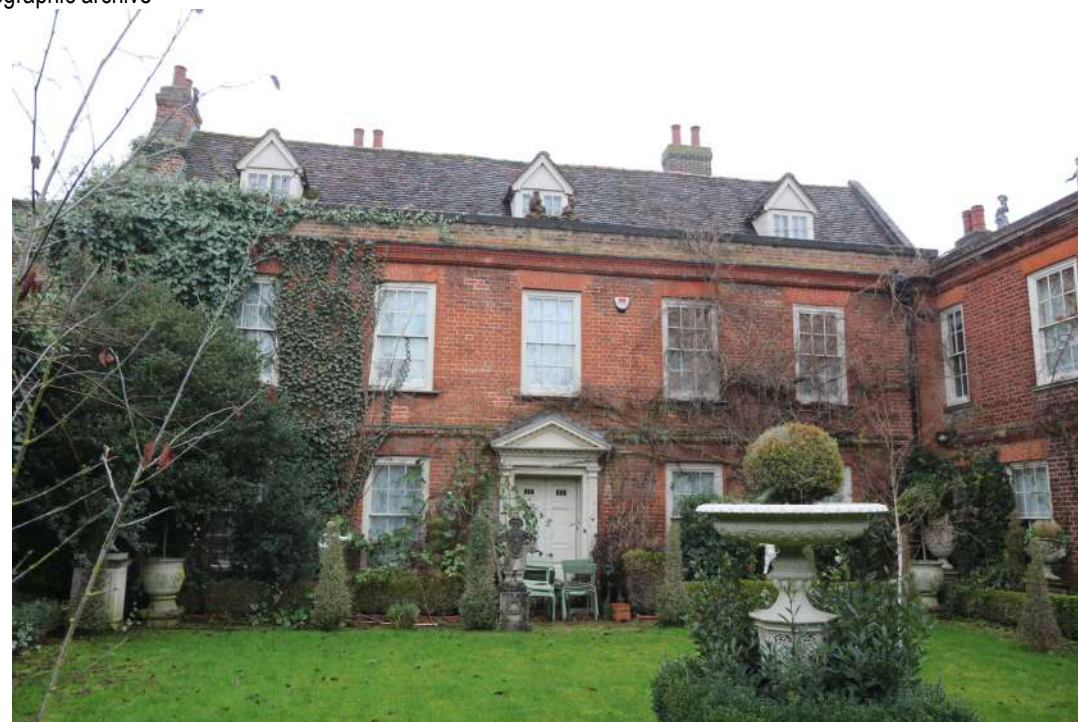
2025.12g\_Photograph\_213  
North-eastern elevation (range 1). Photograph taken facing south-west.

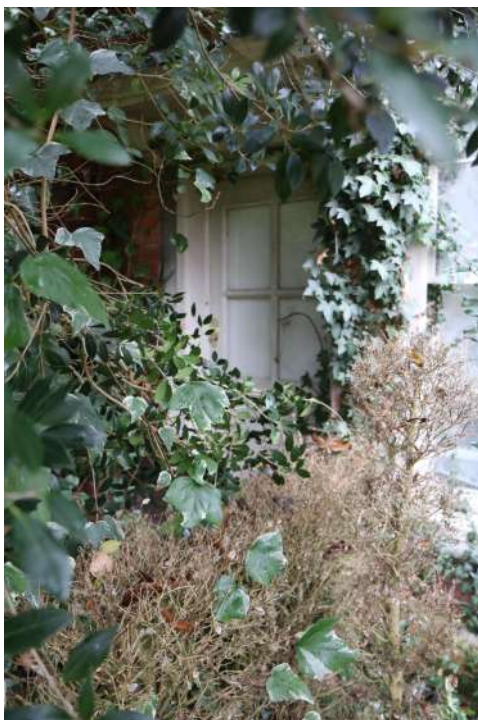
2025.12g\_Photograph\_214  
North-eastern elevation (range 1). Photograph taken facing west south-west.

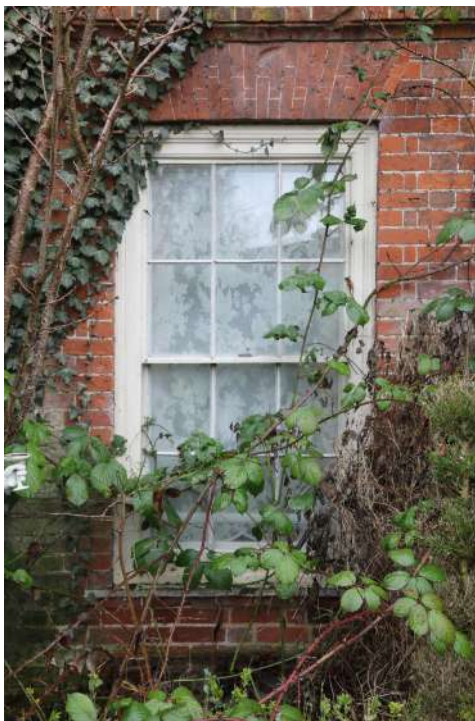
2025.12g\_Photograph\_216  
Detail of window in north-eastern elevation, ground floor (range 1). Photograph taken facing north-west.

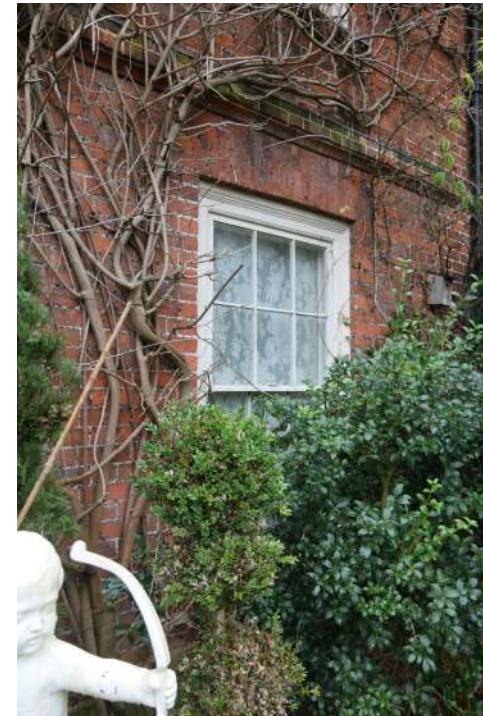
2025.12g\_Photograph\_219

Detail of window in north-eastern elevation, ground floor (range 1). Photograph taken facing west.

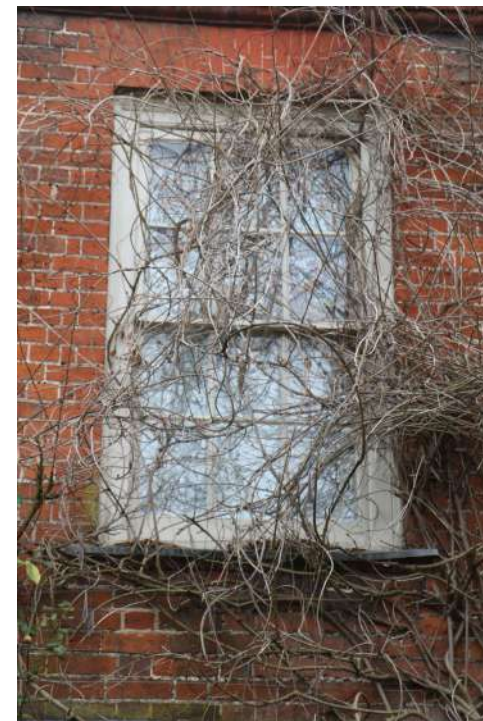
2025.12g\_Photograph\_221

Detail of windows in north-eastern elevation, first floor (range 1). Photograph taken facing south-west.

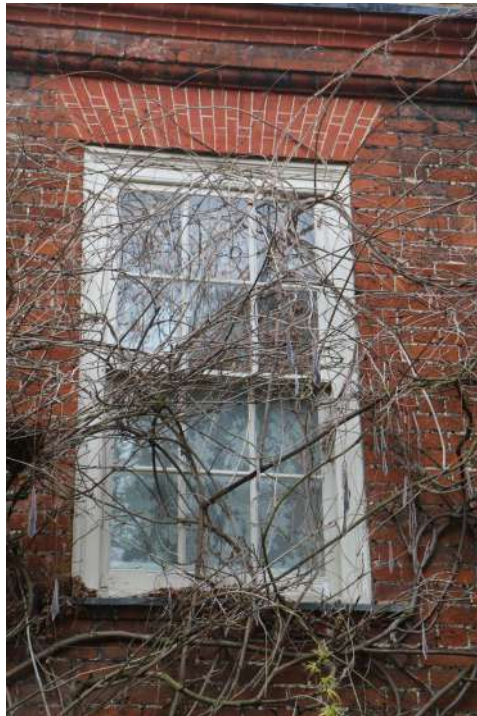
2025.12g\_Photograph\_222

Detail of window in north-eastern elevation, first floor (range 1). Photograph taken facing south-west.

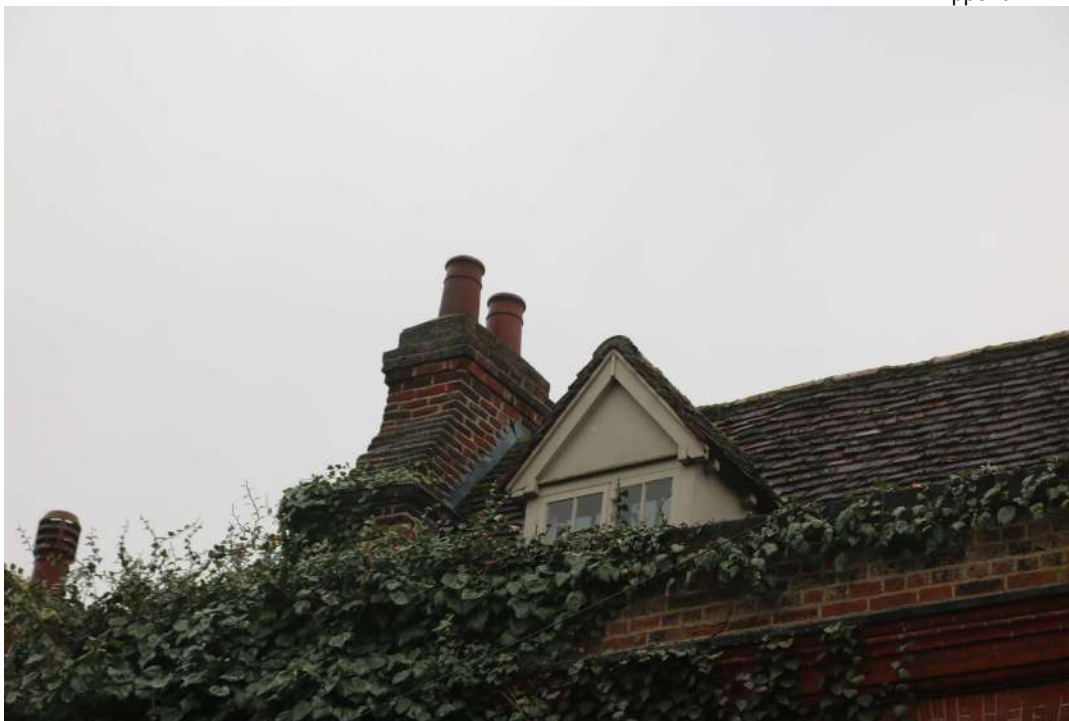
2025.12g\_Photograph\_224

Detail of dormer window, north-eastern elevation (range 1). Photograph taken facing south-west.

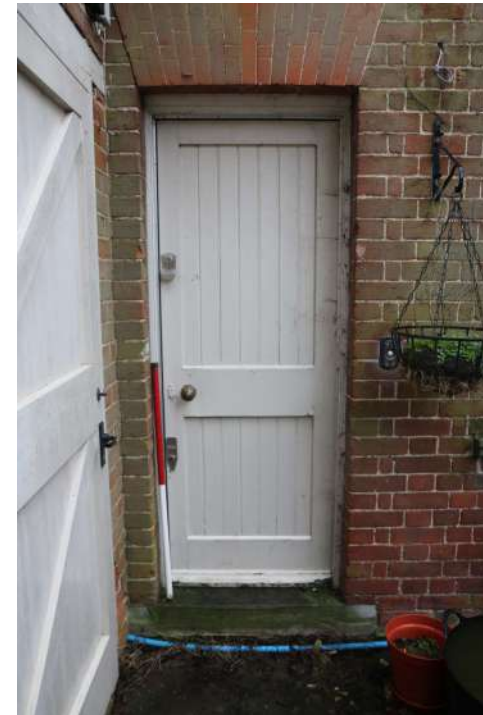
2025.12g\_Photograph\_227  
North-eastern elevation (range 3). Photograph taken facing south south-west.

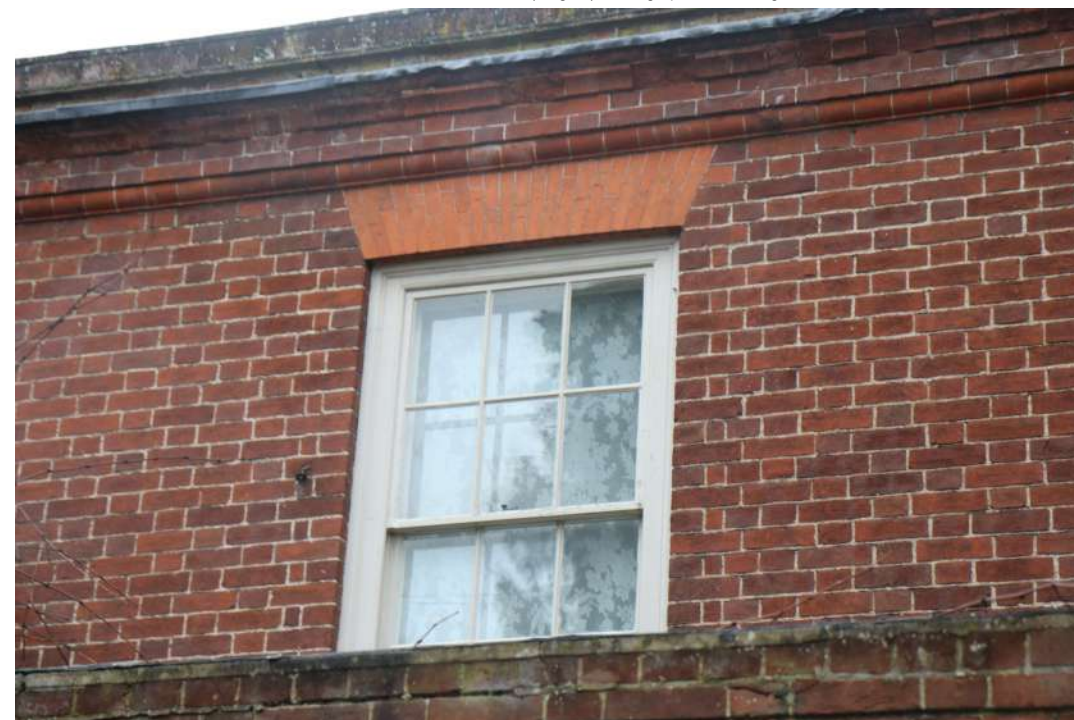
2025.12g\_Photograph\_231  
Detail of window on north-eastern elevation, first floor (range 3). Photograph taken facing south-west.

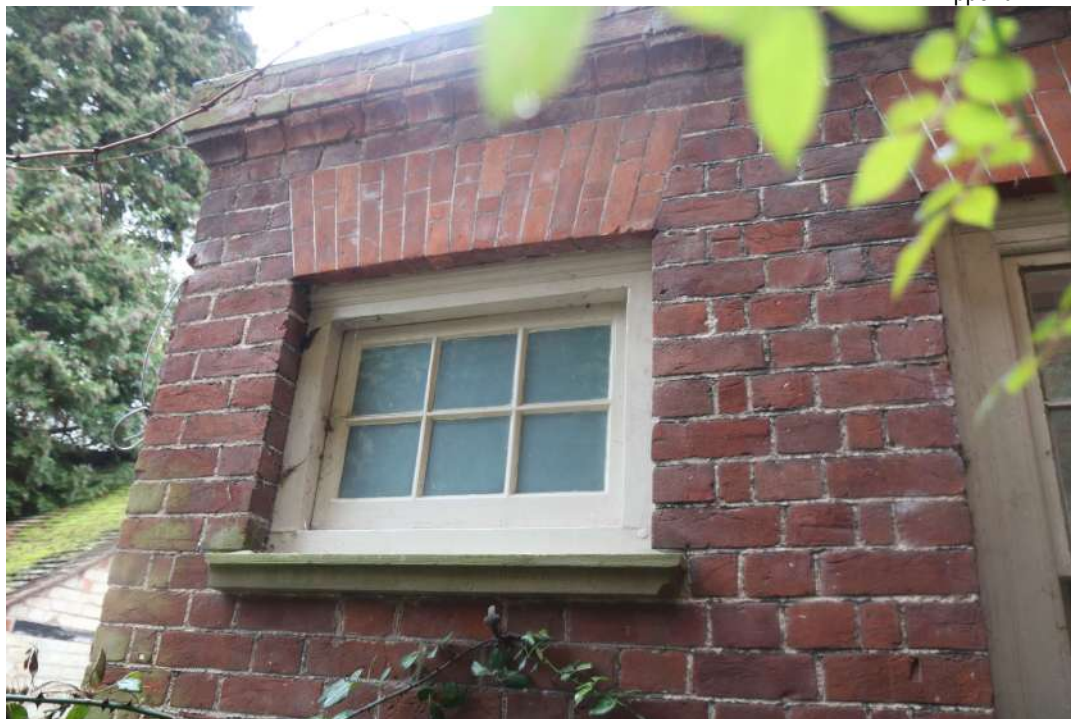
2025.12g\_Photograph\_232  
Detail of window on north-eastern elevation, first floor (range 3). Photograph taken facing south south-west.

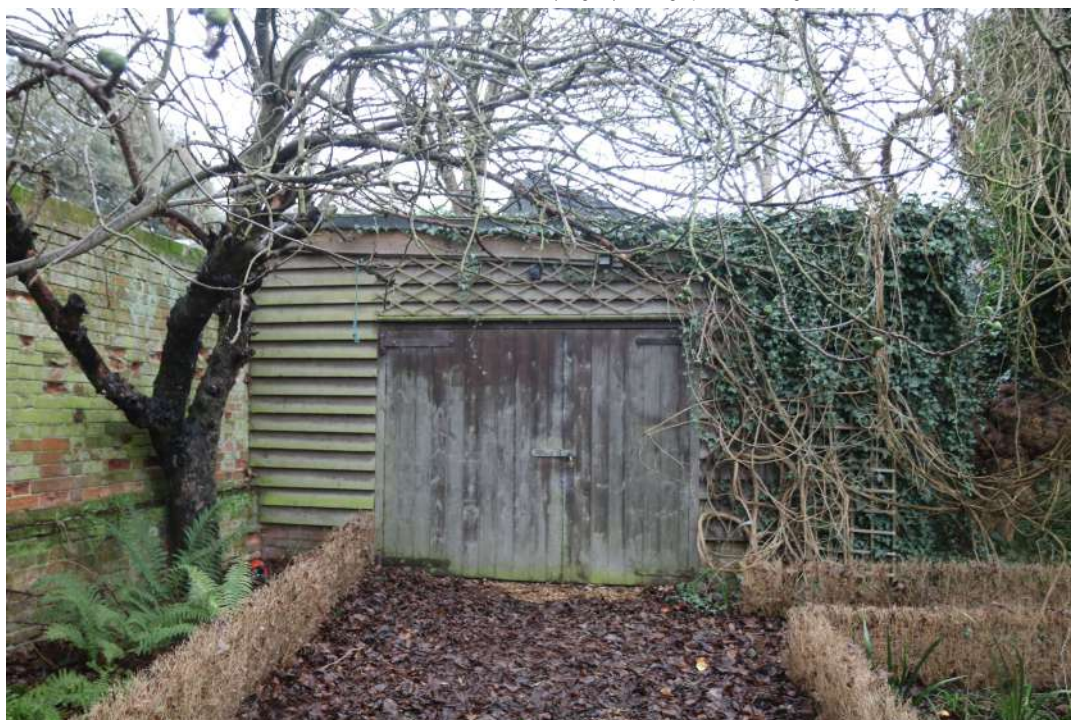
2025.12g\_Photograph\_234  
South-eastern elevation (range 4). Photograph taken facing north-west.

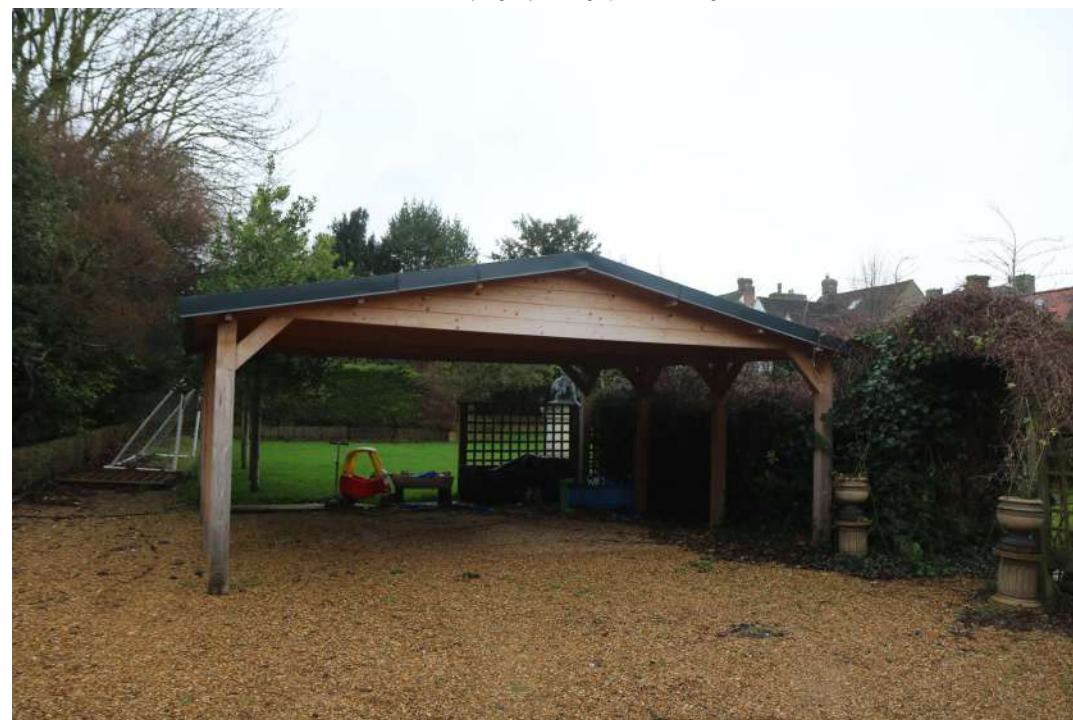
2025.12g\_Photograph\_235  
North-western elevation of garage. Photograph taken facing south-east.

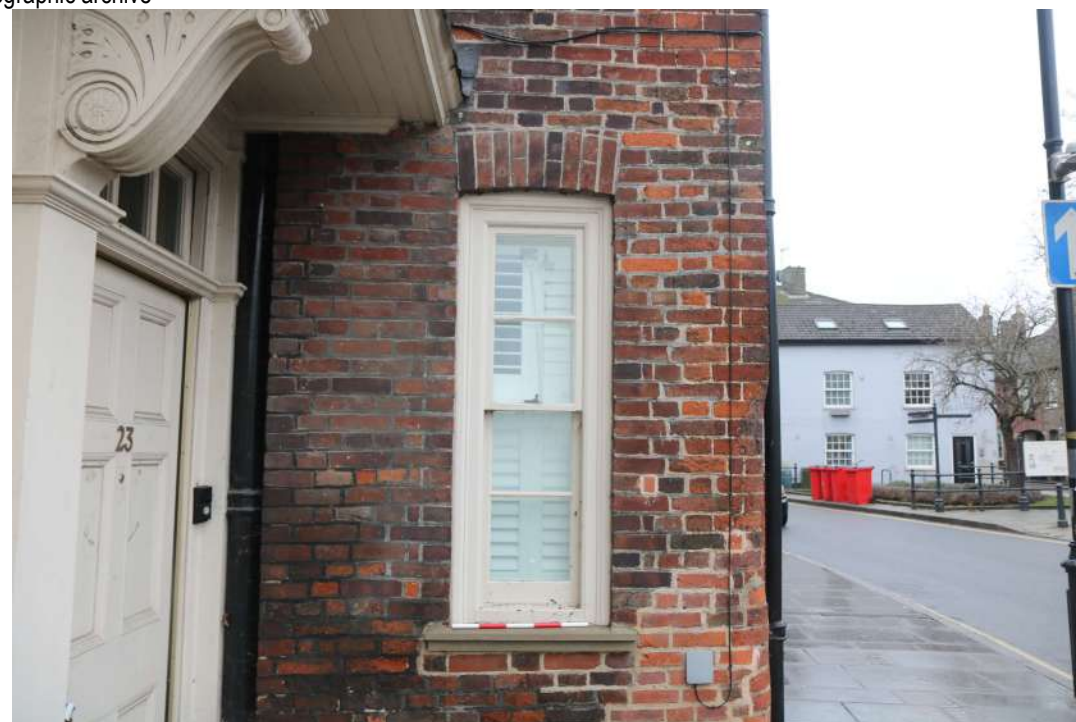
2025.12g\_Photograph\_237  
North-western elevation (ranges 1, 2 and 3). Photograph taken facing south-east.

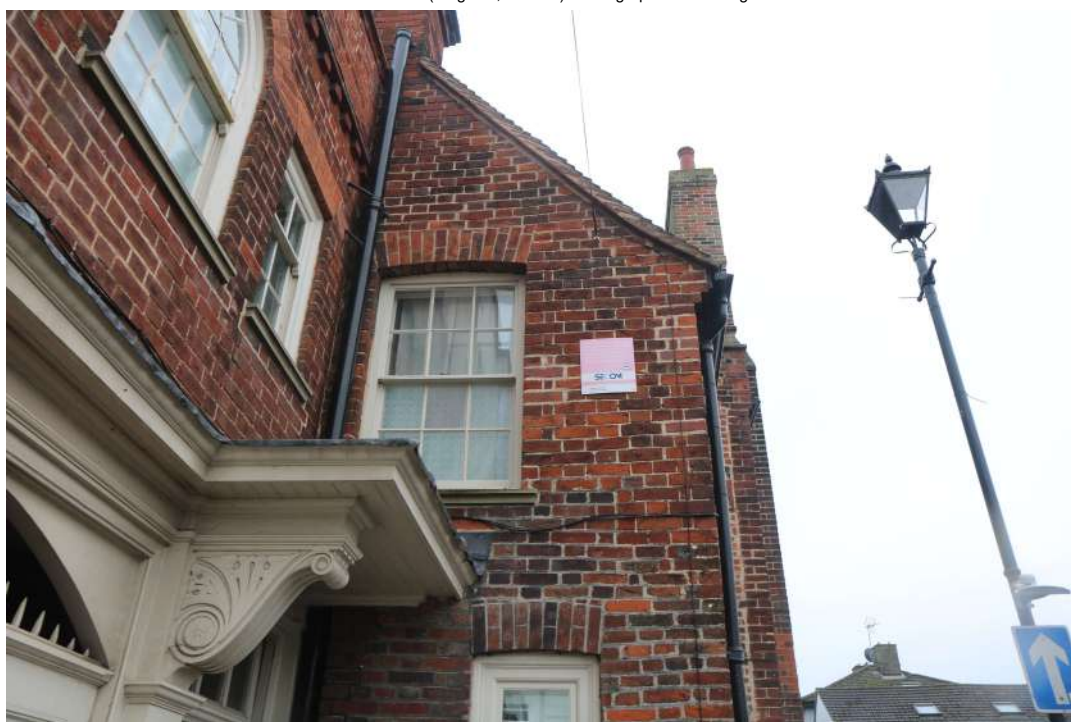
2025.12g\_Photograph\_238  
Detail of window in north-western elevation, first floor (range 2). Photograph taken facing south-east.

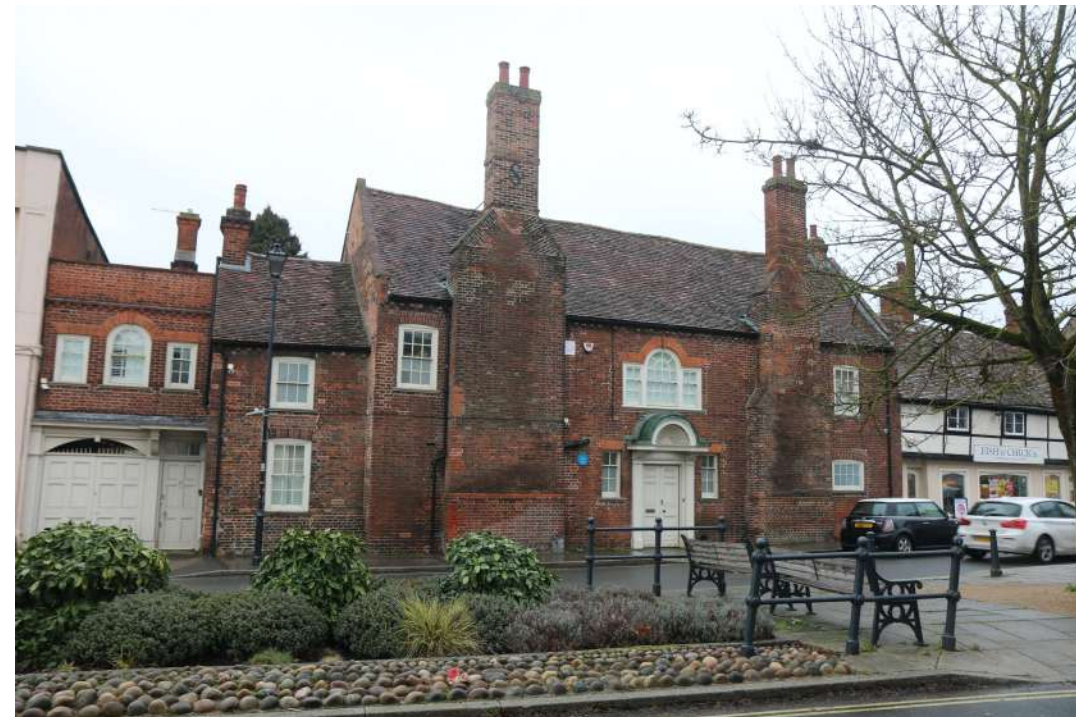
2025.12g\_Photograph\_243

South-western elevation (ranges 1, 2 and 3). Photograph taken facing north-east.

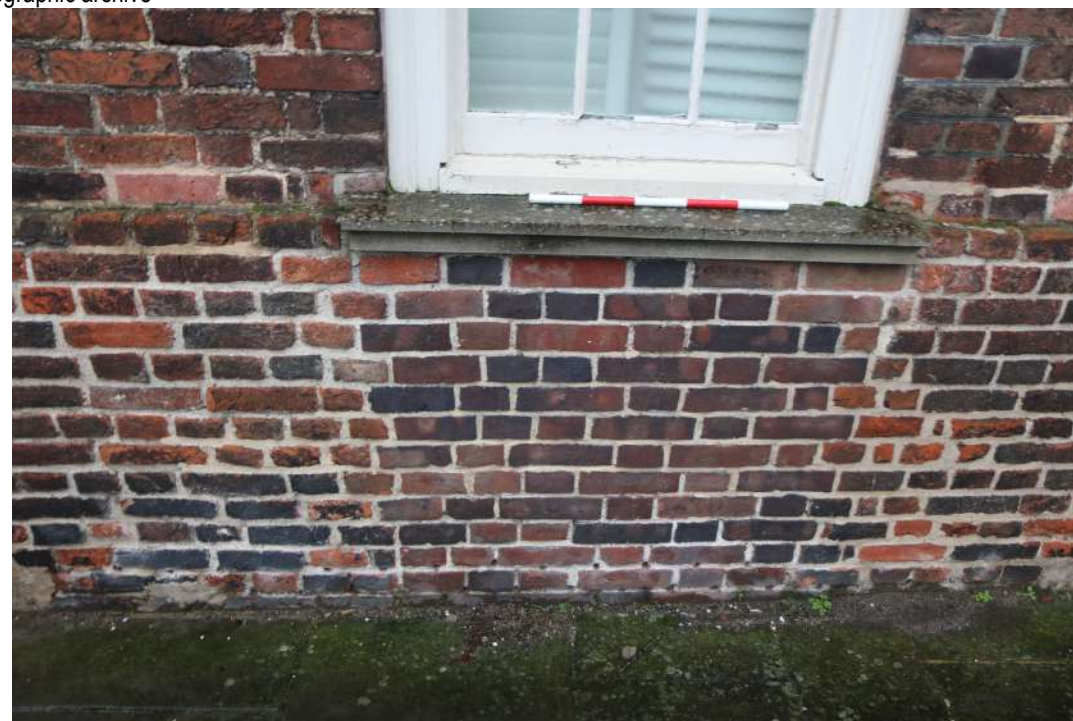
2025.12g\_Photograph\_249  
Detail of window in south-western elevation (range 2). Photograph taken facing north-east.

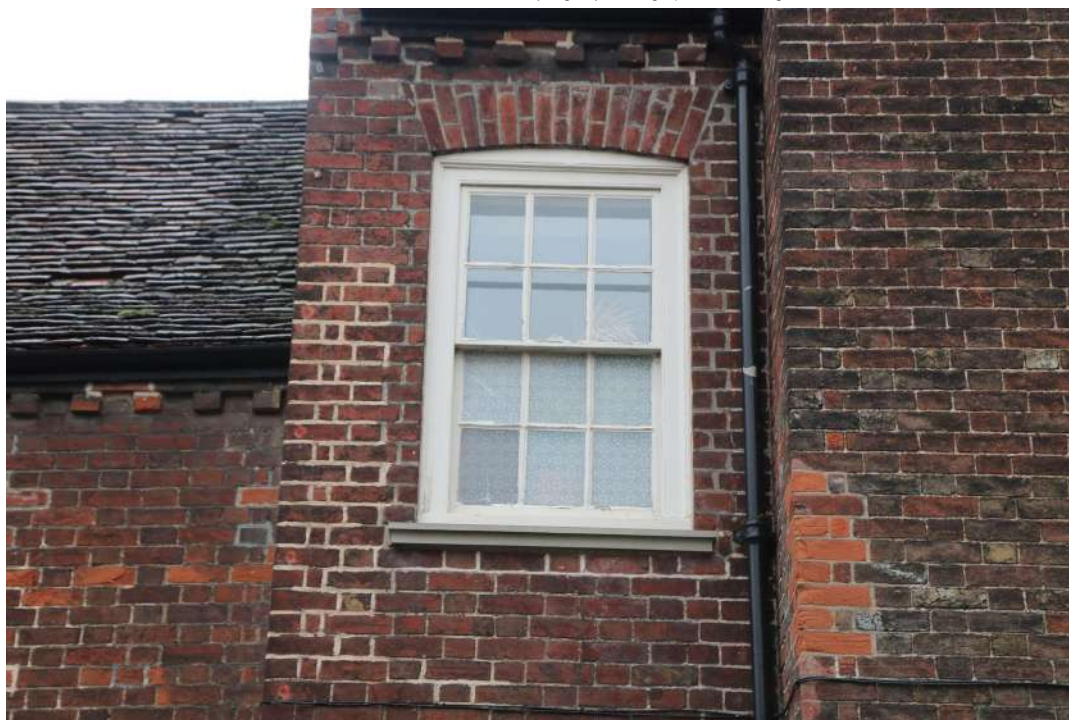
2025.12g\_Photograph\_250  
Detail of change in brickwork in south-western elevation (range 2). Photograph taken facing north-east.

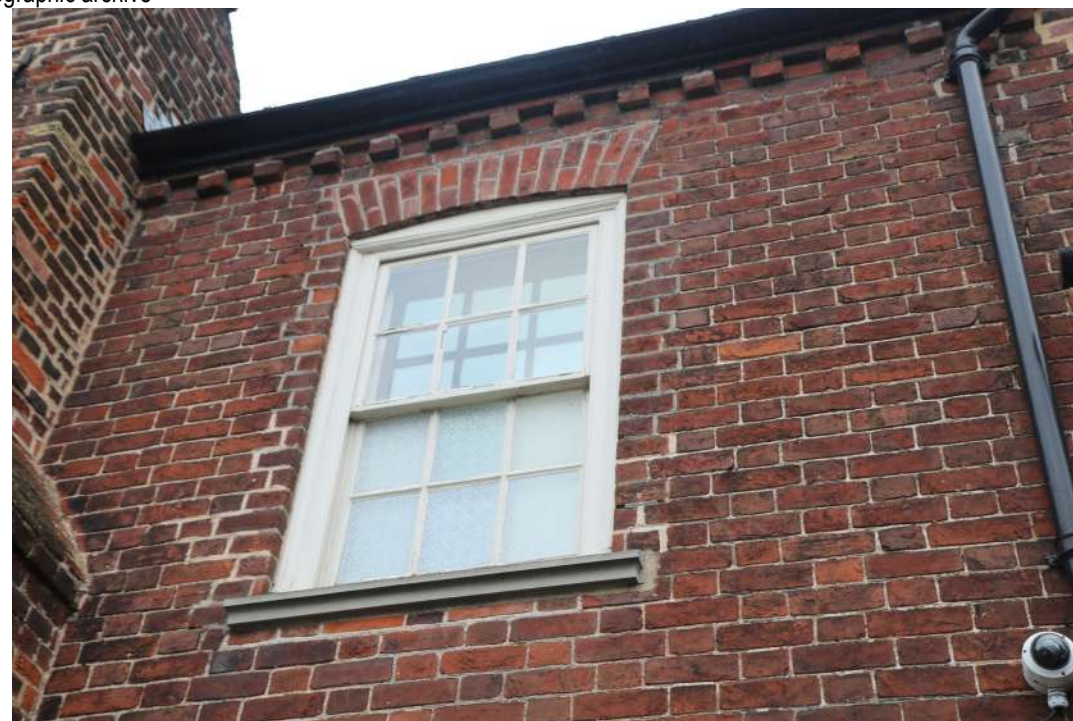
2025.12g\_PhotoGraph\_258  
Detail of window in north-western elevation, first floor (range 1). Photograph taken facing north north-east.

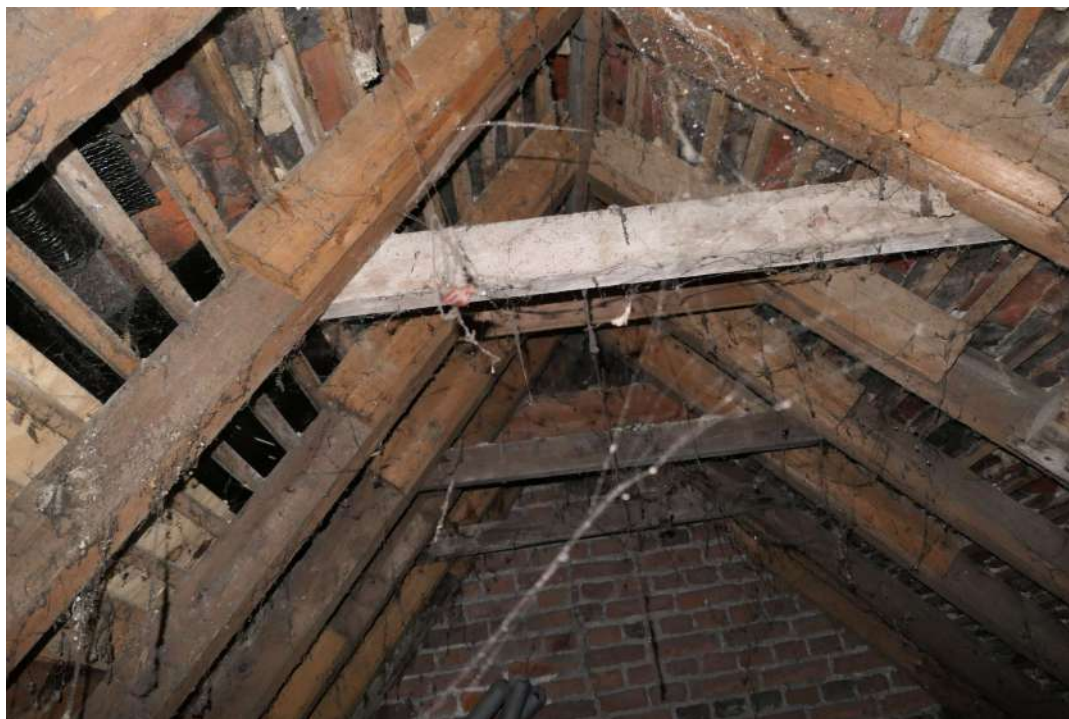
2025.12g\_PhotoGraph\_259  
Detail of roof construction of range 2. Photograph taken facing north-west.

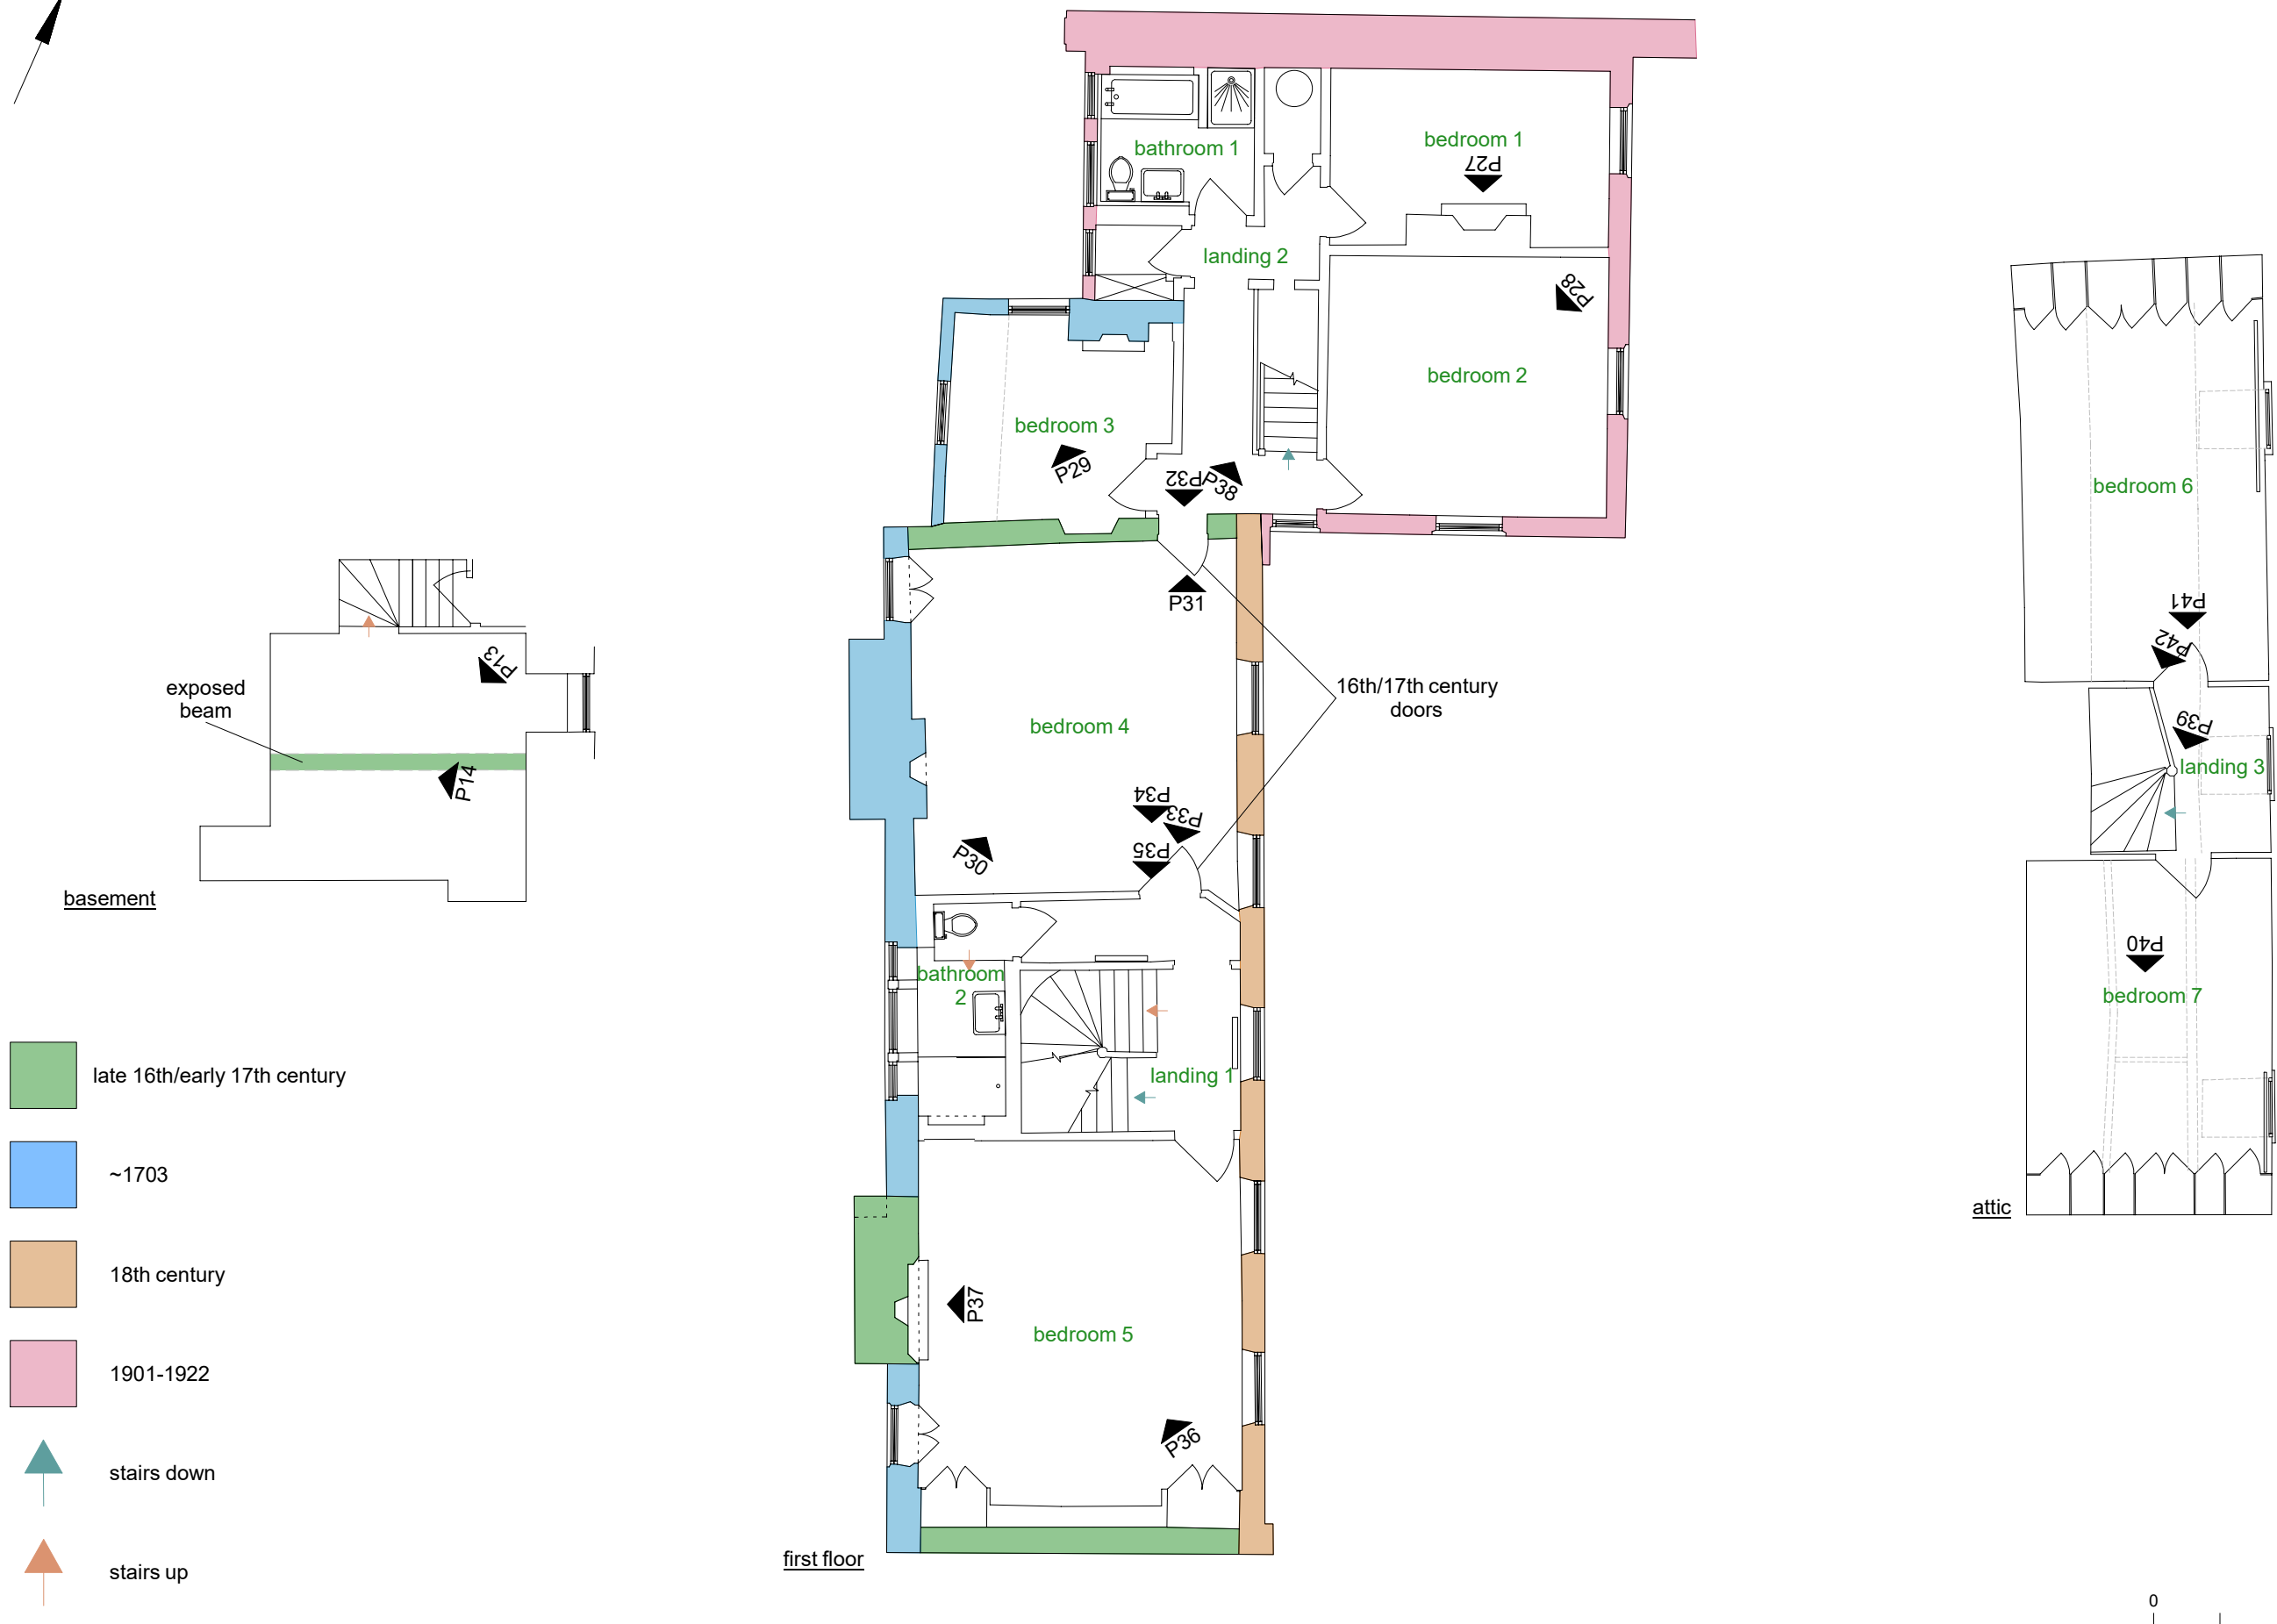
Fig 4 Basement, first floor and attic floor plans. Location and direction of the photographs reproduced in the text shown.

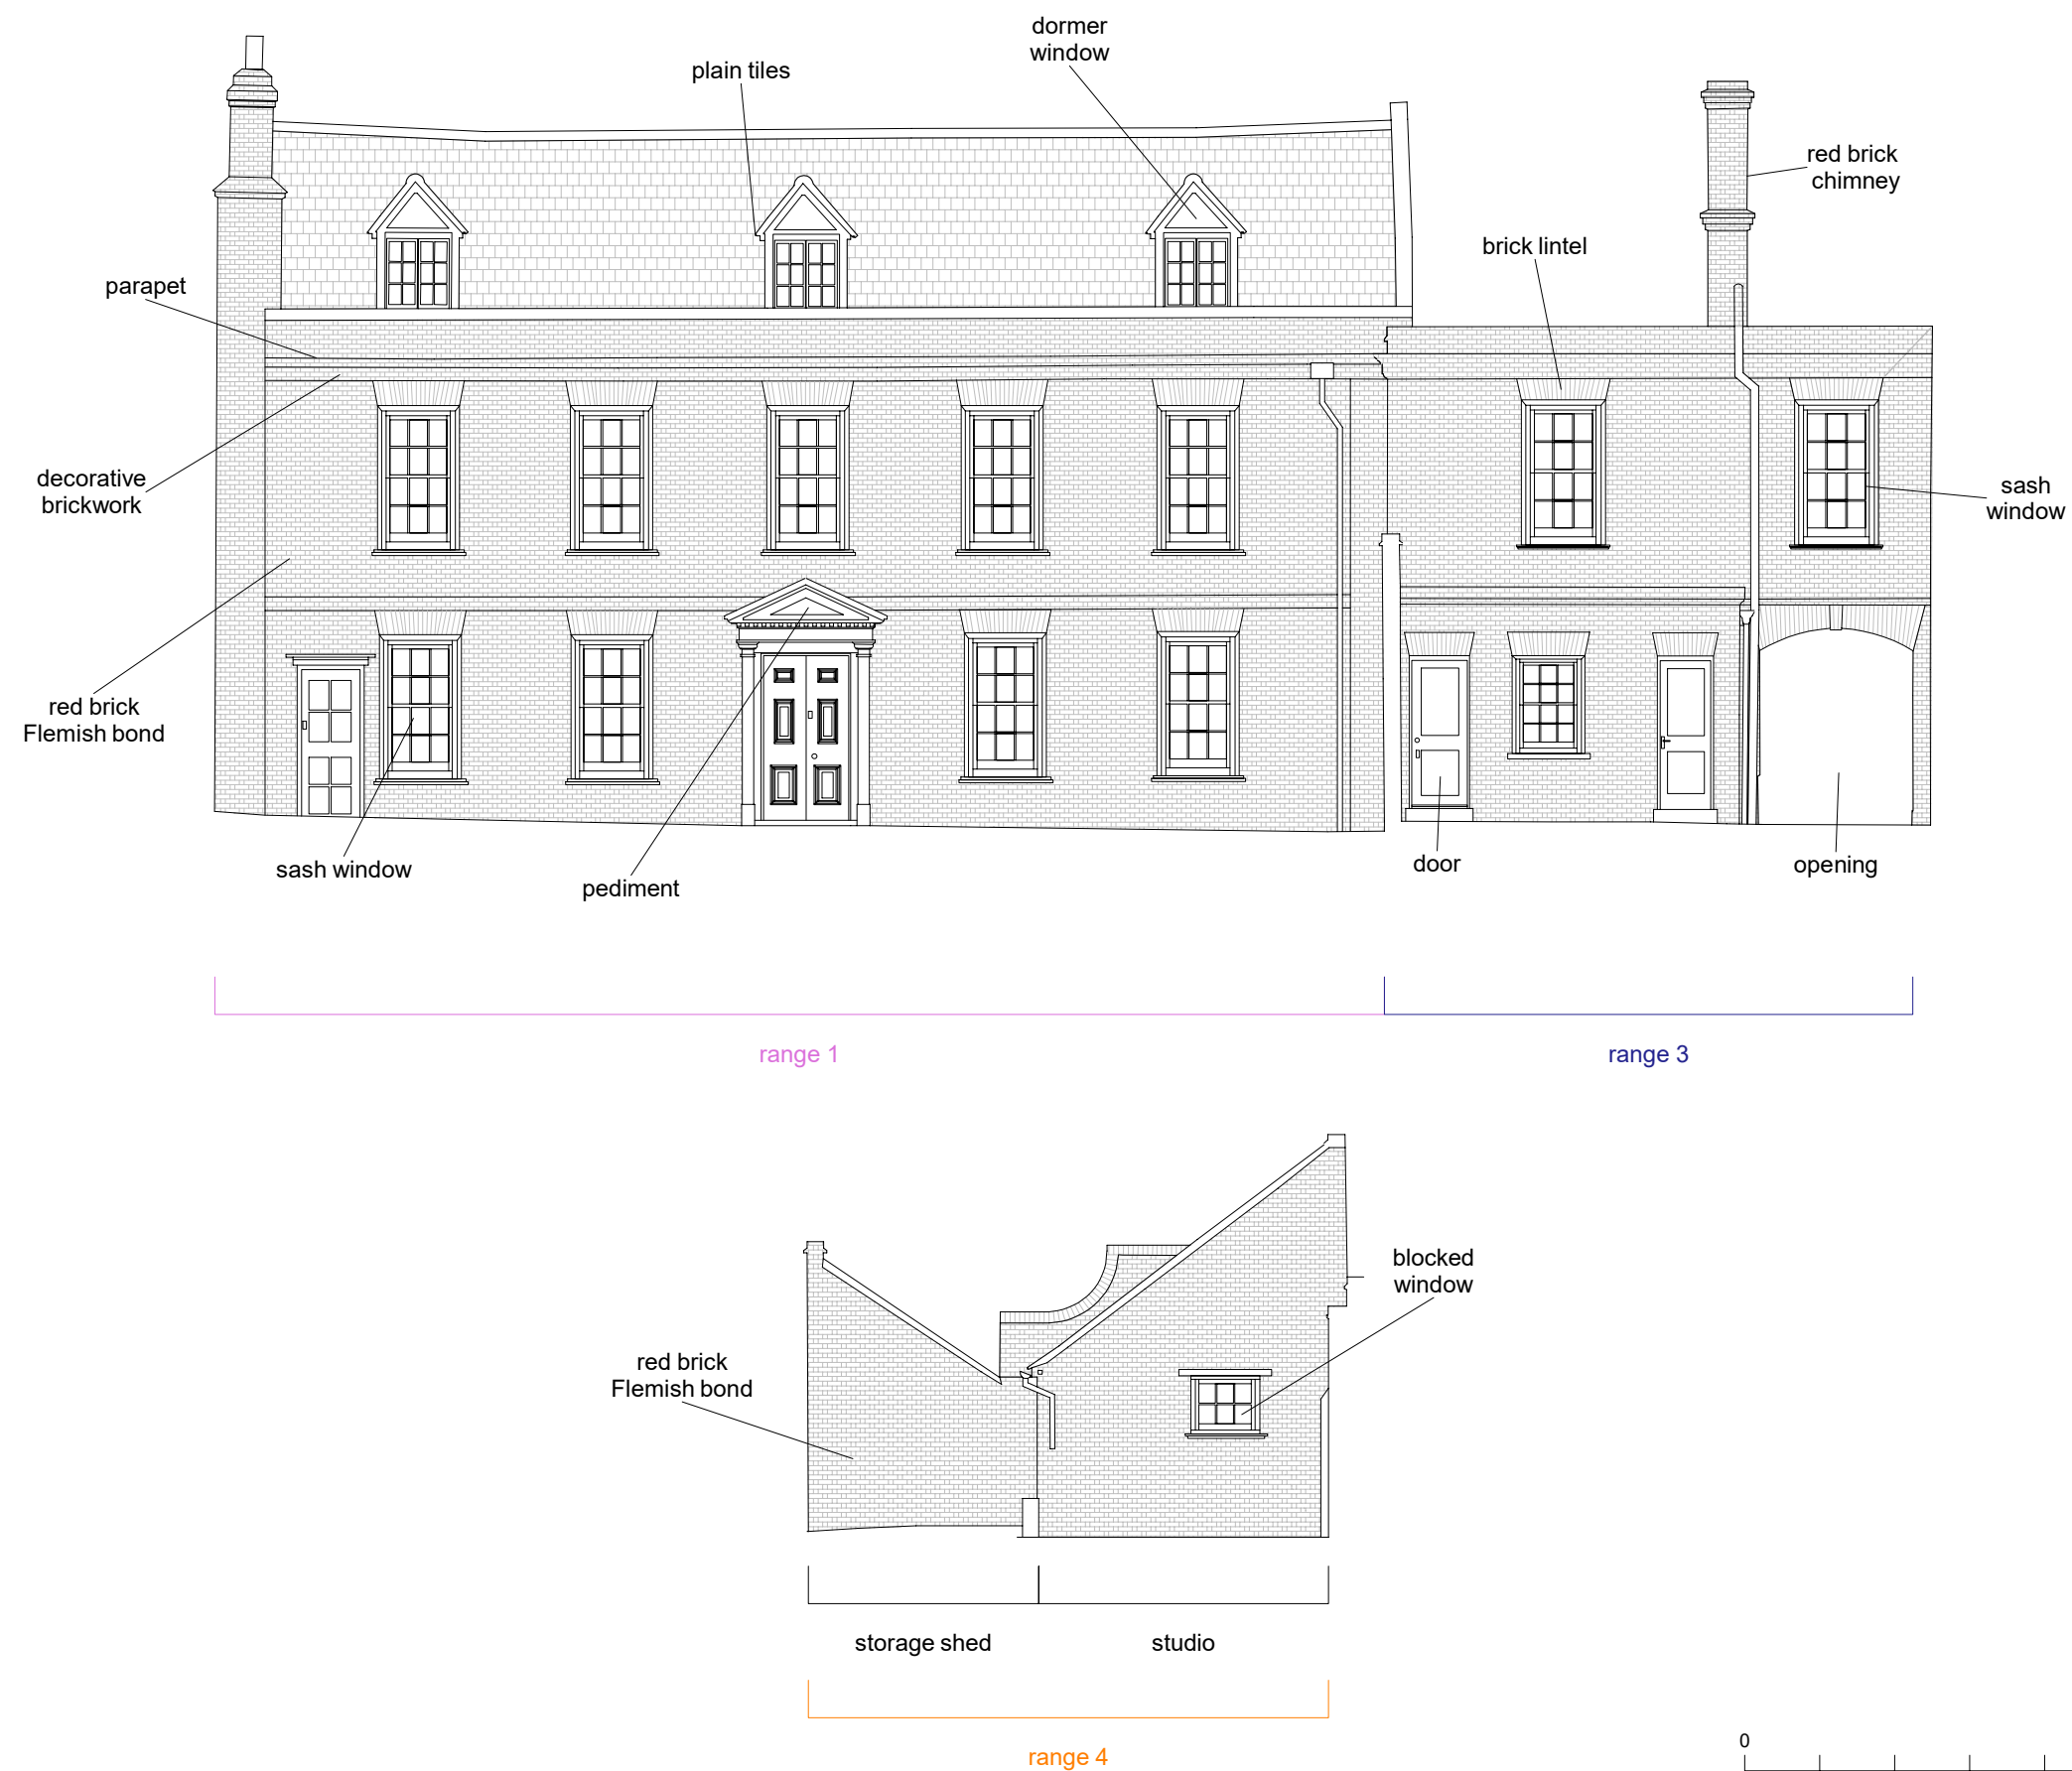
Fig 5 North-eastern elevations.
