**CAT Report 2257  
Issued March 2026**

**Historic building recording of  
The Old Palace, 23 Kneesworth Street, Royston,  
Hertfordshire, SG8 5AB**

**CAT project ref.: 2025/12g  
CAT Report 2257  
OASIS id: colchest3-540229**

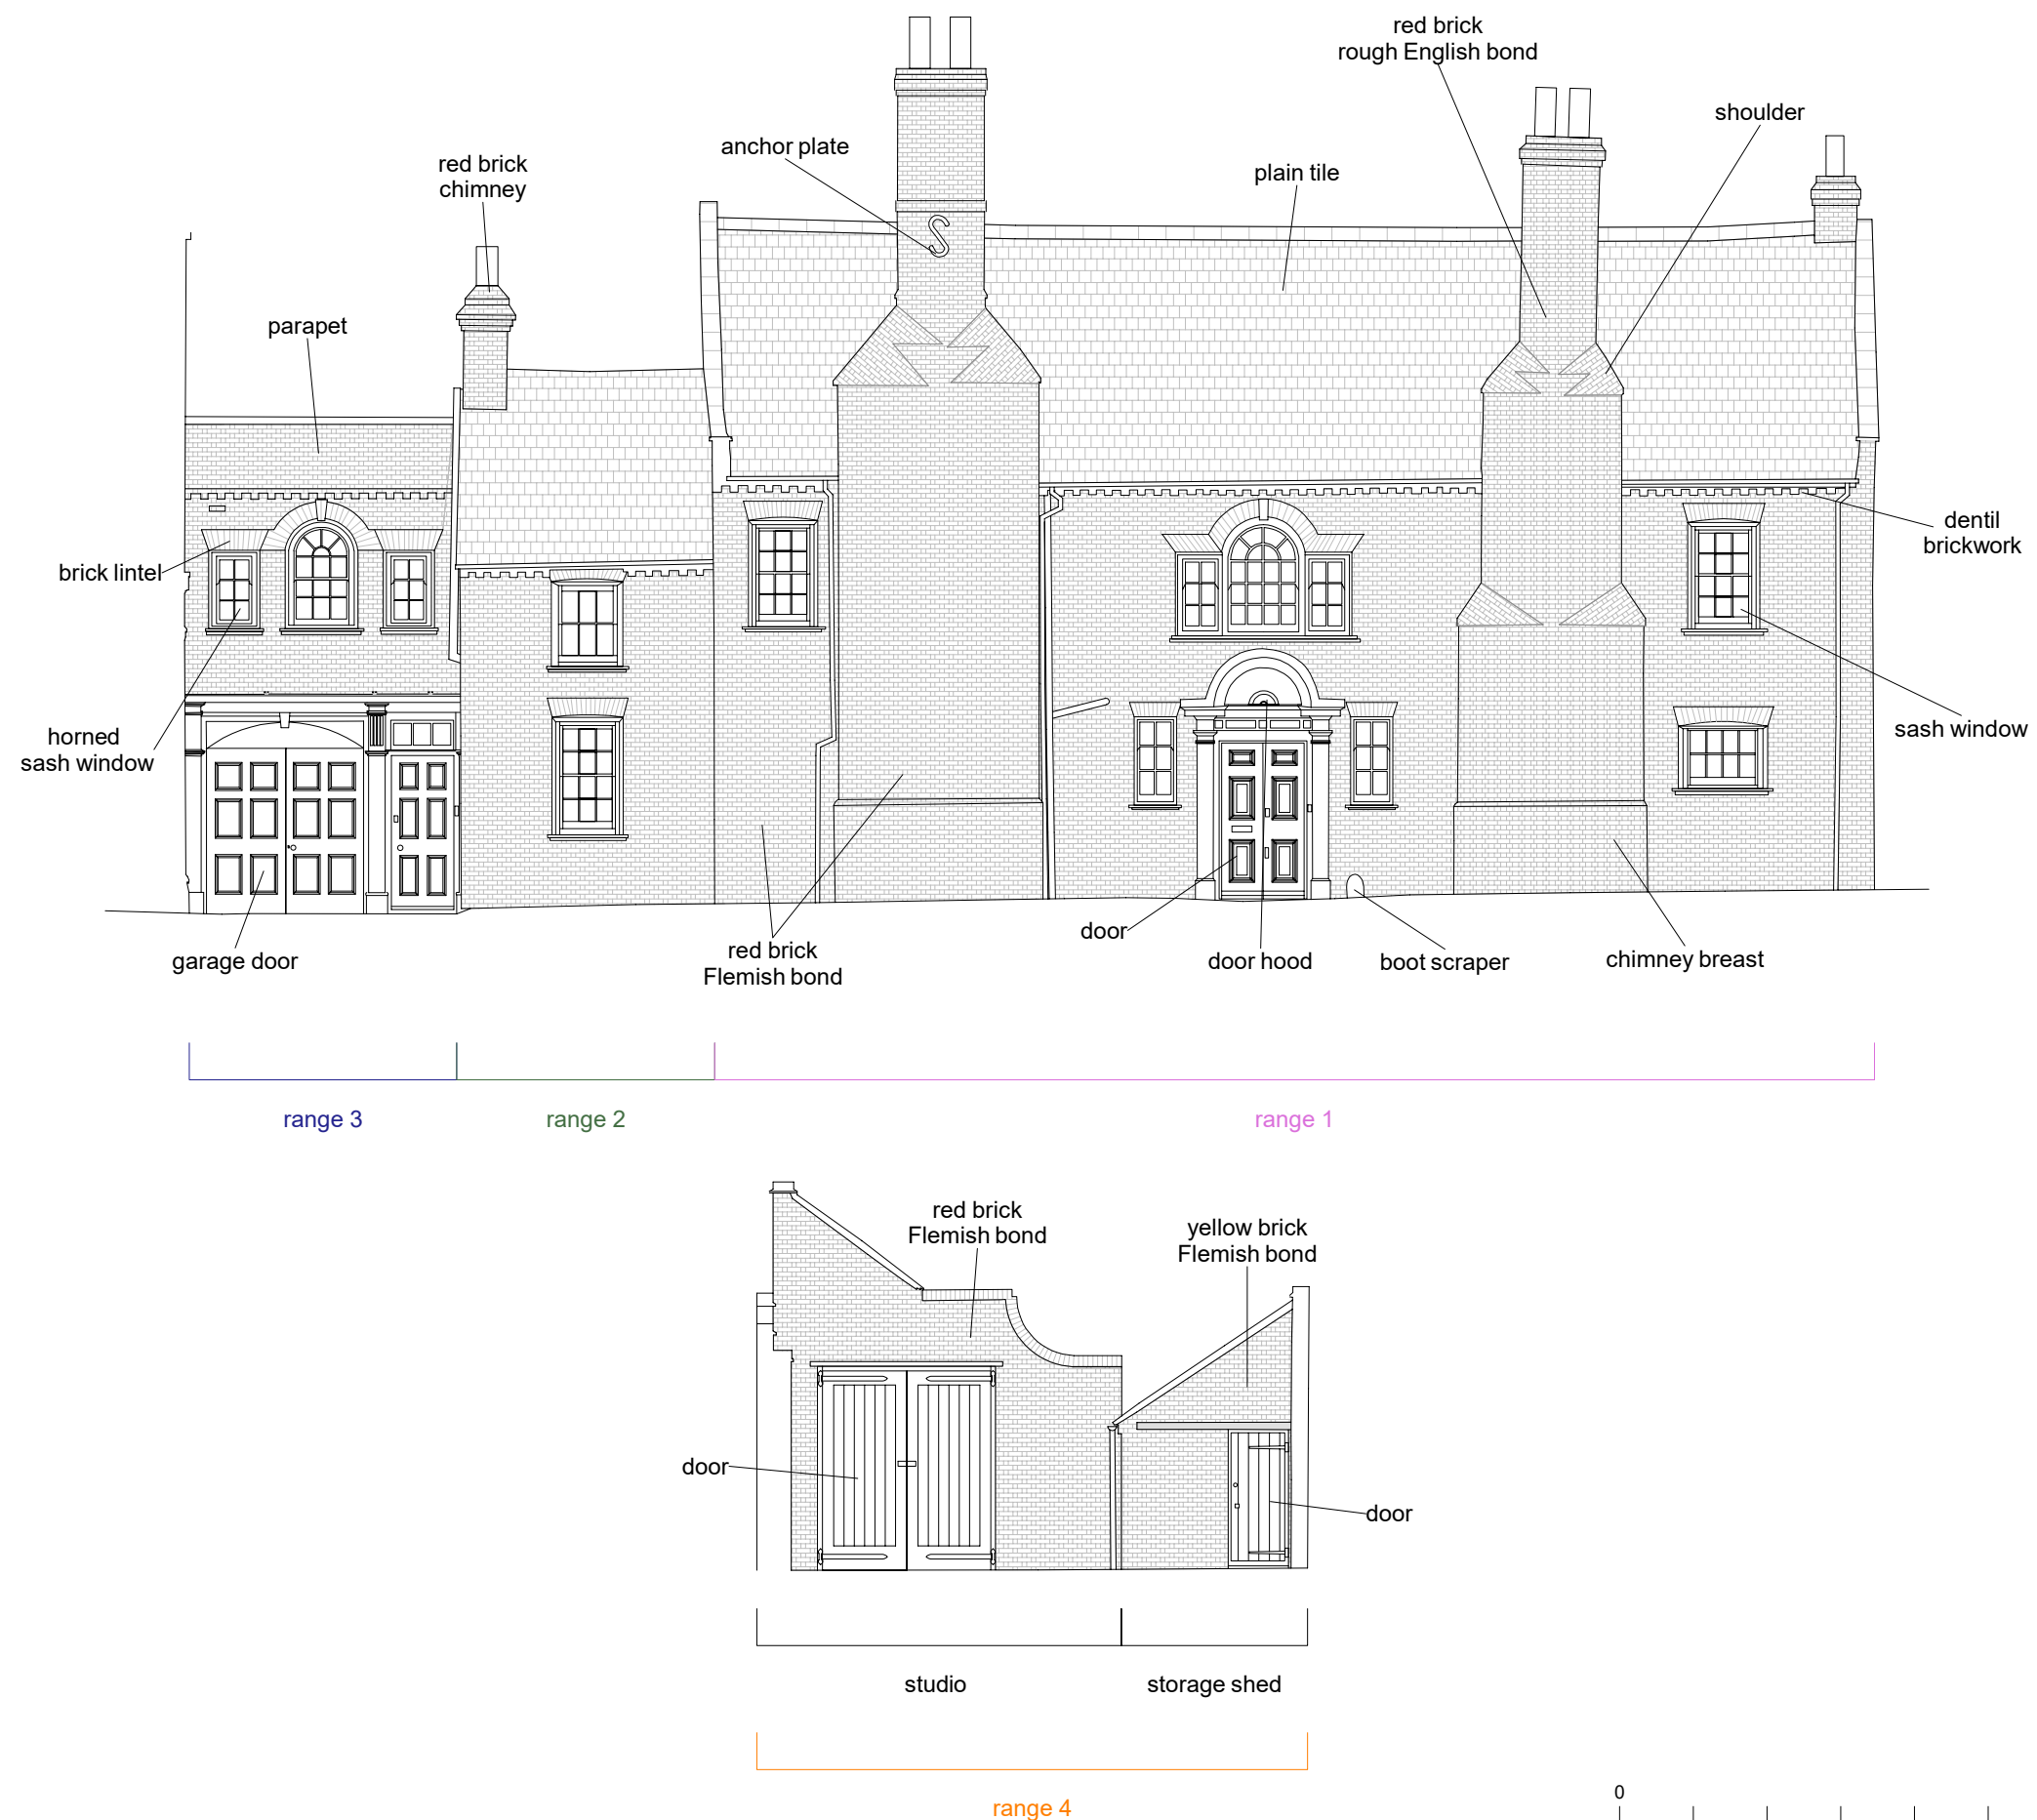
Fig 7 South-western elevations.
