**CAT Report 2267  
Issued May 2026**

**Historic building recording and archaeological  
excavation at Dorewards Hall, The Chase, Bocking,  
Essex, CM7 5LS**

**October 2025 and March 2026**

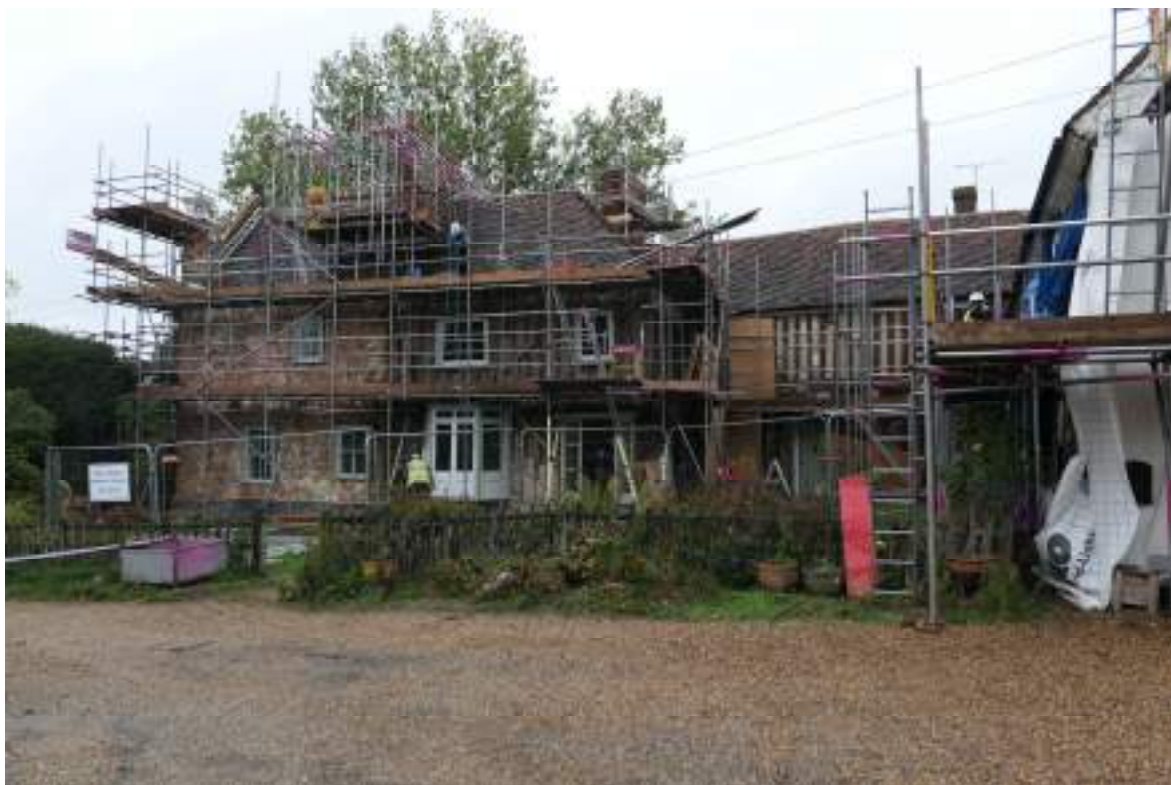
**Photograph 1** South-eastern elevation (ranges 3, 4 and 5). Photograph taken facing west north-west.

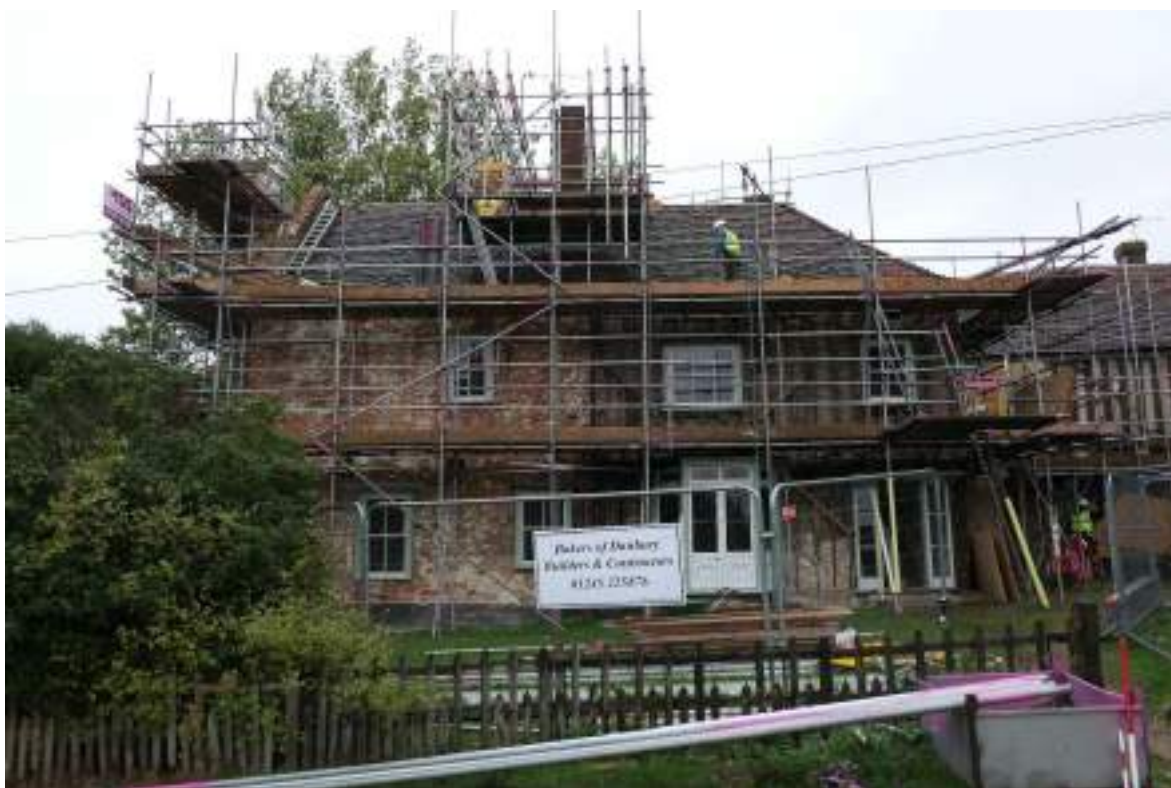
**Photograph 2** South-eastern elevation (range 3 and 4). Photograph taken facing north-west.

The south-eastern elevation of Dorewards Hall comprises ranges 3, 4, 5 and 7. This elevation of range 3 is constructed from red bricks (brick dimensions: 240-255 x 115-120 x 50-65mm), laid in a somewhat haphazard Header bond (Photograph 2). The lower nine courses of brickwork protrude from the brickwork, suggestive of a brick plinth (Photograph 3). Three courses of brick, in a limited area above the plinth, comprise bricks laid on edge with at least one peg-tile incorporated into the wall (Photograph 3). The remains of a probable brick arch are evident in the brickwork (Photograph 4), while the ends of the two internal timbers are exposed among the bricks. Three sash windows are present in this elevation of range 3, which are all later insertions. Both ground floor windows are four-light sash windows, one of which seems have blocked a doorway, as evidenced by the regimented English bond brickwork beneath it (Photograph 4). The first floor window is a horned-sash window, which has four lead-lights with rectangular quarries.

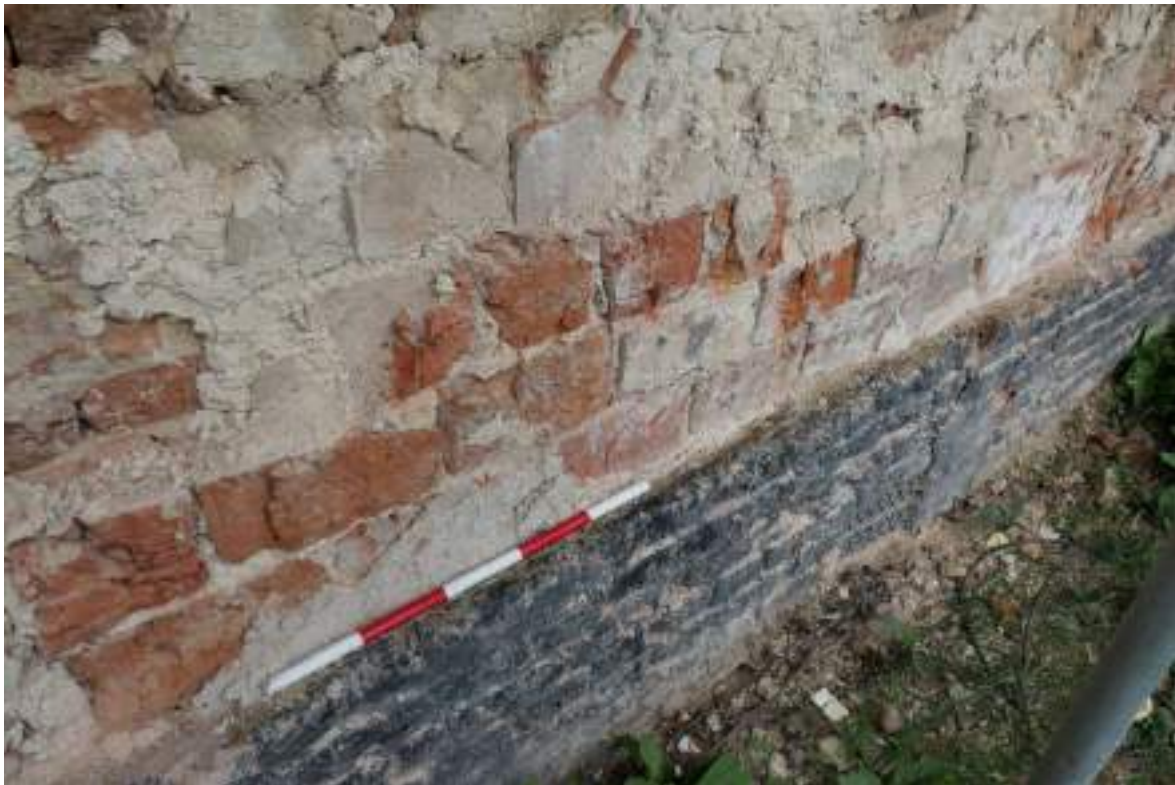
**Photograph 3** Detail of bricks laid on-edge in brickwork and plinth of south-eastern elevation (range 3). Photograph taken facing north.

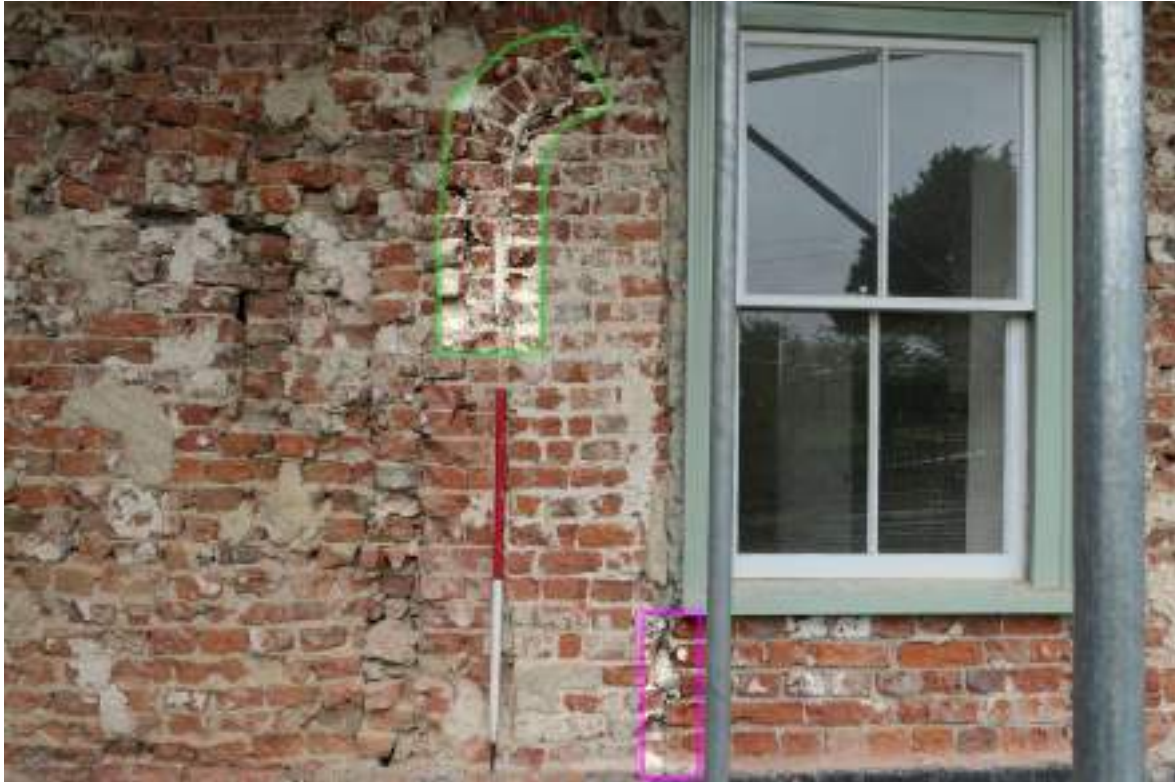
**Photograph 4** Detail of blocked, partially surviving brick arch (green) and break in brickwork evidencing blocked doorway (pink) in south-eastern elevation (range 3). Photograph taken facing north-west.

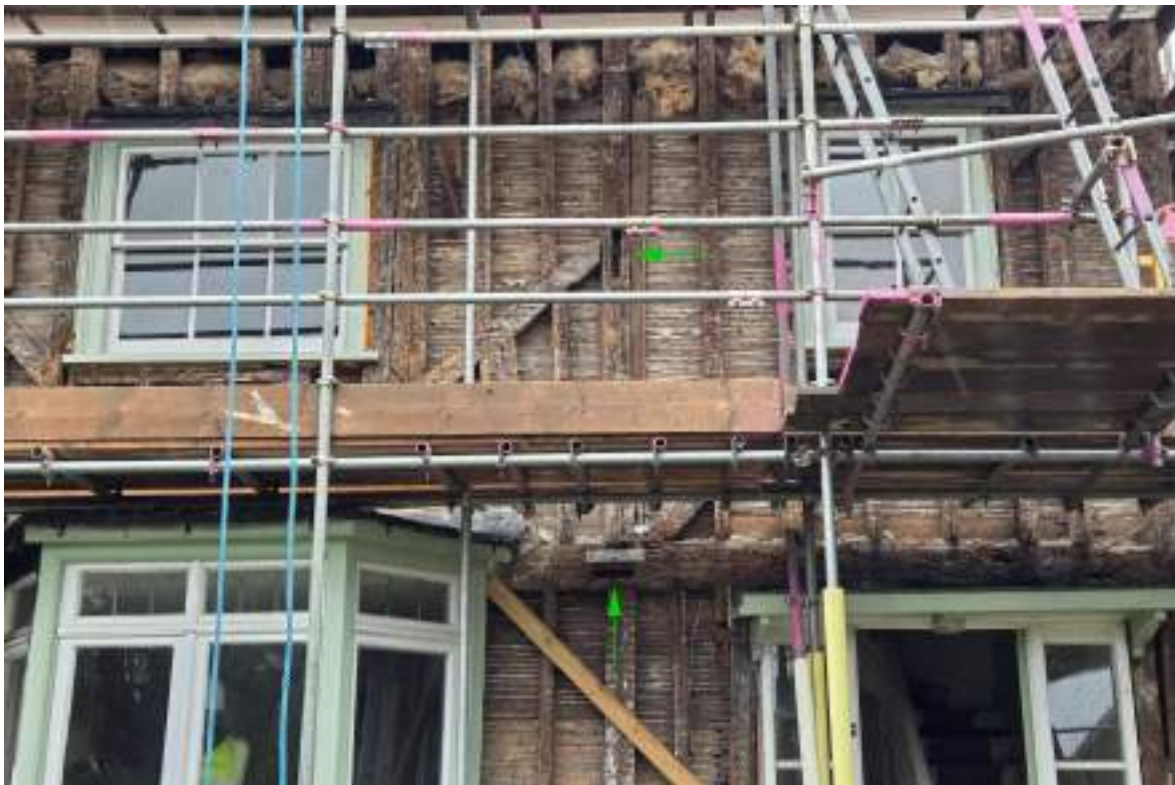
**Photograph 5** Detail of exposed timber-framing, with reused timbers highlighted by green arrows, of south-eastern elevation (range 4). Photograph taken facing north-west.

Ranges 4 and 5 are both timber-framed on the south-eastern elevation, comprising hand-sawn hard wood. The timber-framing of range 4, which has a number of timbers which display evidence of reuse (Photograph 5), appears to utilise primary bracing. A large girding beam interrupts the only intermediate post in the framing and numerous repairs are evident throughout. Some red brick nogging is present at ground floor level. The framing is supported on a red brick plinth (brick dimensions: 215-220 x 105-110 x 60-65mm) laid in English bond. A canted bay window has been inserted into the elevation adjacent to a modern entrance. On the first floor are two inserted timber-framed sash-windows, one six-light and one four-light.

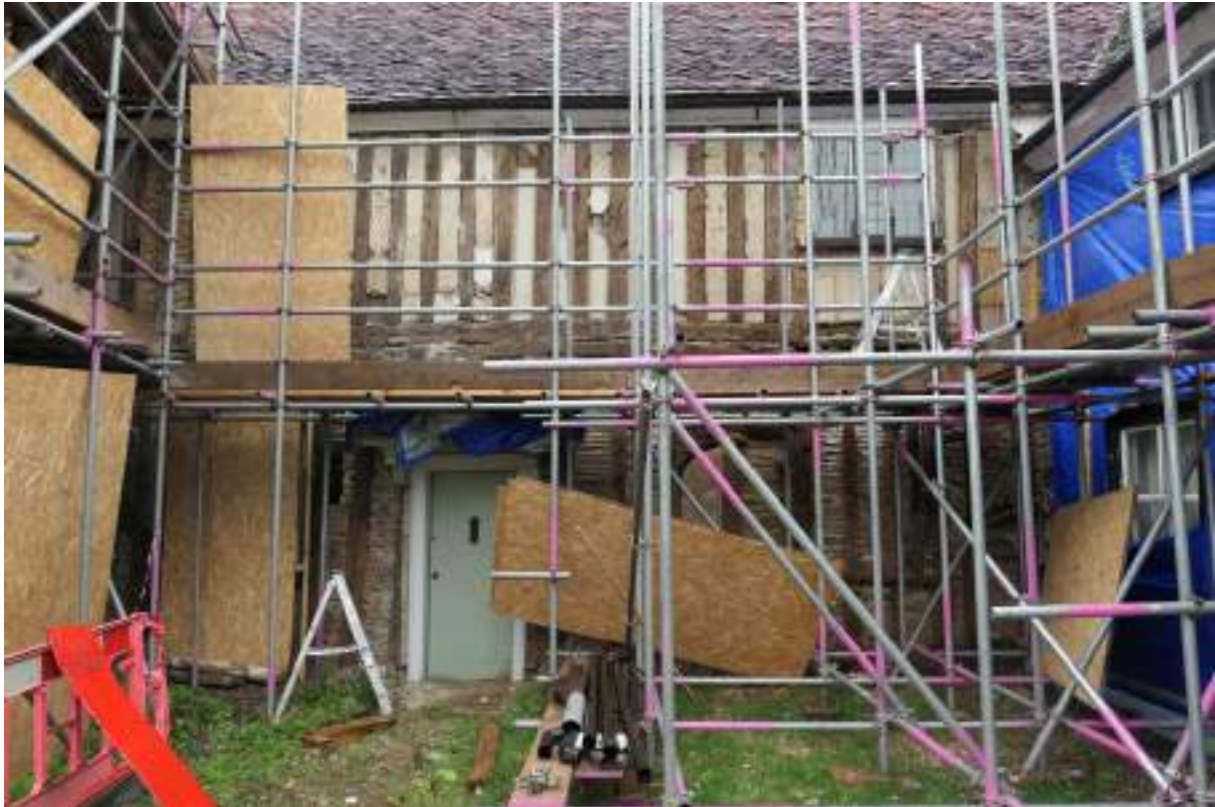
**Photograph 6** South-eastern elevation (range 5). Photograph taken facing north-west.

The upper register of range 5 comprises a series of closely situated studs (Photograph 6), between the studs some plaster survives from which some broken staves project. Incised carpenter's marks are visible on some of the studwork (Photograph 8 & 9). Two girding beams are visible on this elevation, suggesting that the building may have originally been jettied and the lower register has been rebuilt. The upper of the girding beams has a scarf-joint, the diagonal break in which suggests that it is a squint-butted scarf with a secret bridle (Photograph 8). The framing of the lower register also comprises stud work, along with a single primary-brace. Later brick nogging is present between a number of the studs. Towards the north-eastern end of the elevation is a short horizontal rail, possibly suggesting an original window location. Adjacent to this are the remains of a two-centred arched doorway (Photograph 7). The doorway has timber spandrels, one of which is no longer present, and has been blocked by a central post. A modern doorway has been inserted into the frame adjacent to this.

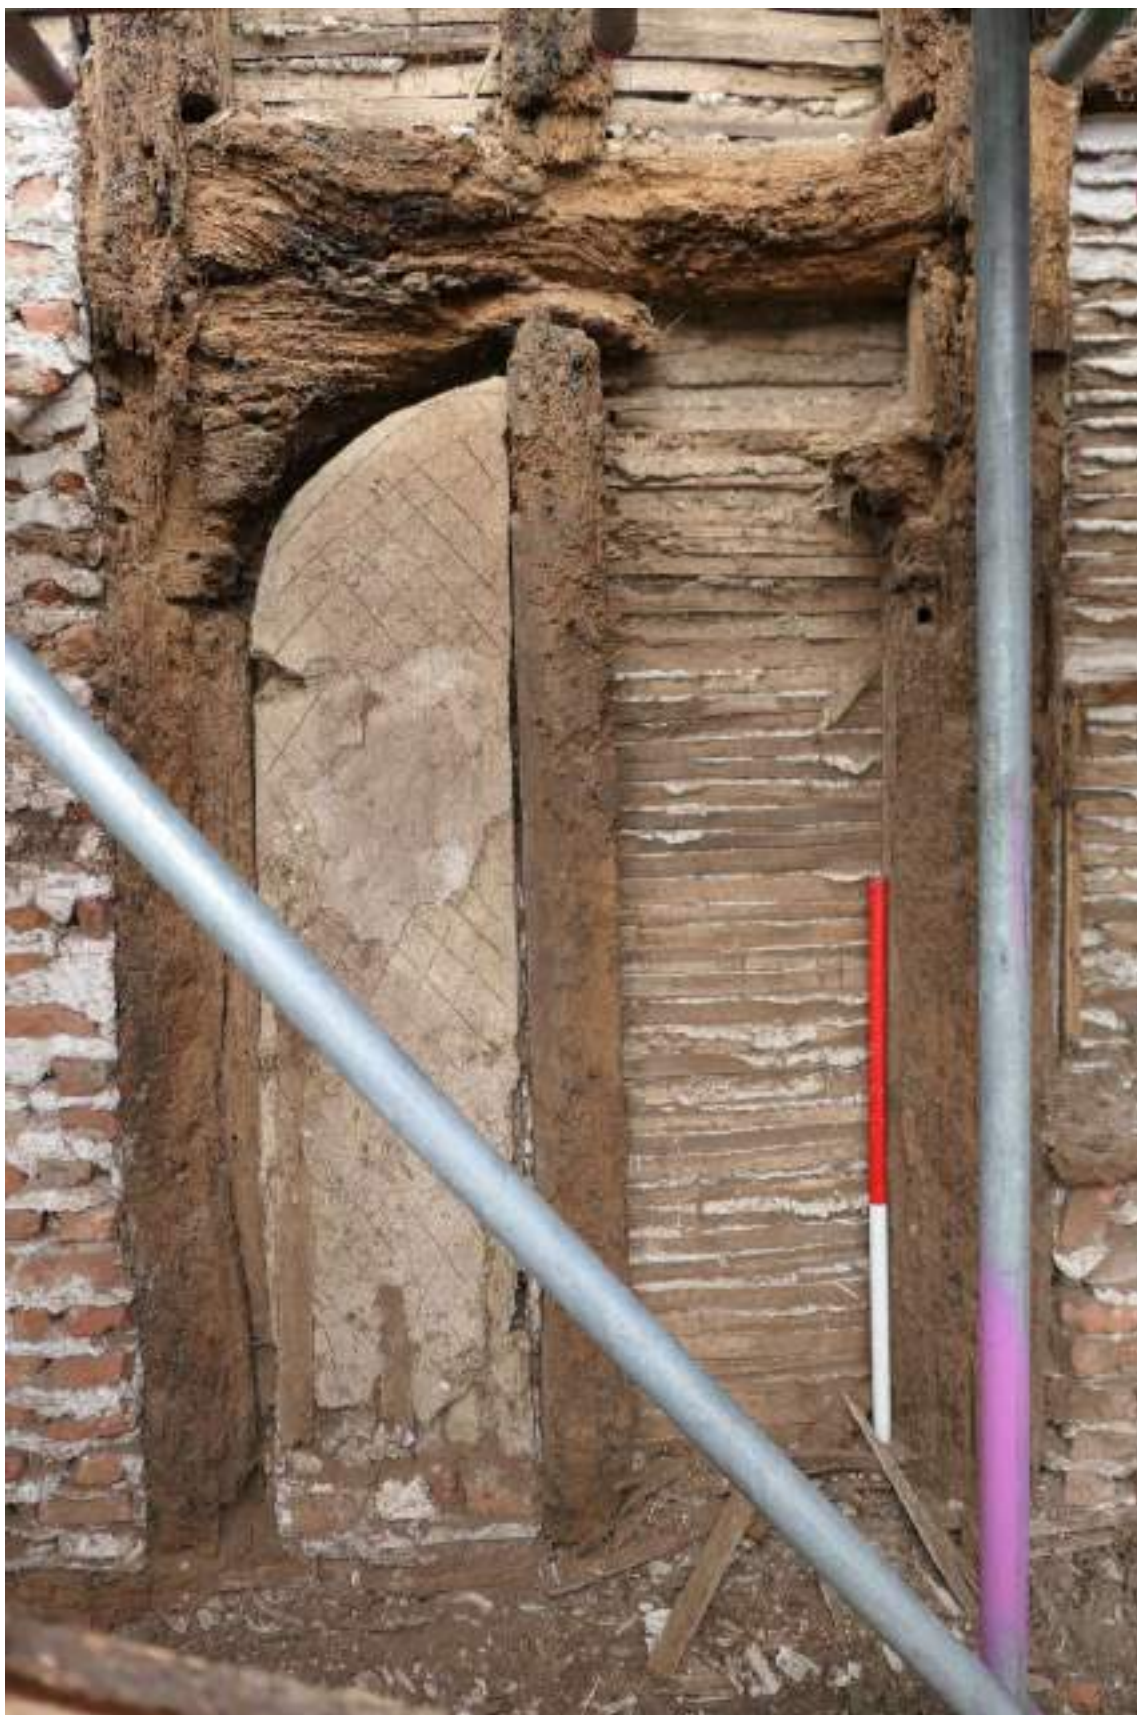
**Photograph 7** Detail of doorway in south-eastern elevation (range 5). Photograph taken facing north-west.

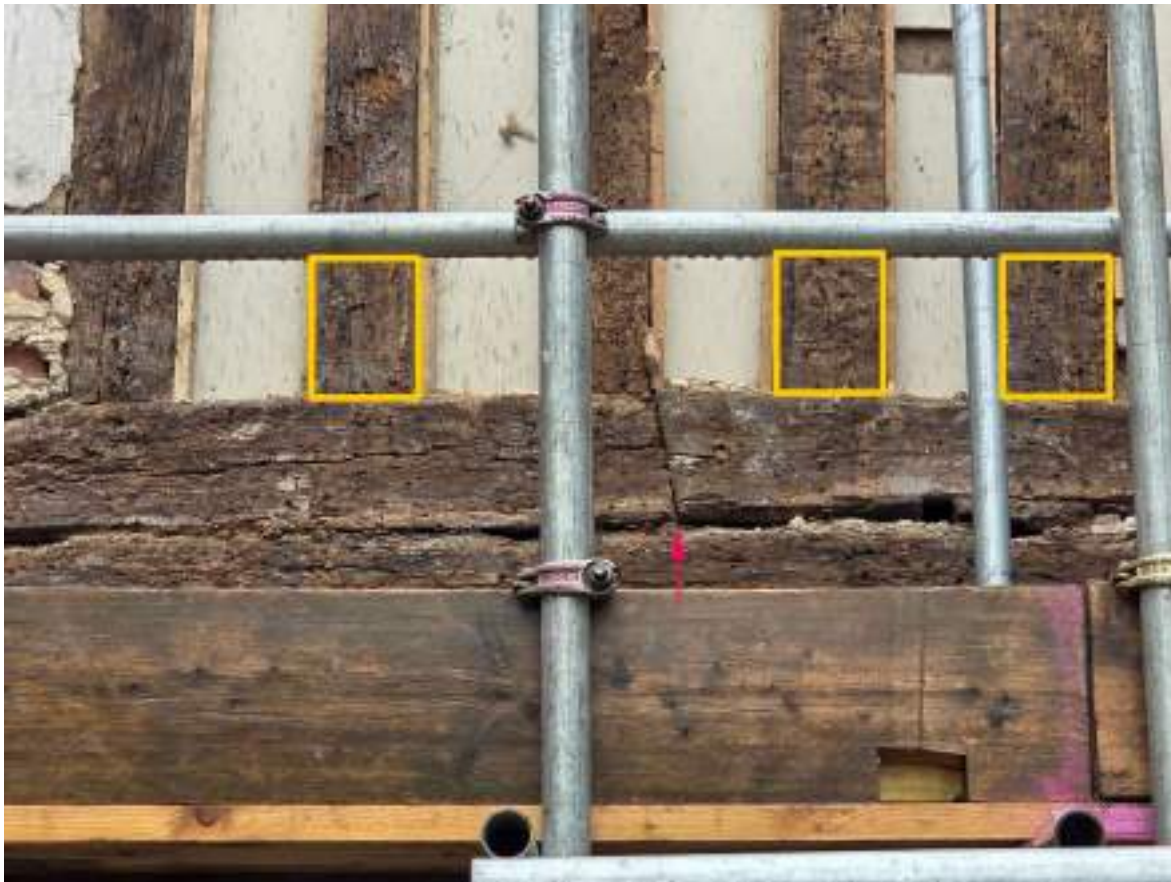
**Photograph 8** Detail of scarf-joint in girding beam (pink arrow) and possible carpenter's marks (outlined in yellow, details shown in Photograph 9) on studs in south-eastern elevation (range 5). Note the double girding beam. Photograph taken facing north-west.

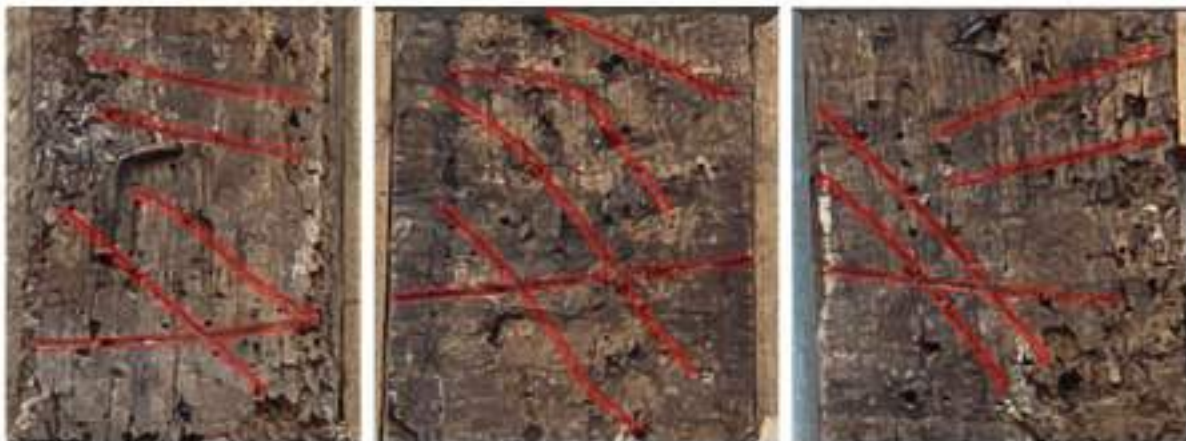
**Photograph 9** Close up detail of carpenter's marks on range 5.

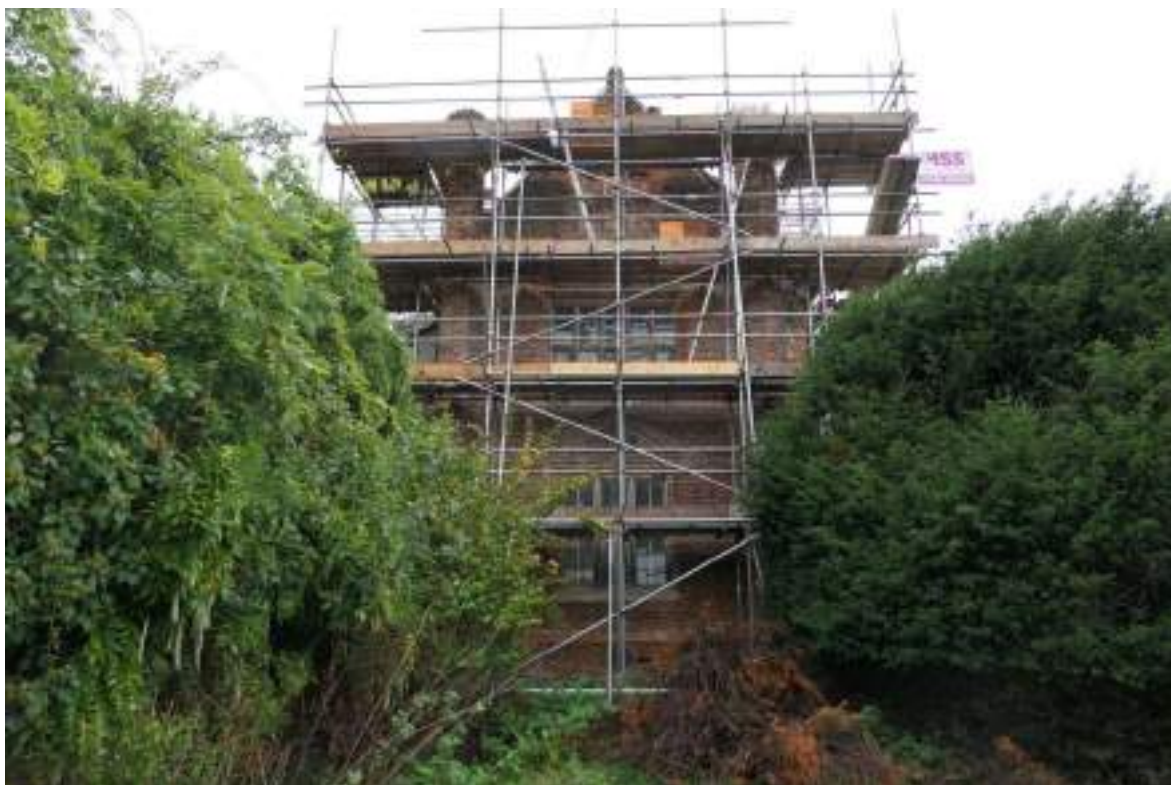
**Photograph 10** South-western elevation (range 3). Photograph taken facing north-east.

The south-western elevation of range 3 is red brick (Photograph 10) (brick dimensions: 240-255 x 115-120 x 50-65mm) laid in rough English bond. On both corners of the elevation is an octagonal red brick buttress (Photograph 12), which projects above the eaves of the roofline. A brick pendant is present at the apex of the gable. Moulded brick strings project between each building storey, a detail which carries across onto the buttresses. Three brick mullion and transom windows are set into the elevation, one at ground floor level, one on the first floor and the final one in the gable. The lower two windows have leaded lights, with square quarries, and are topped with triangular pediments formed from moulded bricks (Photograph 11). The attic window has been blocked with brickwork and is topped with moulded bricks set into a rectangular pattern.

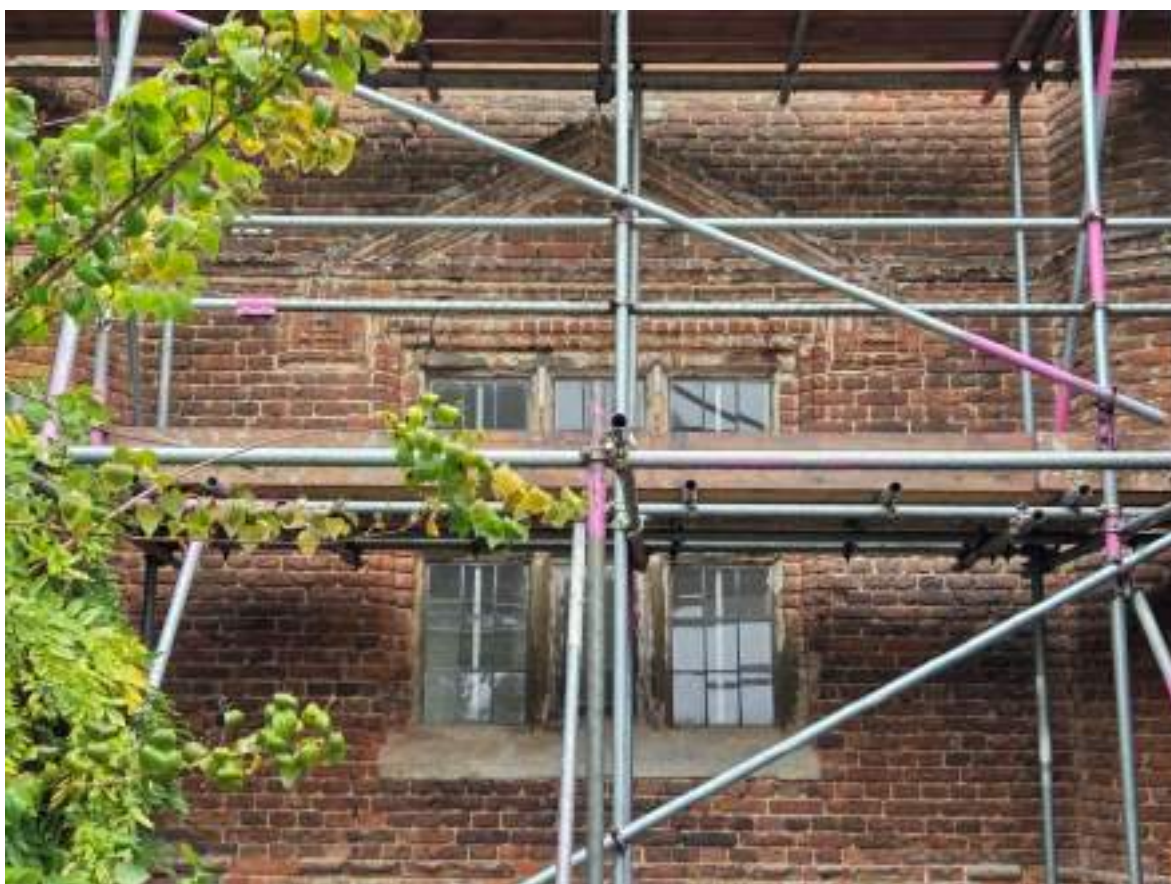
**Photograph 11** Detail of window in south-western elevation (range 3). Photograph taken facing north-east.

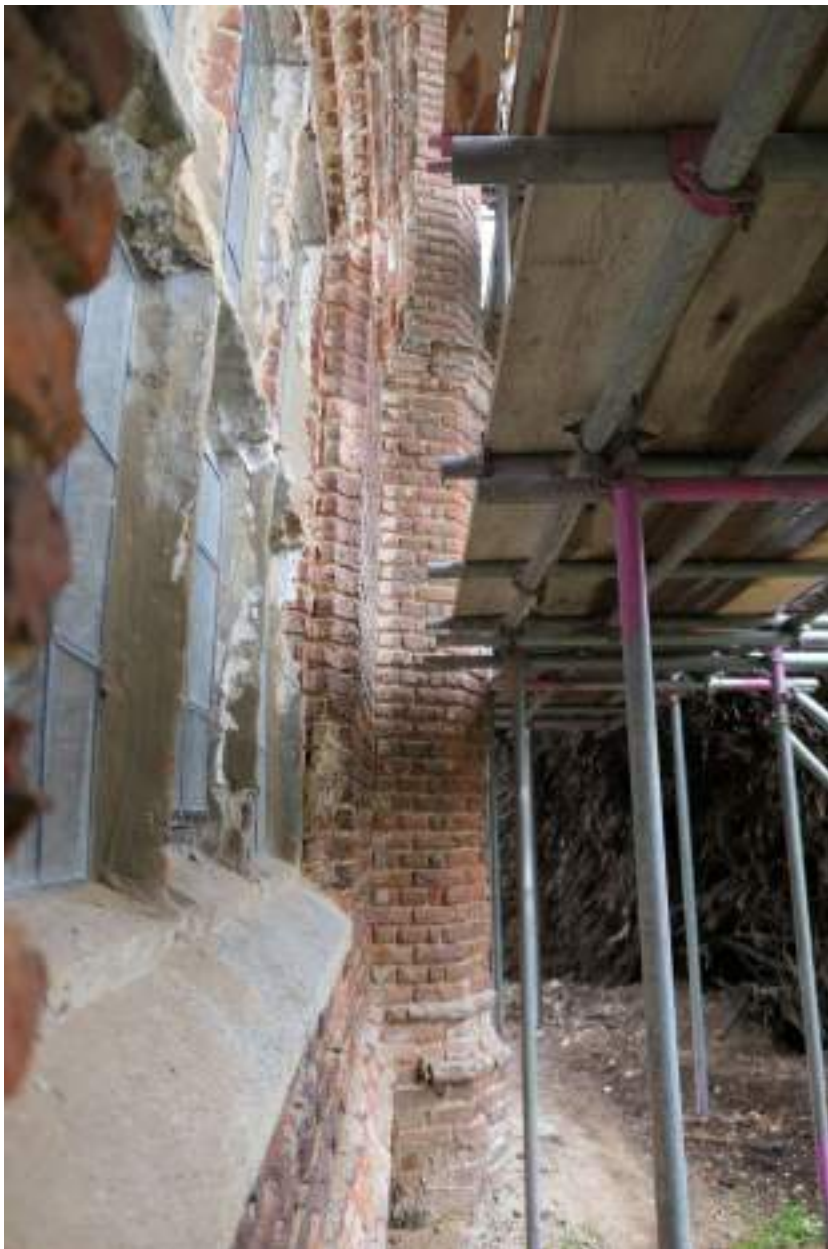
**Photograph 12** Detail of octagonal corner buttress on south-western elevation (range 3). Photograph taken facing south-east.

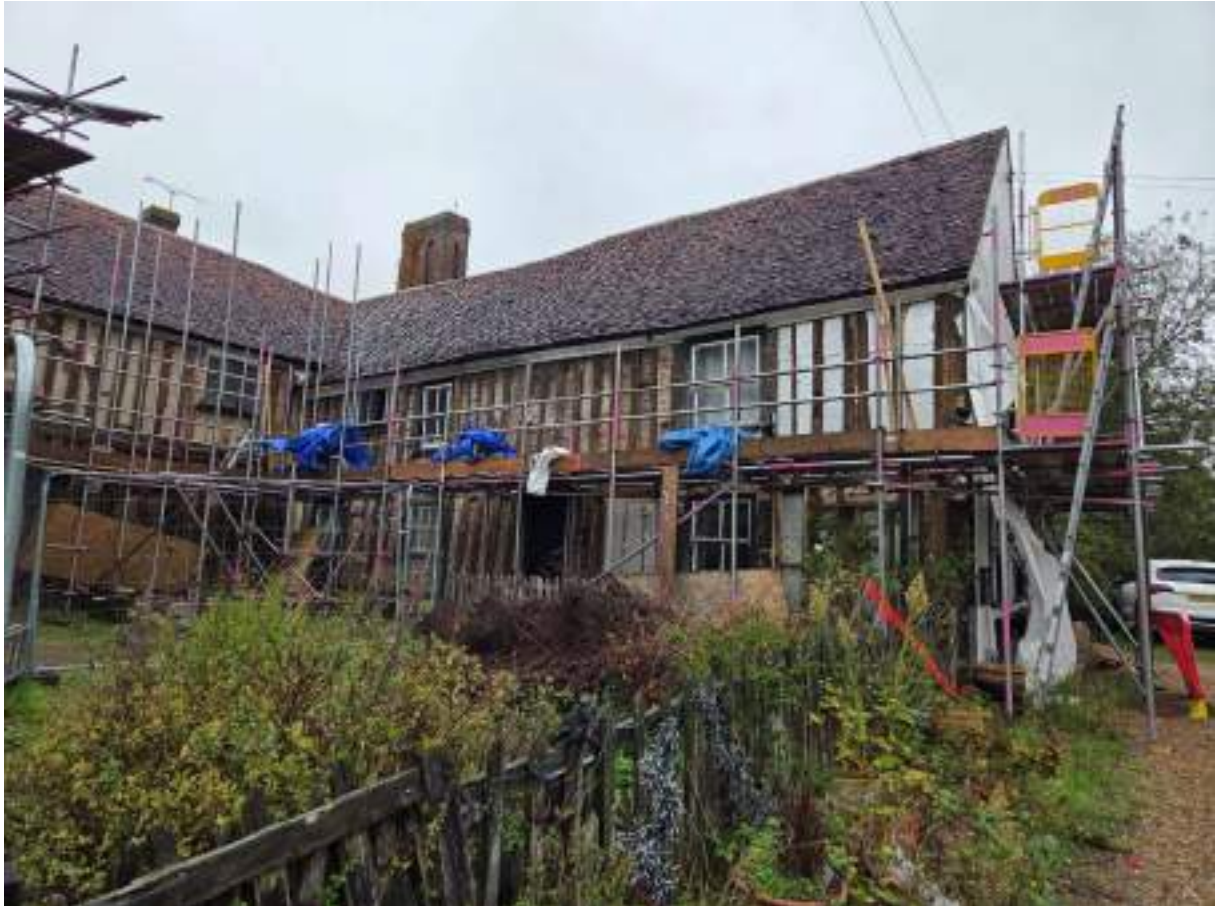
**Photograph 13** South-western elevation (range 7). Photograph taken facing north.

Along the south-western elevation of range 7 (Photograph 13) are a number of studs, which are interrupted by a central girding beam. A series of intermediate posts set along the elevation interrupt the girding beam, which have added iron straps (Photograph 14). The framing has been constructed from hand-sawn timbers, with areas of modern repair. Several sash windows are present in both registers, although it is not immediately evident if they represent insertions or larger replacements.

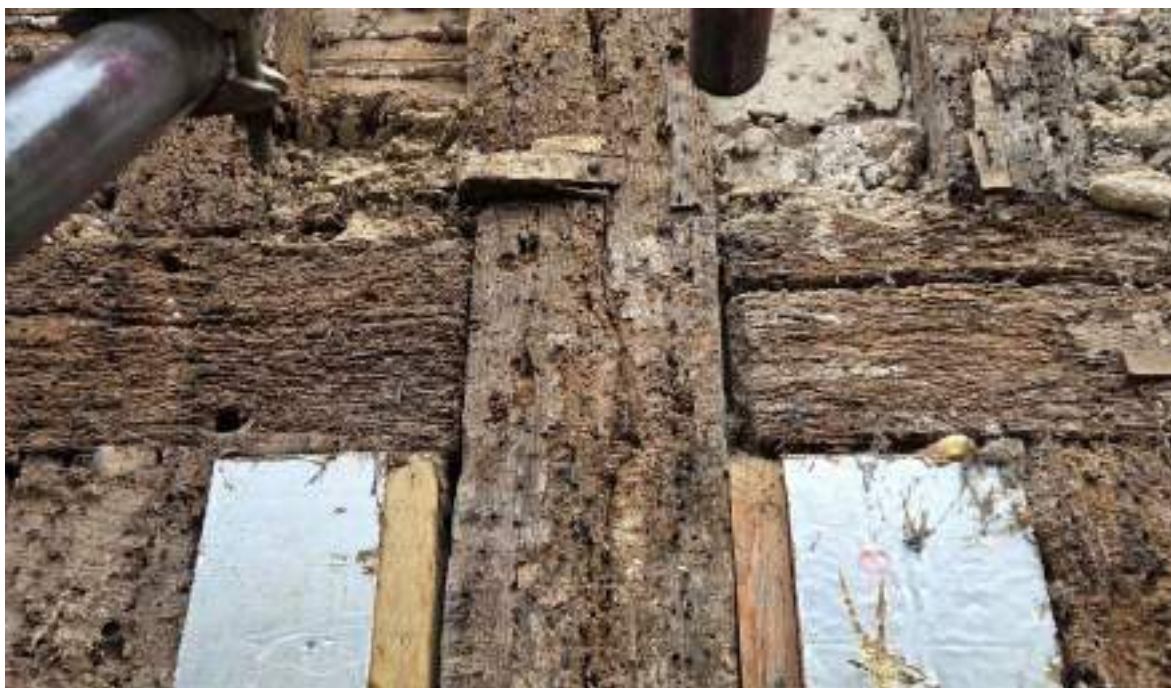
**Photograph 14** Detail of intermediate post interrupting girding beam with an iron strap in south-western elevation (range 7). Photograph taken facing north-east.

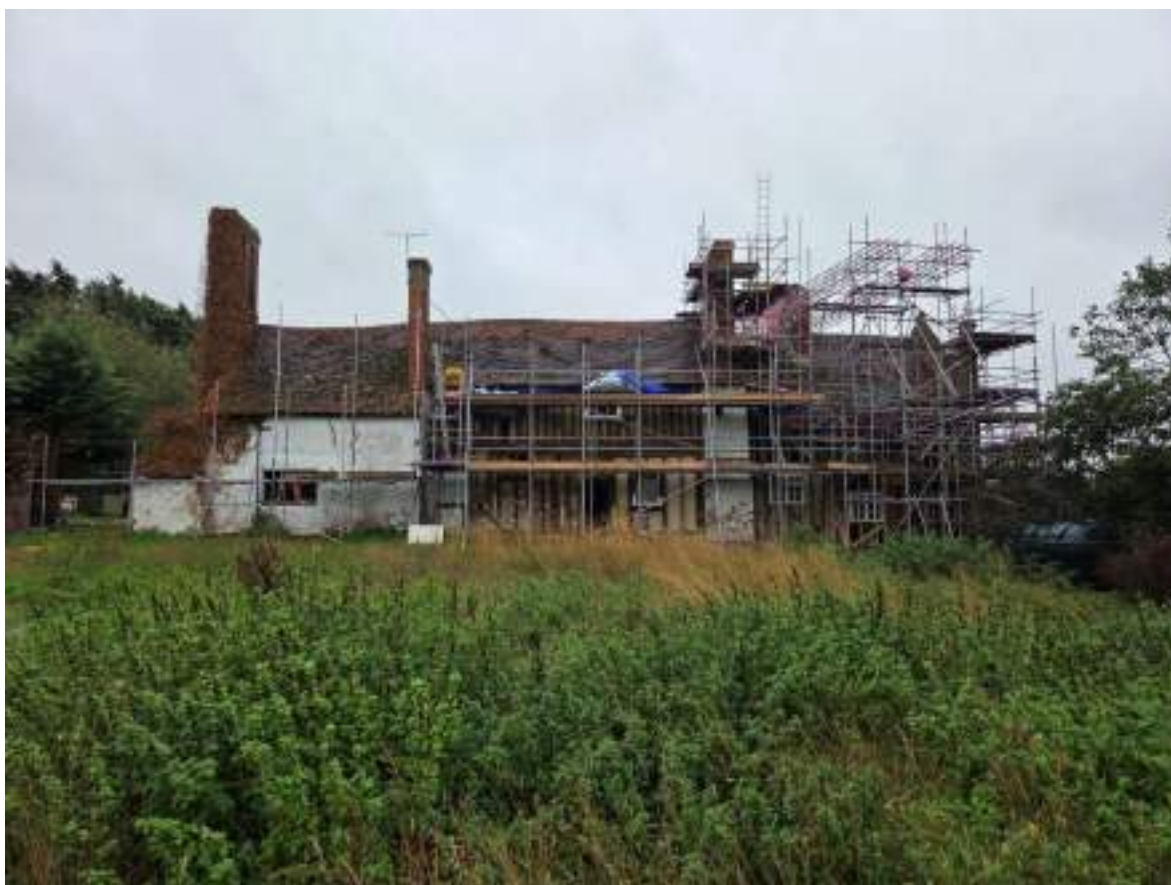
**Photograph 15** North-western elevation (ranges 1, 2, 5 and 6). Photograph taken facing south-east.

Ranges 5 and 6 dominate the north-western elevation (Photograph 15). On this elevation, range 6 comprises brick (brick dimensions: 200-220 x 100 x 65-70mm) laid in Flemish bond and painted white. A window is central to the range, which has a flat arched lintel and concrete sill. No lights survive in the window frame.

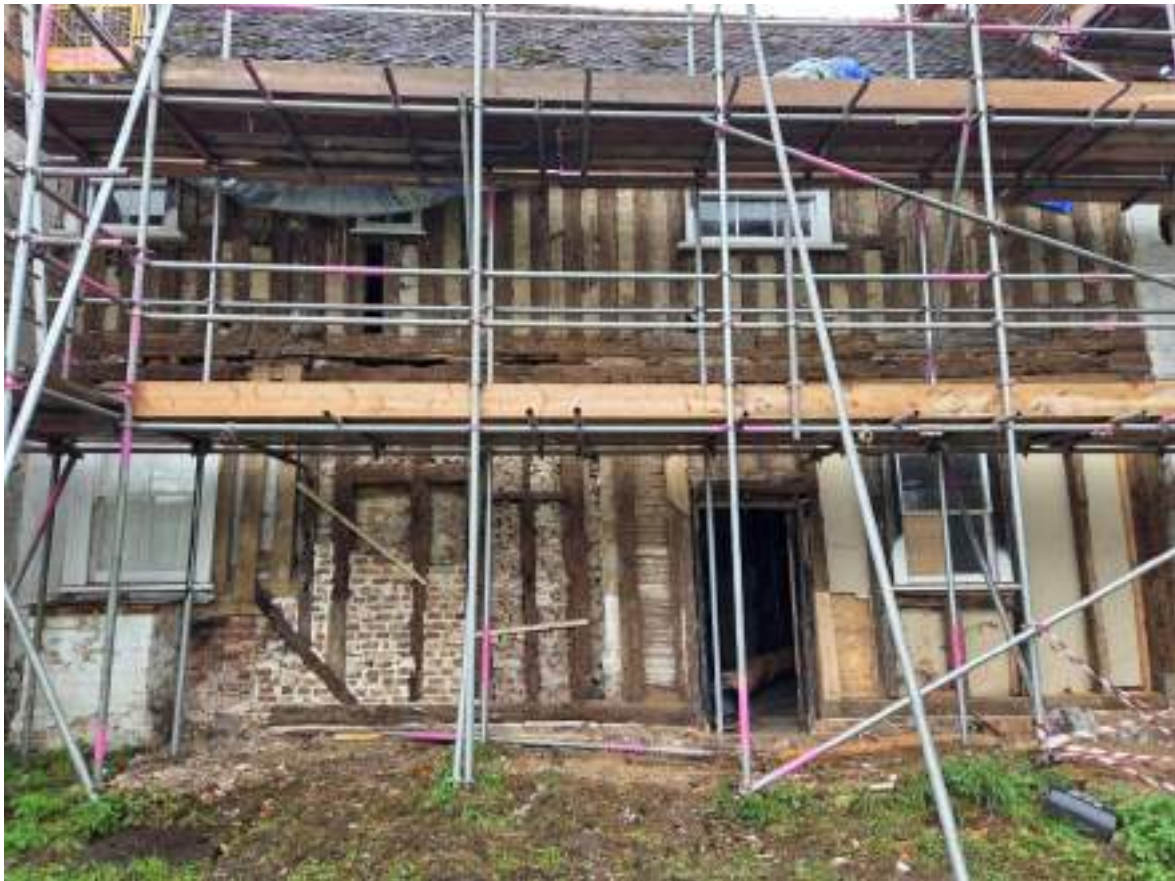
**Photograph 16** Detail of exposed timber-framing of north-western elevation (range 5). Note the double girding beam. Photograph taken facing south-east.

Range 5 is timber-framed (Photograph 16), constructed from hand-sawn timbers some of which have been reused. Similarly to the south-eastern elevation, the upper register of range 5 comprises close studding, while the lower register appears to have been rebuilt, evidenced by the presence of two girding beams. In the upper register of the framing are two short horizontal rails, adjacent to two later windows, which likely represent the remains of the original window openings. A third inserted window is present between these. The framing of the lower registers is less regular, with a truncated primary brace, some horizontal rails and numerous areas of repair. The sill-beam and the lower girding beam both have an edge-halved scarf-joint. Two windows and a door have been inserted into the lower register of range 5. Later brick nogging is present in areas along the ground floor, which also utilises peg-tiles in some areas (Photograph 17).

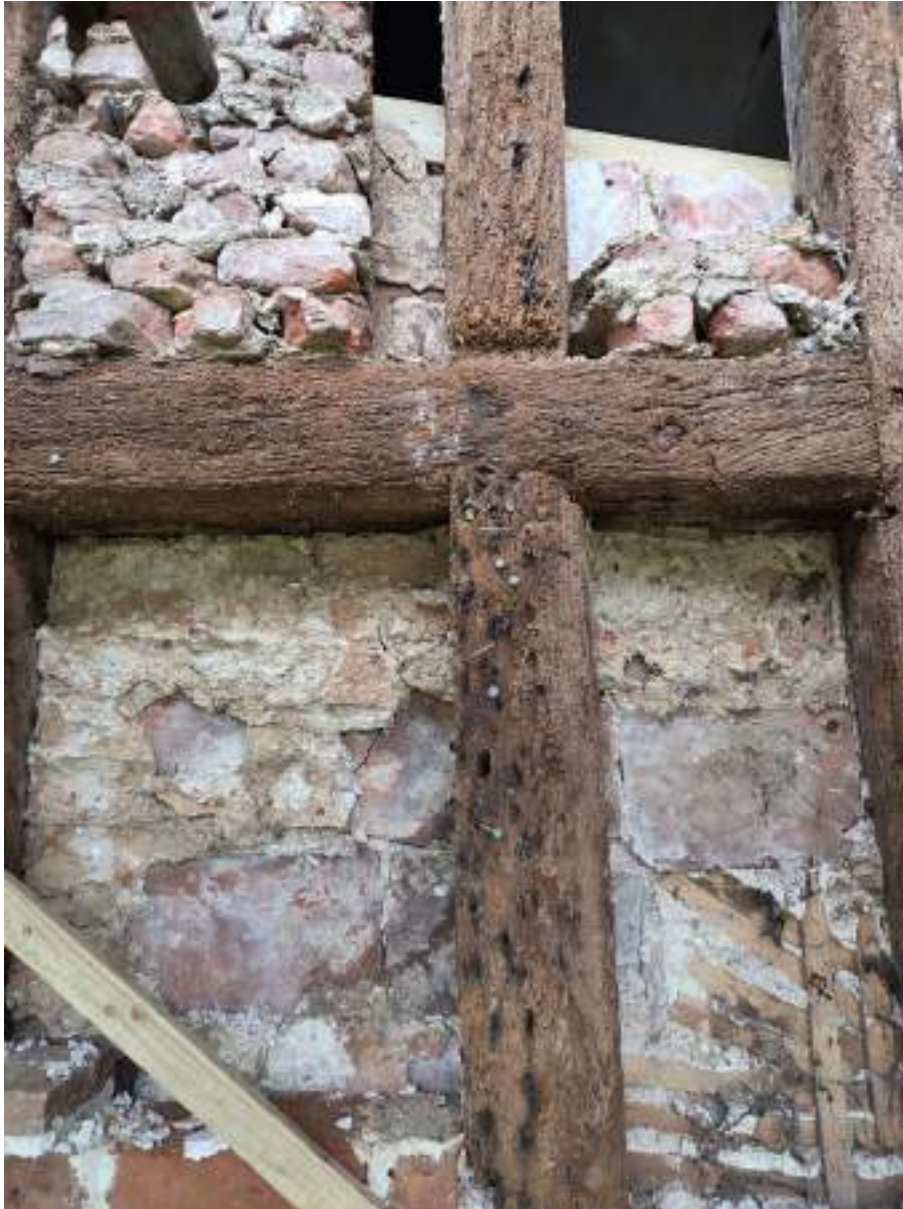
**Photograph 17** Detail of peg-tiles used for noggin in north-western elevation (range 5). Photograph taken facing south-east.

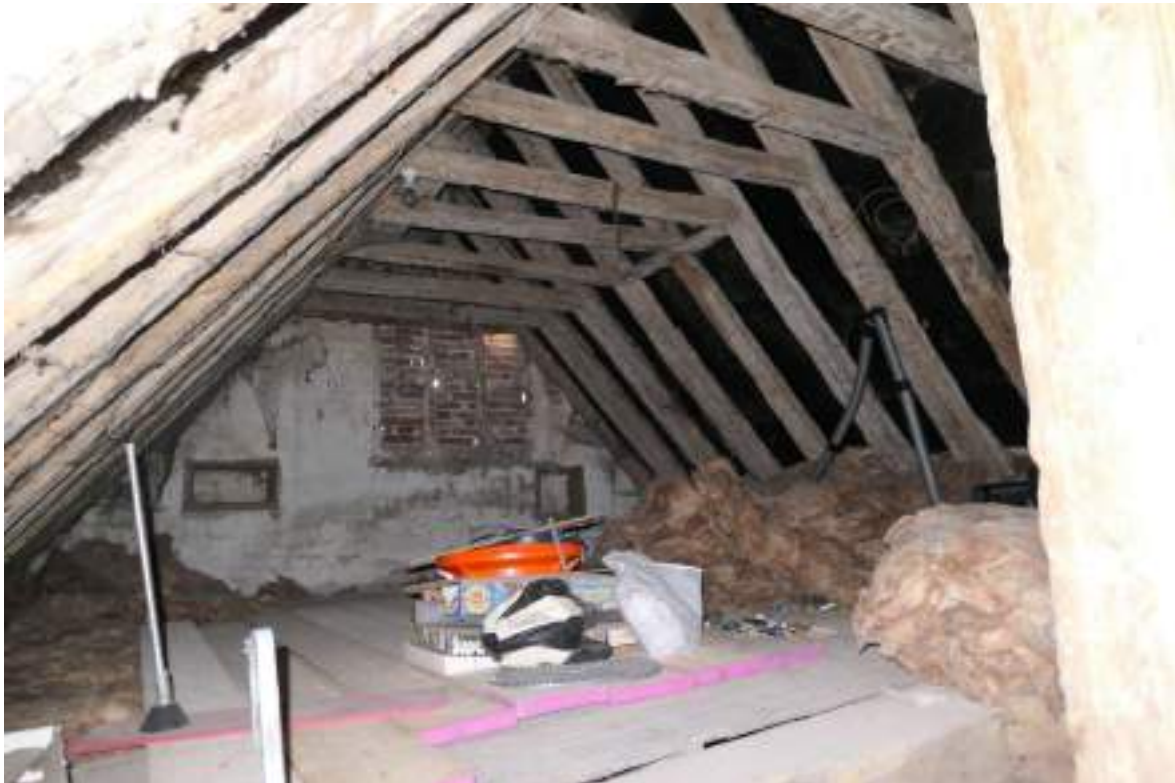
**Photograph 18** Detail of roof construction above range 3. Photograph taken facing west.

The roof structure covering range 3 (Photograph 18) comprises hand-sawn timbers arranged in pairs of rafters, which rise and meet one another at the apex of the roof. Tenoned into each pair of rafters is a collar. Above range 4 (Photograph 4) the roof is also constructed from hand-sawn timbers, the framing, however, comprises pairs of principal rafters which meet at the apex of the roof. Each roof

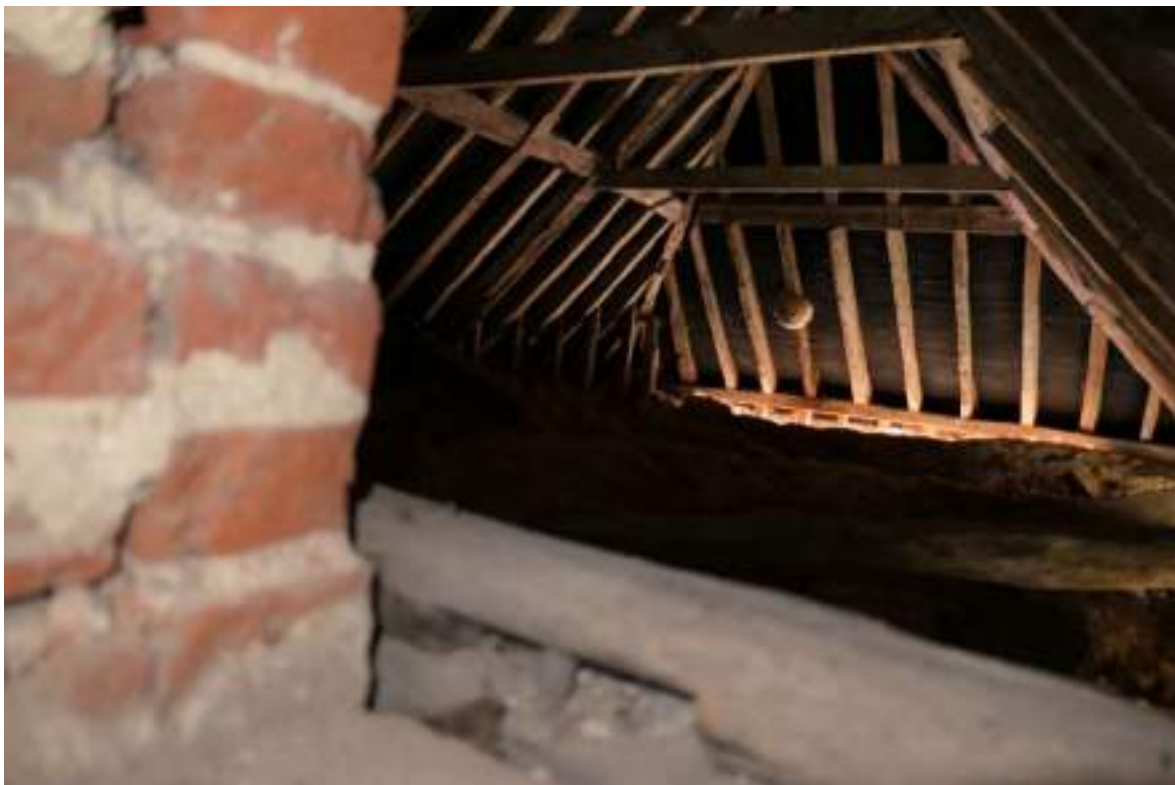
**Photograph 19** Detail of roof construction above range 4. Photograph taken facing north.

pitch, including the hip, has a butt purlin which interrupts a series of common rafters. A collar is present with each set of principal rafters. At least one timber in the roof of range 4 has evidence of reuse.

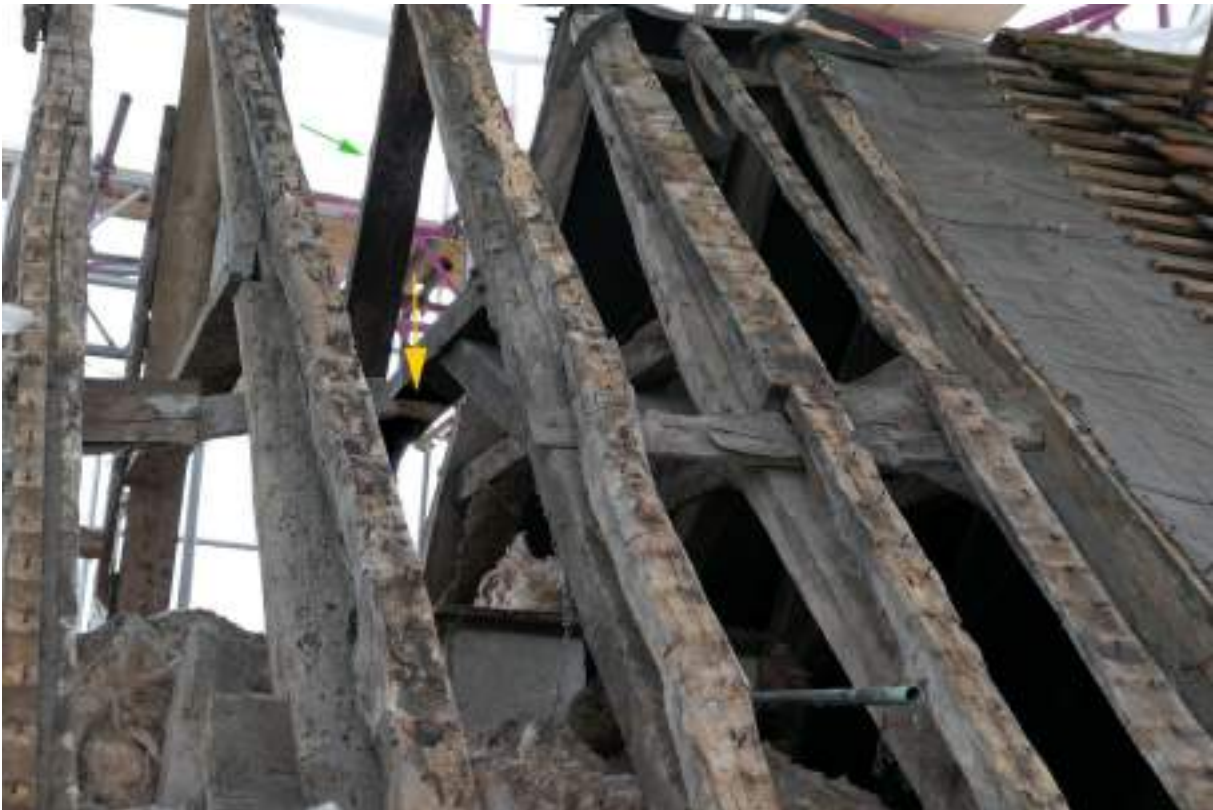
**Photograph 20** Detail of roof construction above range 5. Green arrow highlighting blackened timbers and yellow arrow highlighting the void in the blackening, likely caused by a central purlin. Photograph taken facing south south-east.

Immediately adjacent to one another are the roofs of ranges 5 and 6. Only partially visible, the roof structure that covers range 5 (Photograph 20) appears to comprise pairs of rafters, which meet at the roof's apex, each of which have a collar. An upward brace projects from each rafter to meet the underside of its associated collar. The last truss in the series appears to have been blackened by smoke, a void in which implies a central collar purlin has been removed suggesting that this represents the remains of a crown post roof. The roof associated with range 6 (Photograph 21), however, is formed from pairs of rafters which rise to meet an inserted ridge-board. A series of collars are present along the length of the roof, which are secured into the rafters with lap-dovetail joints. Each roof pitch has a single purlin, which are clasped by the collars. Both roof structures comprised hand-sawn timbers, some which are quite crudely processed.
