**CAT Report 2267  
Issued May 2026**

**Historic building recording and archaeological  
excavation at Dorewards Hall, The Chase, Bocking,  
Essex, CM7 5LS**

**October 2025 and March 2026**

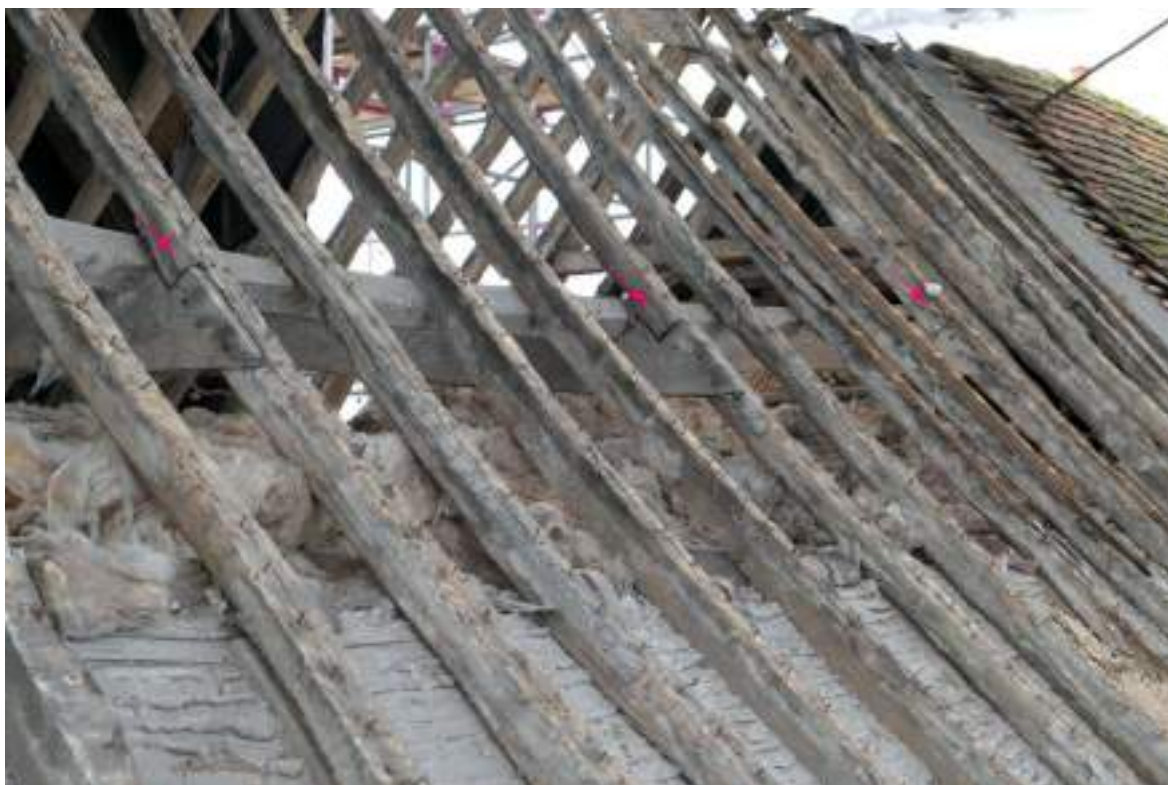
**Photograph 21** Roof timbers covering range 6. Pink arrows pointing to lap-dovetail joints securing the collars. Photograph taken facing south.

Immediately adjacent to one another are the roofs of ranges 5 and 6. Only partially visible, the roof structure that covers range 5 (Photograph 20) appears to comprise pairs of rafters, which meet at the roof's apex, each of which have a collar. An upward brace projects from each rafter to meet the underside of its associated collar. The last truss in the series appears to have been blackened by smoke, a void in which implies a central collar purlin has been removed suggesting that this represents the remains of a crown post roof. The roof associated with range 6 (Photograph 21), however, is formed from pairs of rafters which rise to meet an inserted ridge-board. A series of collars are present along the length of the roof, which are secured into the rafters with lap-dovetail joints. Each roof pitch has a single purlin, which are clasped by the collars. Both roof structures comprised hand-sawn timbers, some which are quite crudely processed.

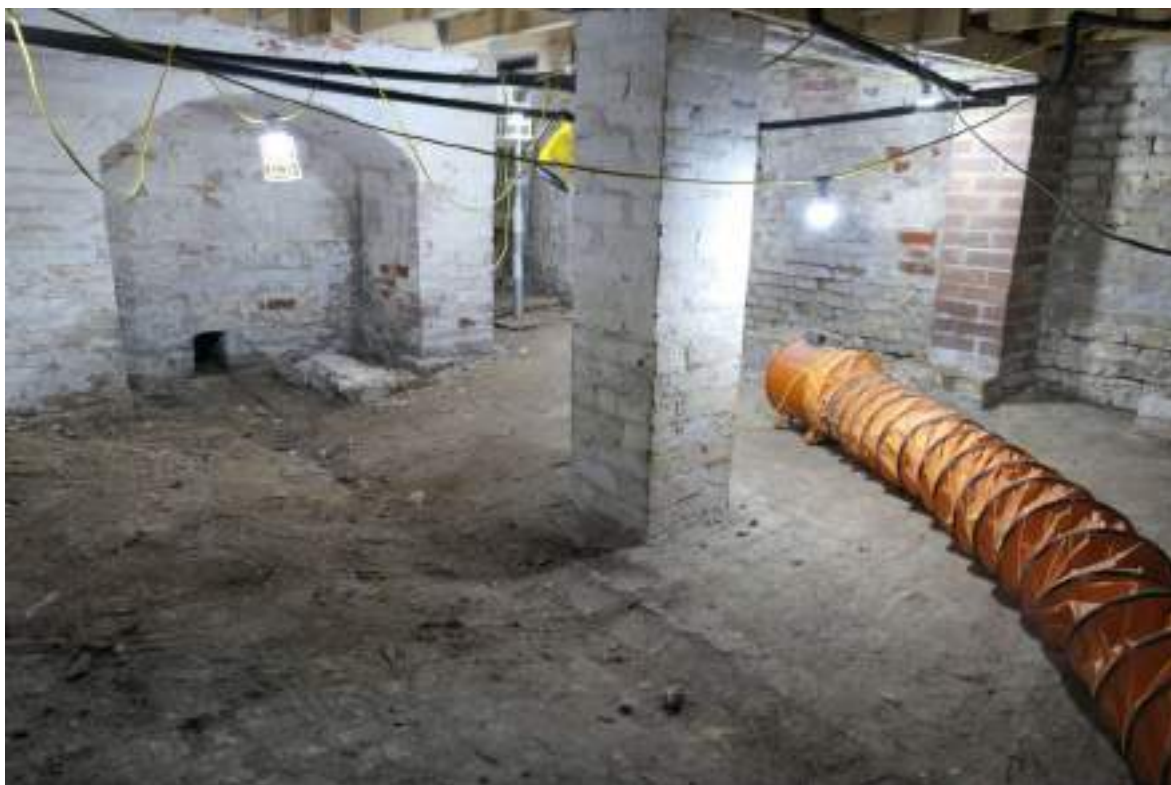
**Photograph 22** Interior of basement. Photograph taken facing east.

At the south-western end of the basement, the floor is brick (brick dimensions: 210-230 x 100-110 x ?mm) while the rest of the floor is compacted soil.

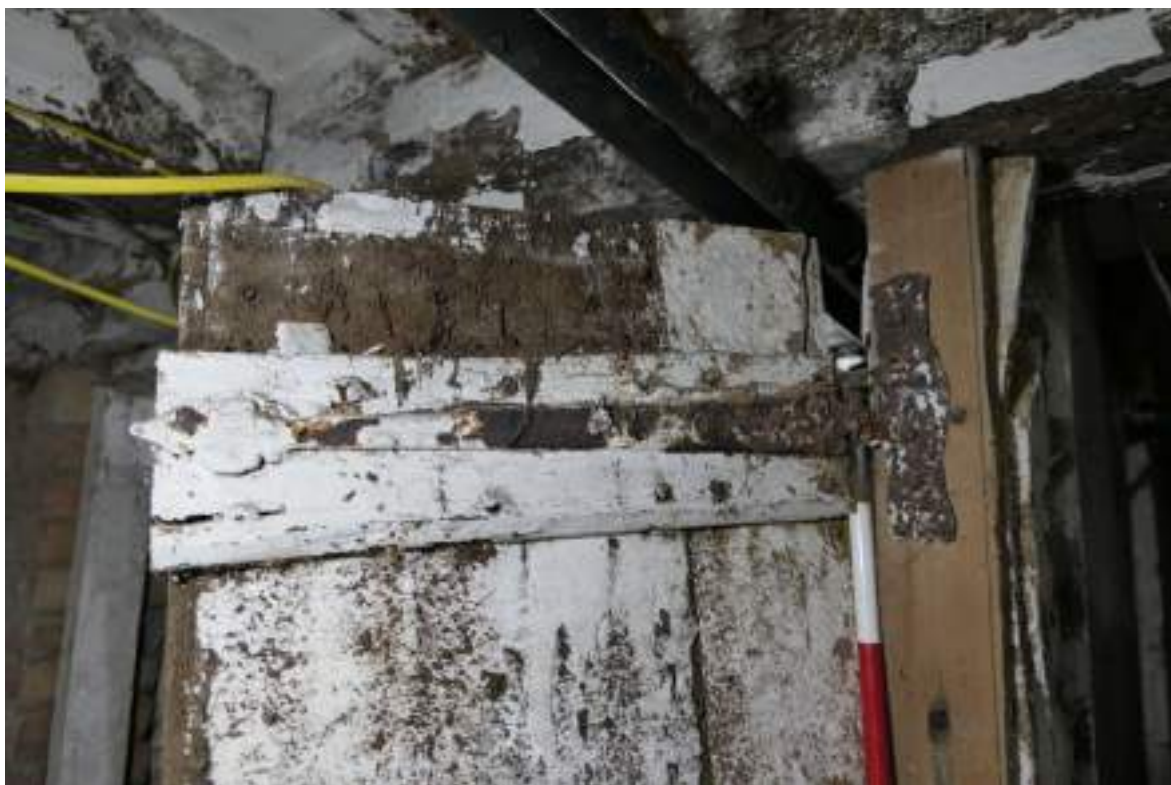
**Photograph 23** Detail of strap hinge on door in basement. Photograph taken facing north.

Two doors are present in the basement. One represents the remains of a plank and batten door, secured with iron strap hinges (Photograph 23). The door appears to have originally comprised at least three panels of irregular widths, secured with three battens. The hinges have tapered straps that extend into spearhead-shaped ends with a flared base plate. The second door comprises a series of thin slats flanked by two wider planks, secured with two battens (Photograph 24). A large, iron lock case is present above the second batten.

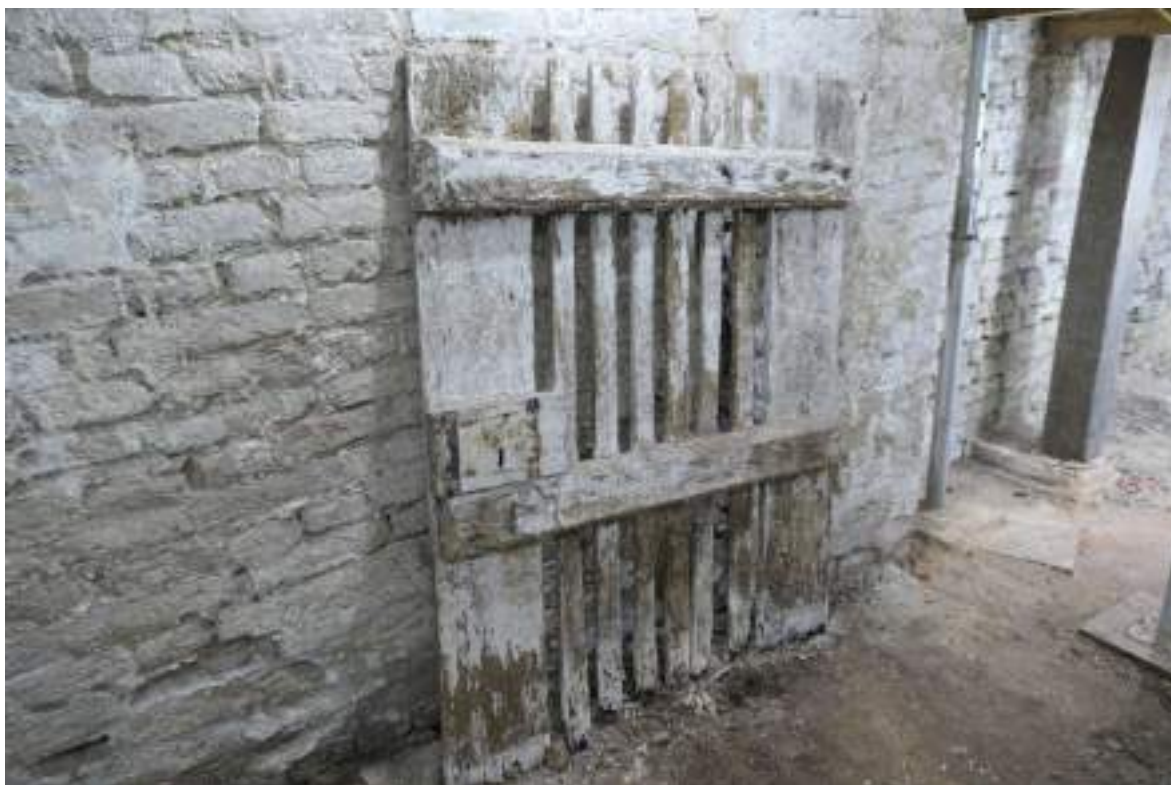
**Photograph 24** Detail of door in basement. Photograph taken facing south-east.

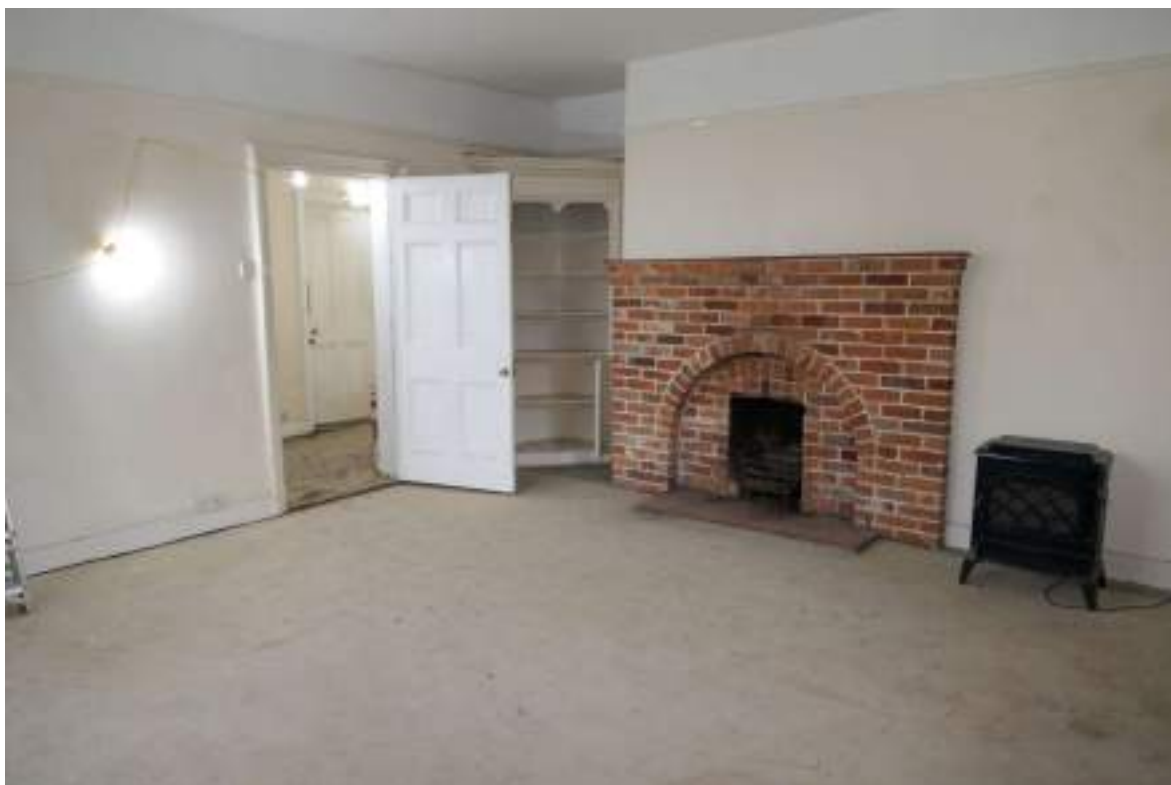
**Photograph 25** Interior of dining room. Photograph taken facing north.

The dining room is located on the ground floor of range 3 (Photograph 25). A window is set into both the south-western and south-eastern walls. The south-western window is a brick mullion and transom window, with cavetto shaped mullions and transoms, dividing six-lights comprising leaded windows with rectangular quarries (Photograph 26). One light has a casement opening with a spiral handle. The south-eastern is a four-light horned sash window with a timber sill. A six-panel door is present in the north-western wall, with a decorative architrave and a round brass knob. In the corner of the room is an in-built display cupboard, with numerous moulded decorative elements. A later brick fireplace is present in the north-eastern wall, with quarry tiles along the mantel and on the hearth. A moulded picture rail is present along each wall of the dining room with a plain skirting board along the base.

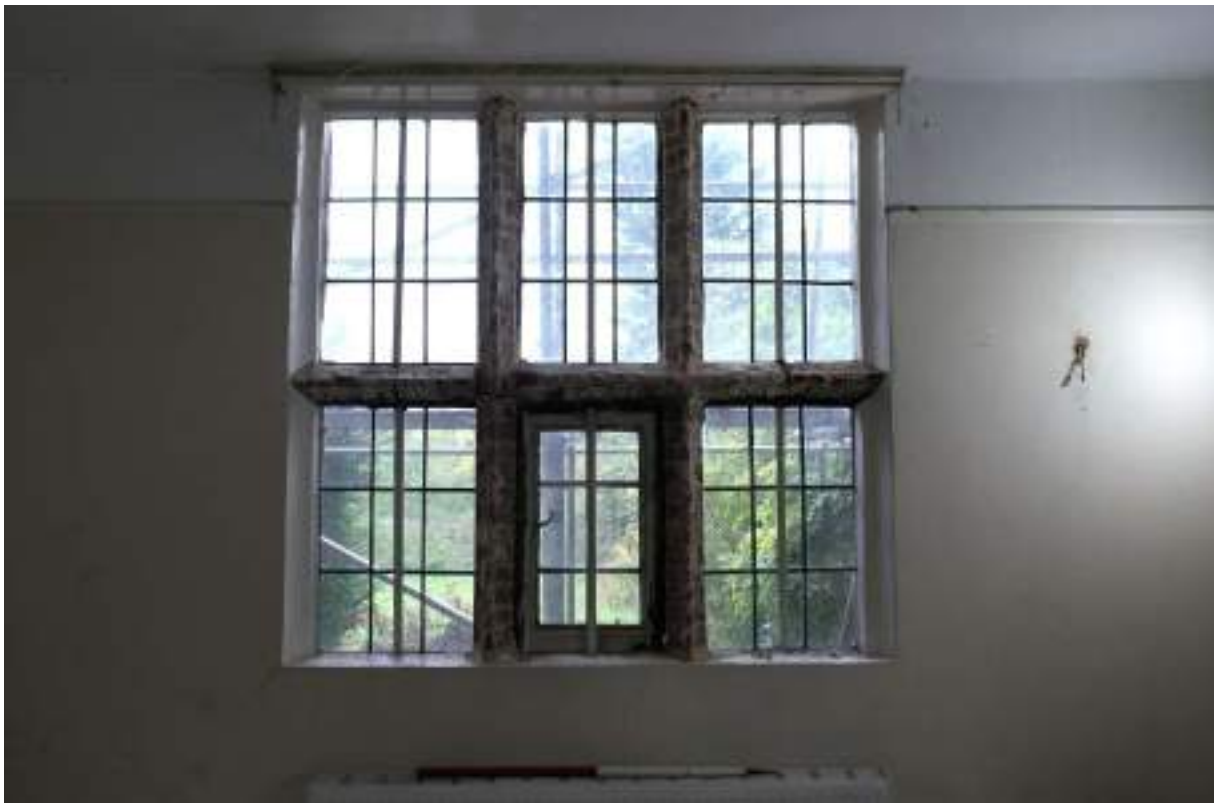
**Photograph 26** Detail of window in south-western wall of dining room. Photograph taken facing south-west.

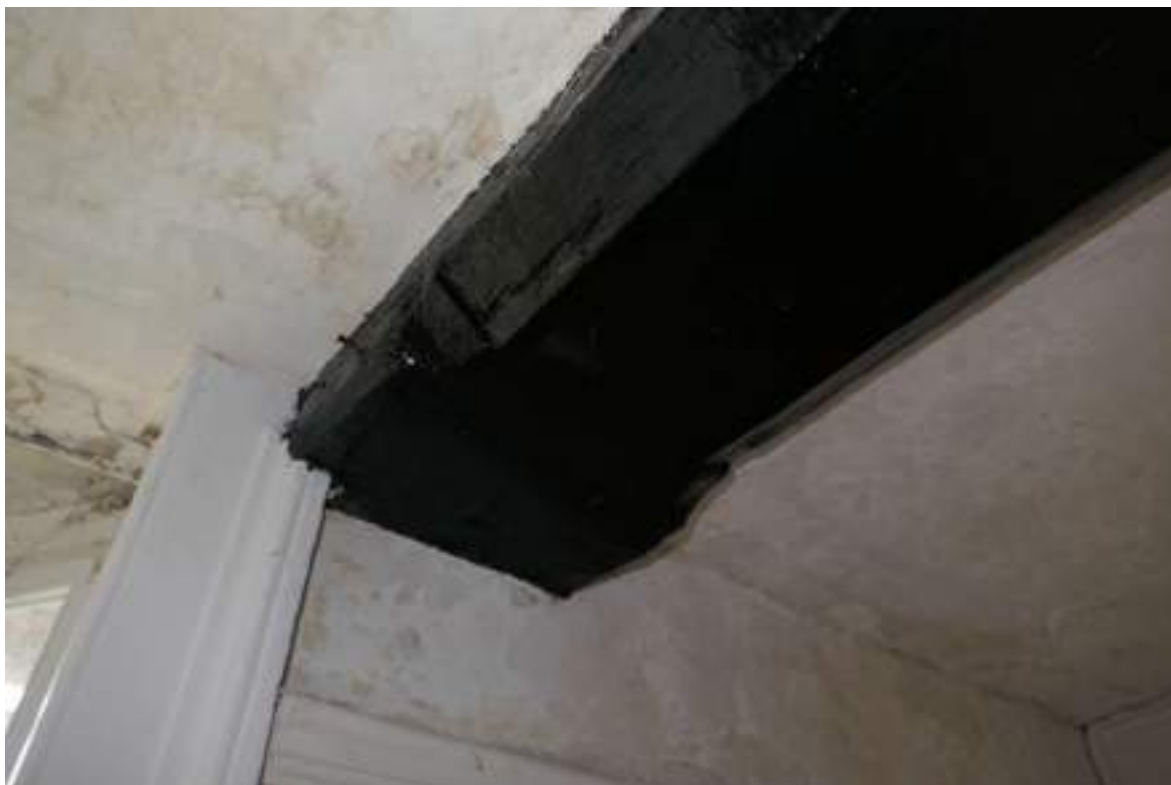
**Photograph 27** Detail of curved stepped stop on chamfered binding beam in ceiling of living room. Photograph taken facing south.

Situated in range 4, a large binding-beam is present in the ceiling of the living room. The beam is chamfered with curved step stops and is painted black (Photograph 27). An archway is present in the north-western and south-western walls of the living room (Photograph 28). Both are a three-centred arch with a moulded surround. There is a fireplace in the south-western wall, with a timber surround and a brick firebox. The surround has a central plaque flanked by intricate carvings. An iron fire grate is present in the firebox. A canted bay window, with double doors, and a horned sash window are both located in the south-eastern wall. A six-panel door is located in the north-eastern wall, with a decorative architrave, while a small serving hatch is present in the north-western wall. A moulded skirting board and picture rail are also present.

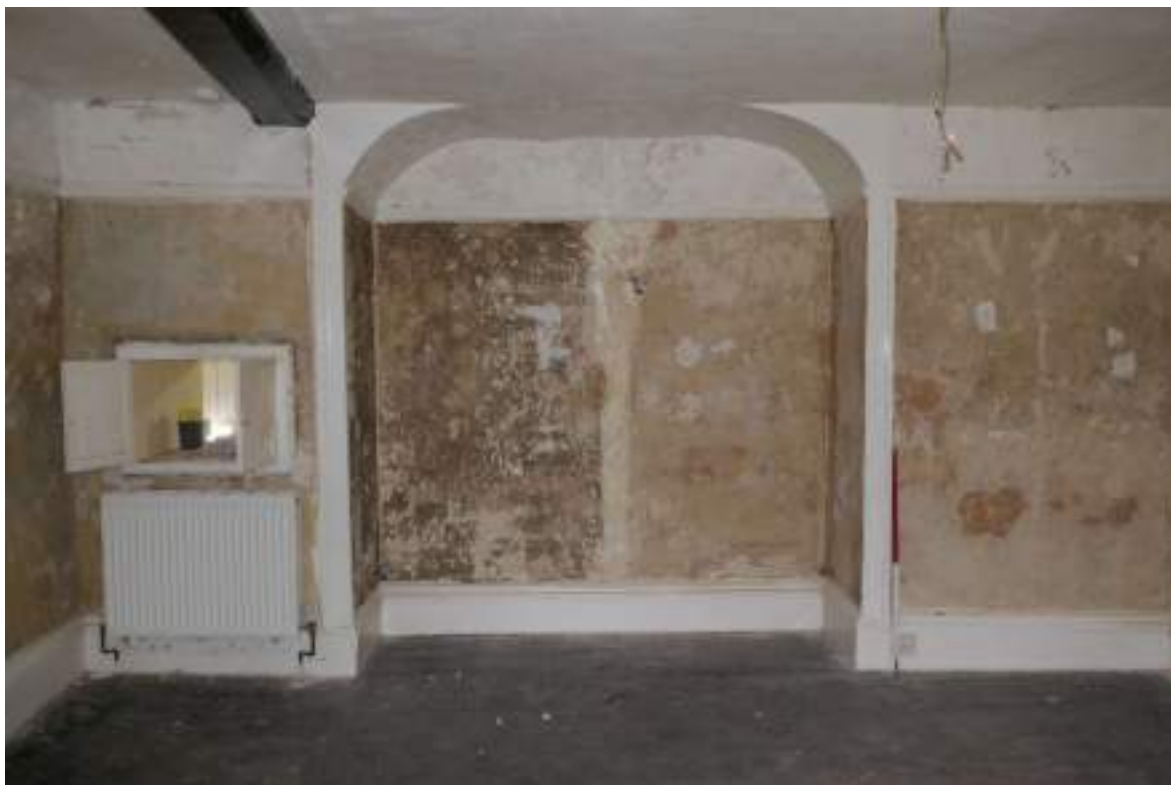
**Photograph 28** Detail of arch in north-western wall in living room. Photograph taken facing north-west.

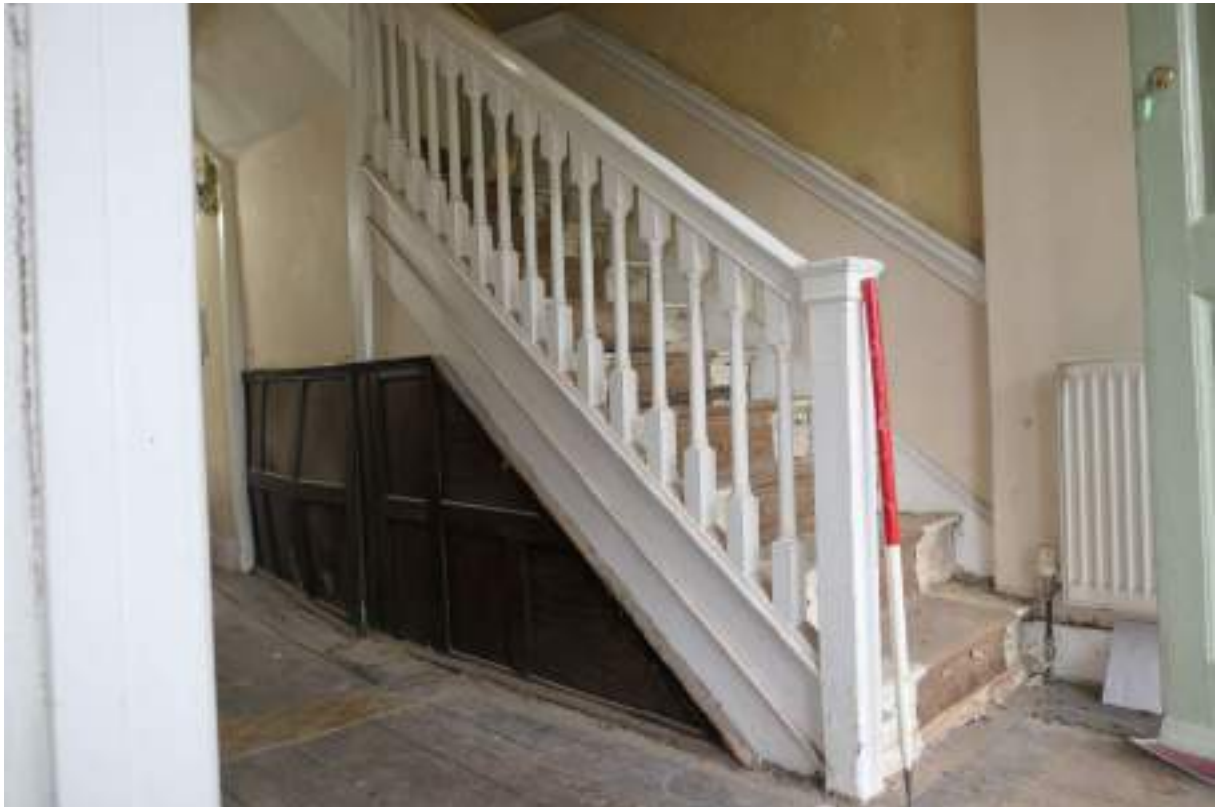
**Photograph 29** Detail of staircase in entrance hall. Photograph taken facing north.

Adjacent to the living room is the entrance hall. There are timber panels cladding two walls and an archway leading to corridor 1. A set of closed-string stairs occupies the north-eastern wall of the entrance hall, which are a straight slight with a winder (Photograph 29). The balustrade has gun-barrel balusters, with minimal turned decoration and tall, rectangular blocks, a round-topped handrail and three newel posts. The posts are plain, with a square profile, topped with a flat cap finial. Each step had a moulded nosing while a plain, rounded handrail is present on the wall side of the staircase. A door is present in the south-eastern and south-western walls of the entrance hall. The south-eastern is a modern six-panel external door, flanked by fixed windows, while the south-western door is a six-panel door with a decorative architrave.

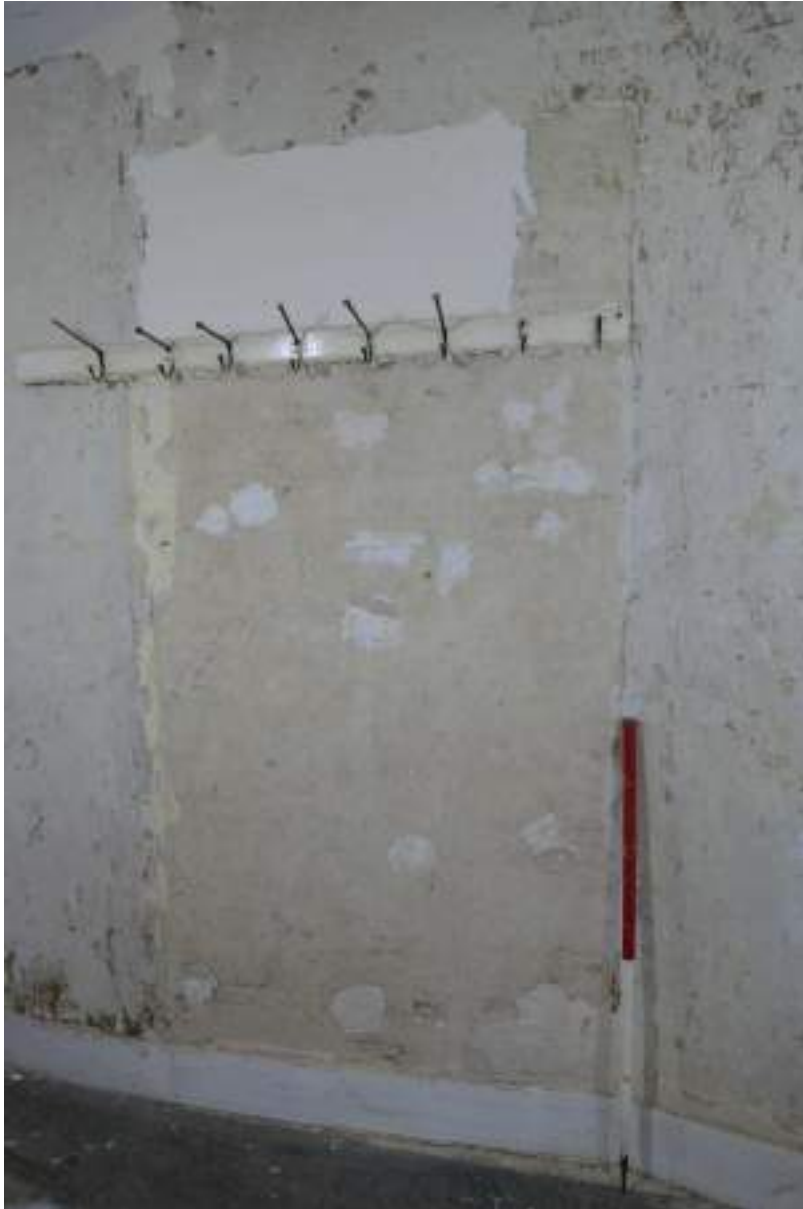
**Photograph 30** Detail of blocked doorway in south-eastern wall of corridor 1. Photograph taken facing east south-east.

Corridor 1 runs along the north-western side of the dining and living rooms. The south-eastern wall is curved at the northern end, within which appears to be a blocked door opening (Photograph 30). There are multiple doorways along the corridor, containing a combination of four and six-panel doors, each with a decorative surround. A timber-lined serving hatch is present in the south-eastern wall while a window, with timber shutters, is located in the north-western wall. The shutters are panelled timber, with a plain security bar, and have a sliding mechanism (Photograph 31). Three steps are present towards the south-western end of the corridor, which are timber with plain rounded nosings. At the end of the corridor is the pantry, which was inaccessible at the time of recording.

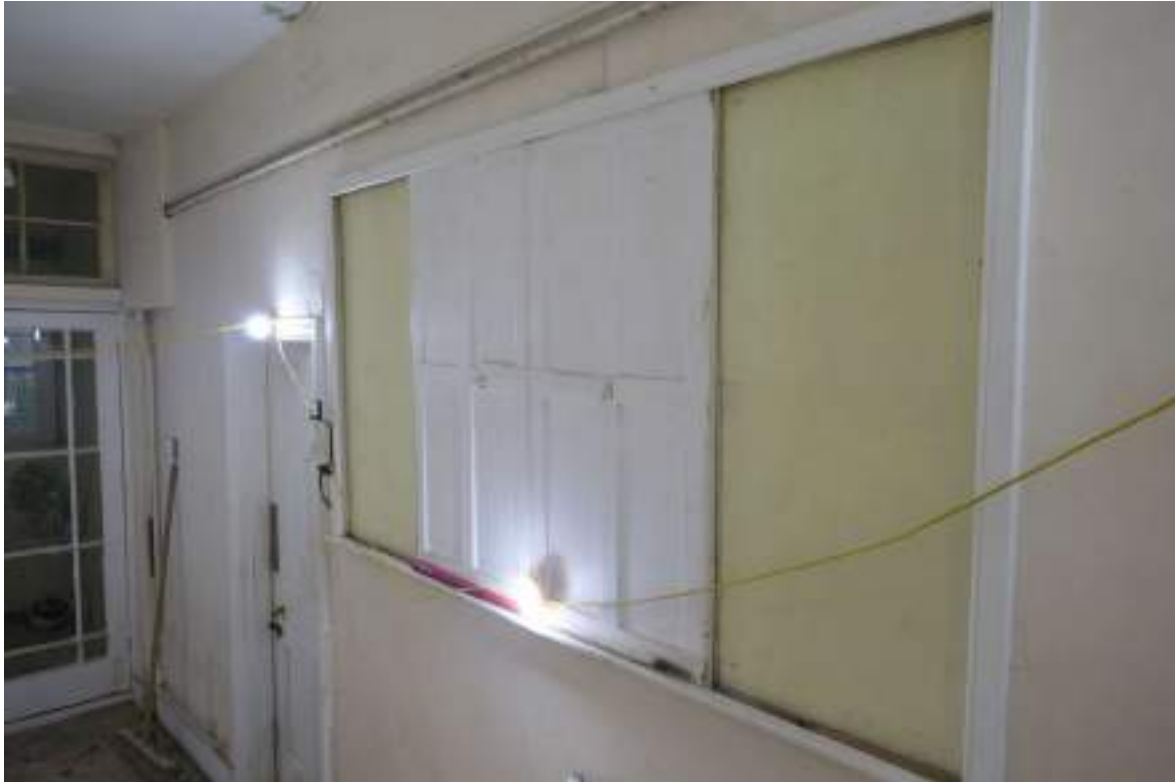
**Photograph 31** Detail of window shutters in north-western wall of corridor 1. Photograph taken facing west.

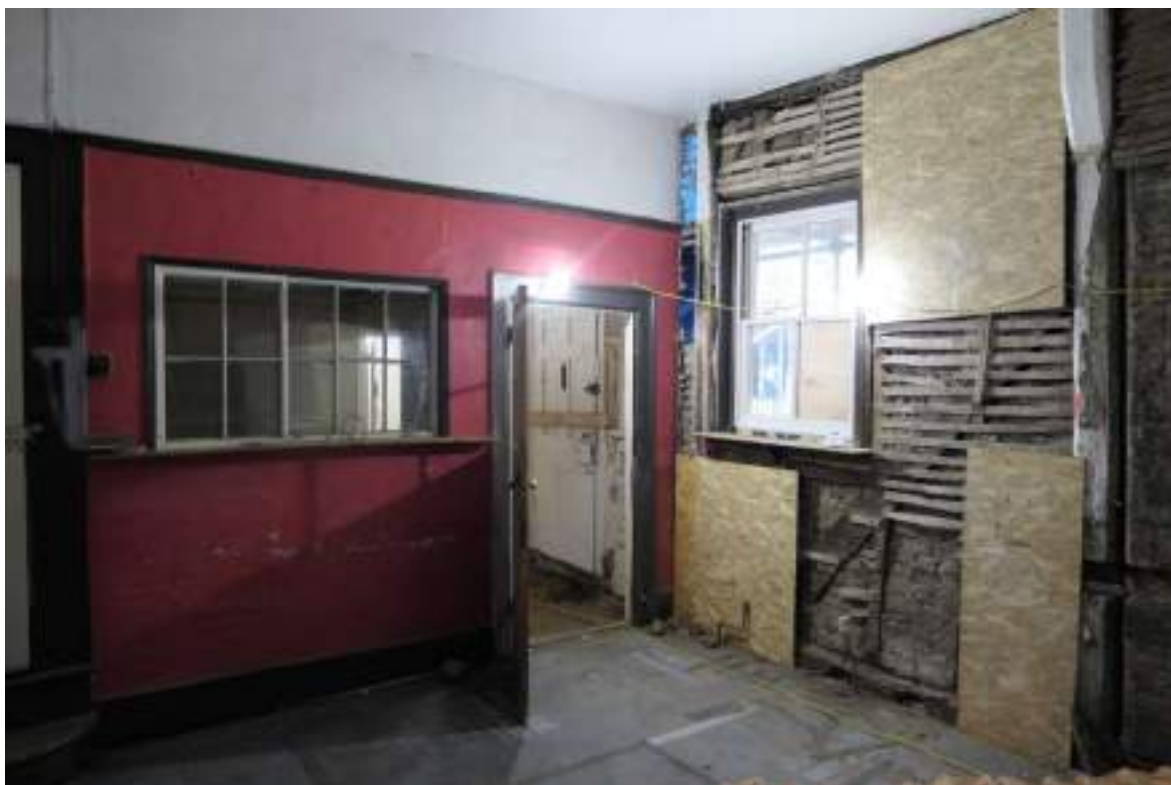
**Photograph 32** Interior of office. Photograph taken facing south-east.

The office occupies the south-western end of range 5 (Photograph 32). The plaster has been removed from the north-western wall of the office, exposing the laths and some of the timber-framing beneath. The timbers are mostly hand-sawn, except for in areas of modern repair, some of which are reused (Photograph 33). A primary brace is visible in the framing, along with brick nogging. Windows are present in three walls, two of which are four-light sash windows and the third a ten-light horizontal sash window. Six doors are also set across the room, which are largely either two, four and six-panel, with one vertically planked door. Each door has a timber surround, with differing levels of decoration. A large brick fireplace dominates the south-western wall; it has two carved timber panels embedded into the brickwork and dentil detailing along the mantle. The opening has a curved arch and a brick-lined hearth.

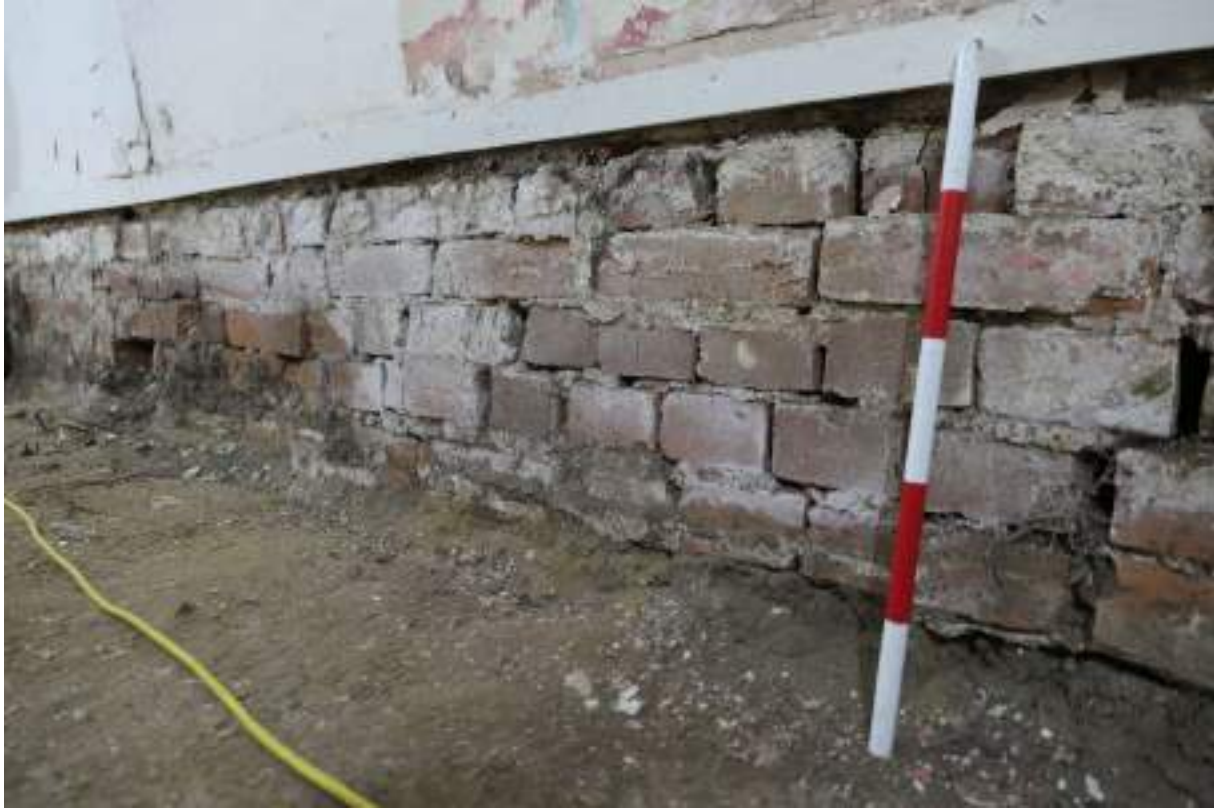
**Photograph 34** Detail of brick plinth visible in south-eastern wall of corridor 2. Photograph taken facing east south-east.

A number of doors lead off corridor 2, each of which are either four or six-panel with a decorative architrave. The doors in the north-western wall have stable door openings. A red brick plinth is exposed at the base of the south-eastern wall, comprising red bricks (230-240 x 110-120 x 75-75mm) laid without a regular bonding pattern (Photograph 34).

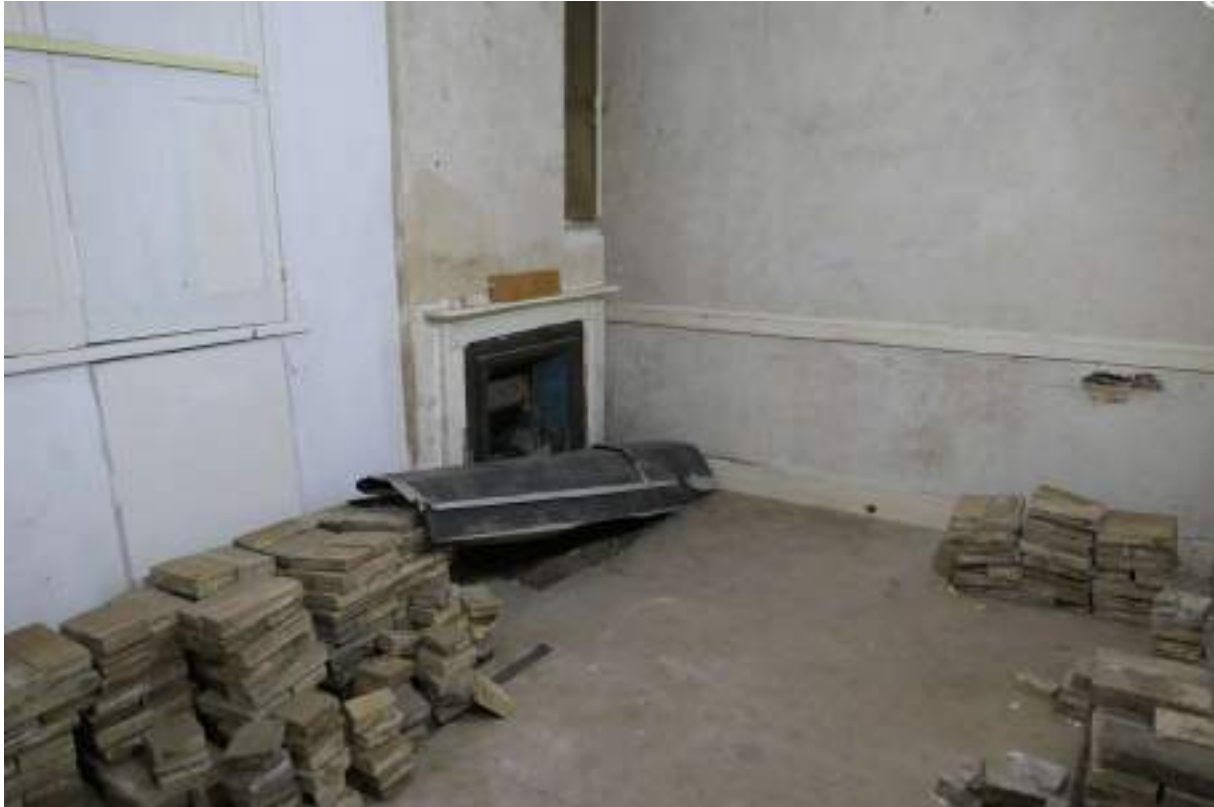
**Photograph 35** Interior of spare room 2. Photograph taken facing north.

Spare room 2 inhabits the northern corner of range 5 (Photograph 35). A shuttered window is present in the north-western wall while a four-panel door is in the south-eastern wall. The window shutters are panelled with a plain security bar and open via a sliding mechanism. A fireplace is situated adjacent to the shuttered window. It has a timber surround, with bullseye corners and a fluted design, and an iron firebox with blue tiles. An iron fire grate is also present. An in-built cupboard occupies the space next to the fireplace, which has panelled doors. In-built cupboards/drawers are also present in the south-western wall, in an area with a sloped ceiling. A relatively plain dado rail and skirting board exist along each wall.

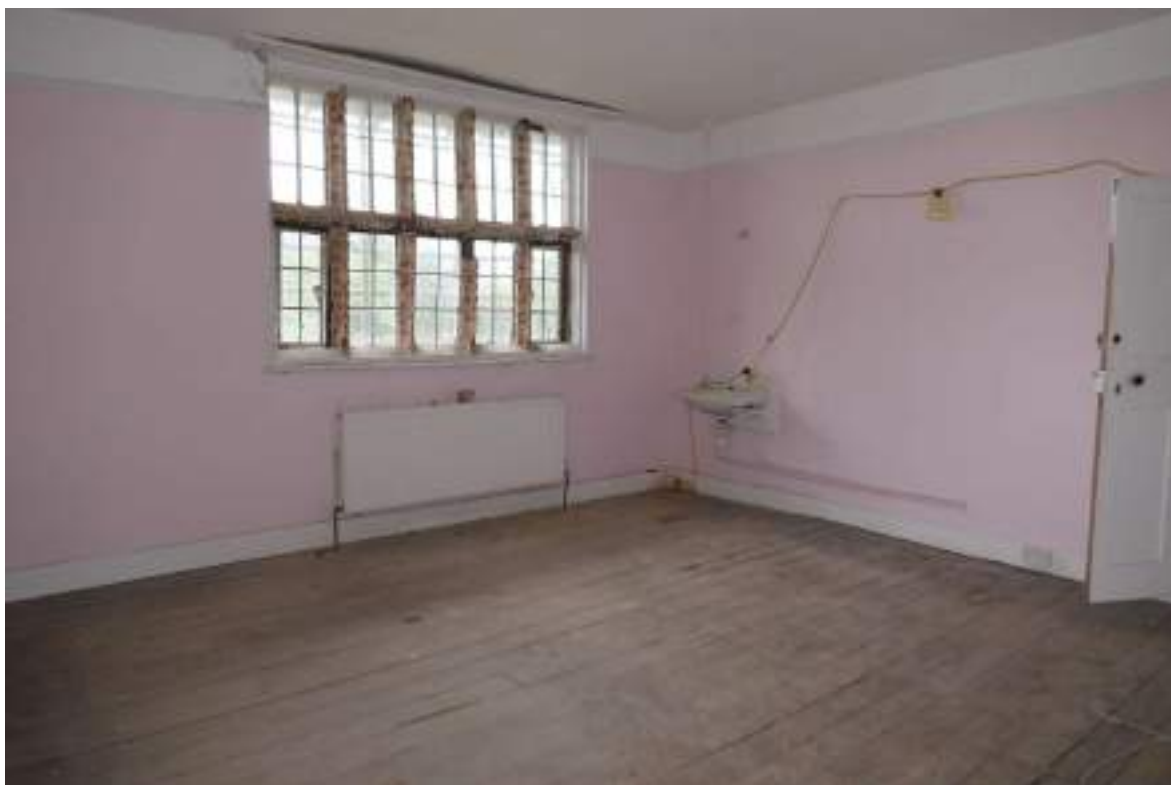
**Photograph 36** Interior of bedroom 1. Photograph taken facing west.

Bedroom 1 is located in range 3 (Photograph 36). It has an eight-light window, with brick cavetto-shaped mullions and transoms in the south-western (Photograph 37). Each light is leaded, comprising square quarries, two of which have casement openings with monkey tail handles and handles with a rounded knob. In the south-eastern wall is a leaded sash window, also with square quarries. Doors are located in the north-western and north-eastern walls, both of which have four panels and decorative architraves. There is a fireplace in the north-eastern wall, with a lightly decorative timber surround. A plain skirting board and a moulded picture rail line the walls.

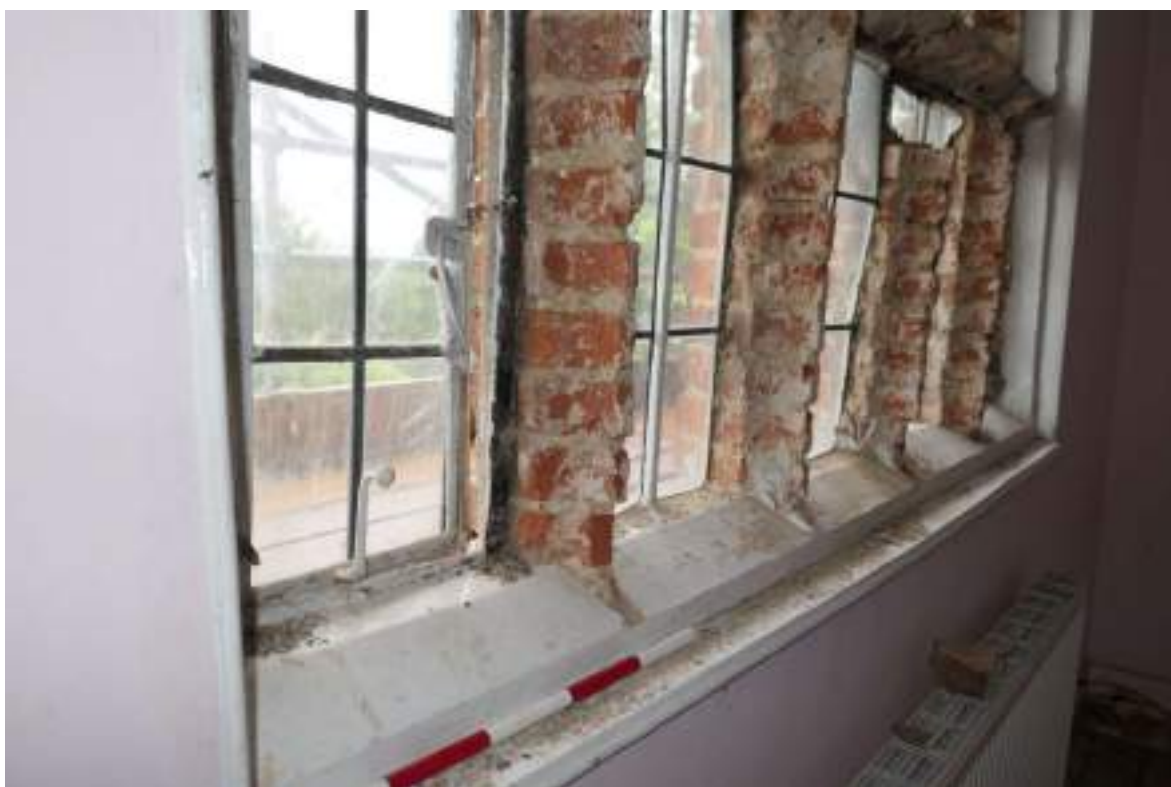
**Photograph 37** Detail of brick mullions in window in south-western wall of bedroom 1. Photograph taken facing west.

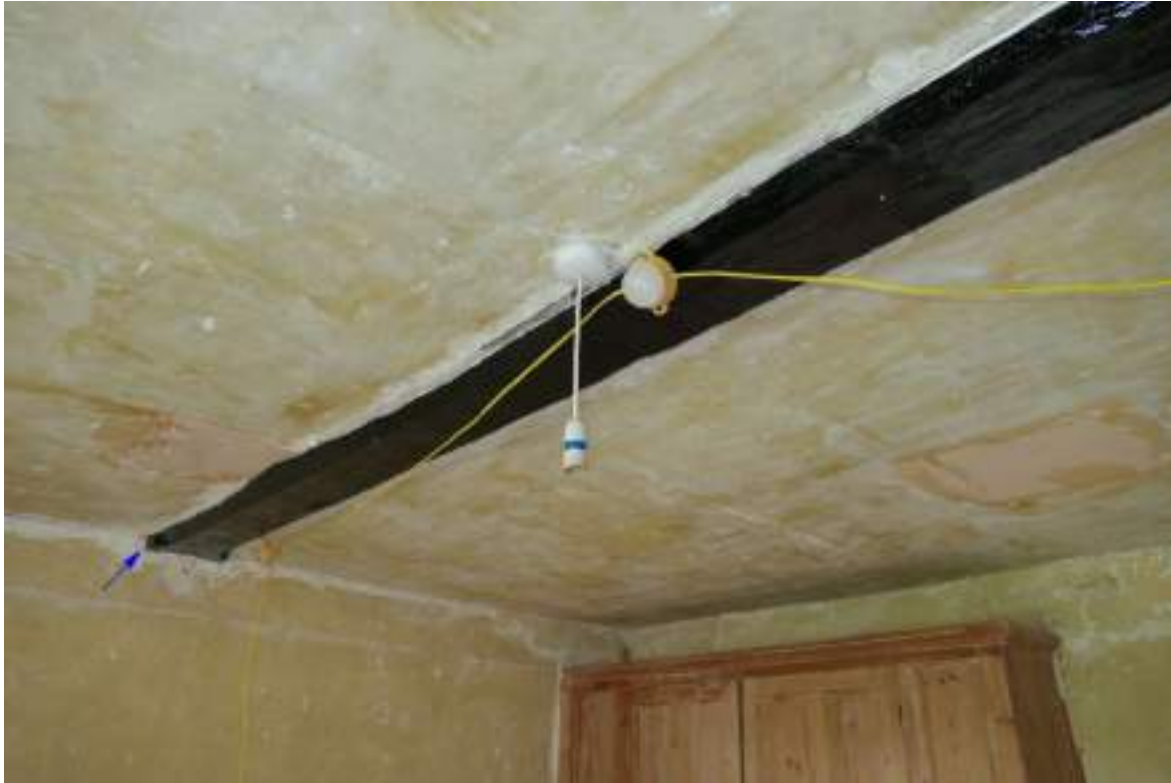
**Photograph 38** Detail of chamfered bridging joist, with curved stepped stops (blue arrow).  
Photograph taken facing west.

Situated in range 4, bedroom 2 has two partially exposed beams in the ceiling. Both are layered with black paint and have chamfered edges. The north-east/south-west aligned beam has curved step stops visible at one end (Photograph 38). A six-light sash window is present in the south-eastern wall, while a two panel-door is located in the north-eastern and south-western walls. All have moulded architraves. A plain skirting board lines the base of the walls.

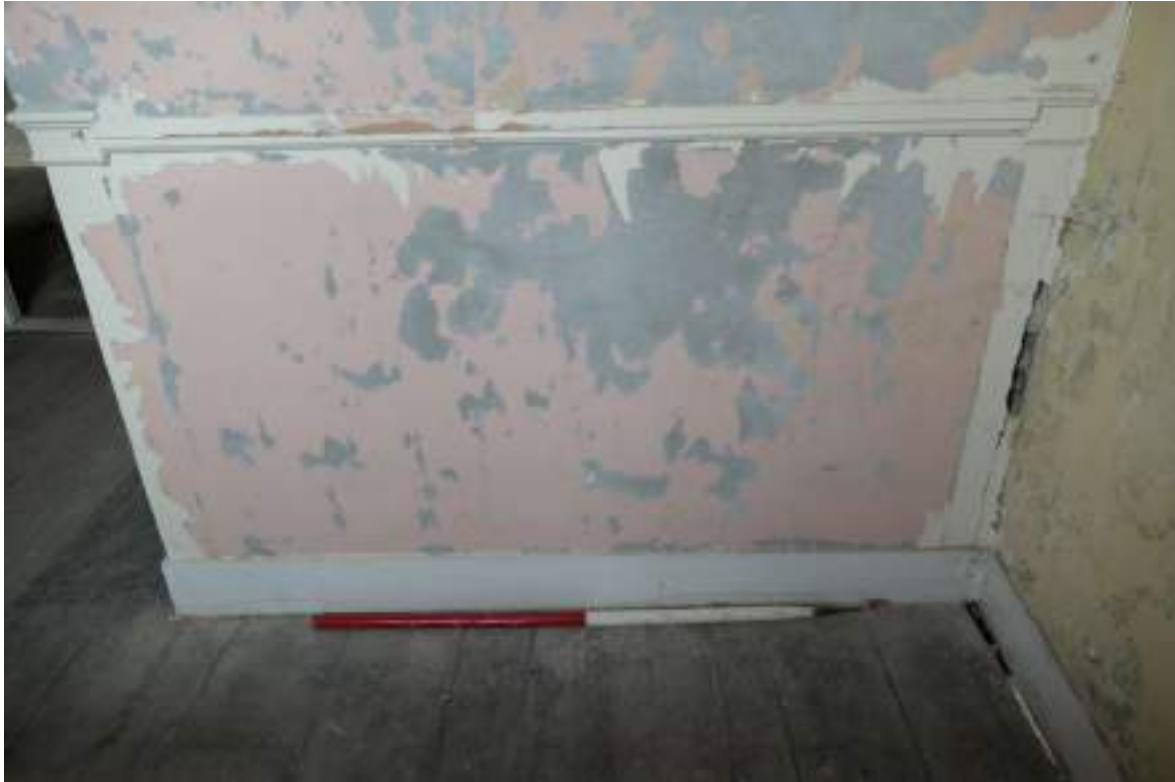
**Photograph 39** Detail of stair balustrade incorporated into wall in bedroom 3. Photograph taken facing north-west.

A number of exposed hand-sawn timbers are present in the walls and ceiling of bedroom 3, which is located in the eastern corner of range 4. The timbers comprise two tie-beams and a corner-post. Two newel posts and lengths of handrail, the same style as the stairs in the entrance hall, are visible in the north-western and south-western walls, suggesting that bedroom 3 was originally part of the landing (Photograph 40). A four-light sash window is present in the south-eastern wall.

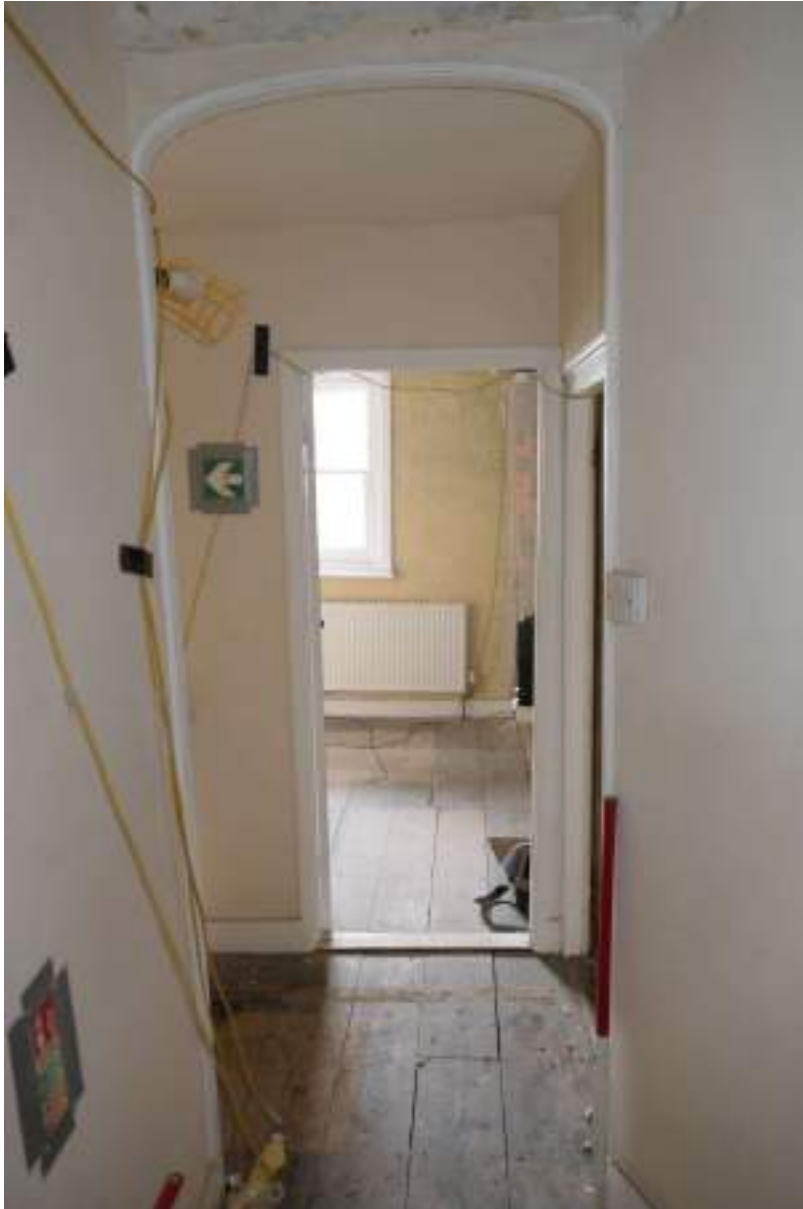
**Photograph 40** Detail of arched doorway in corridor 3. Photograph taken facing south-east.

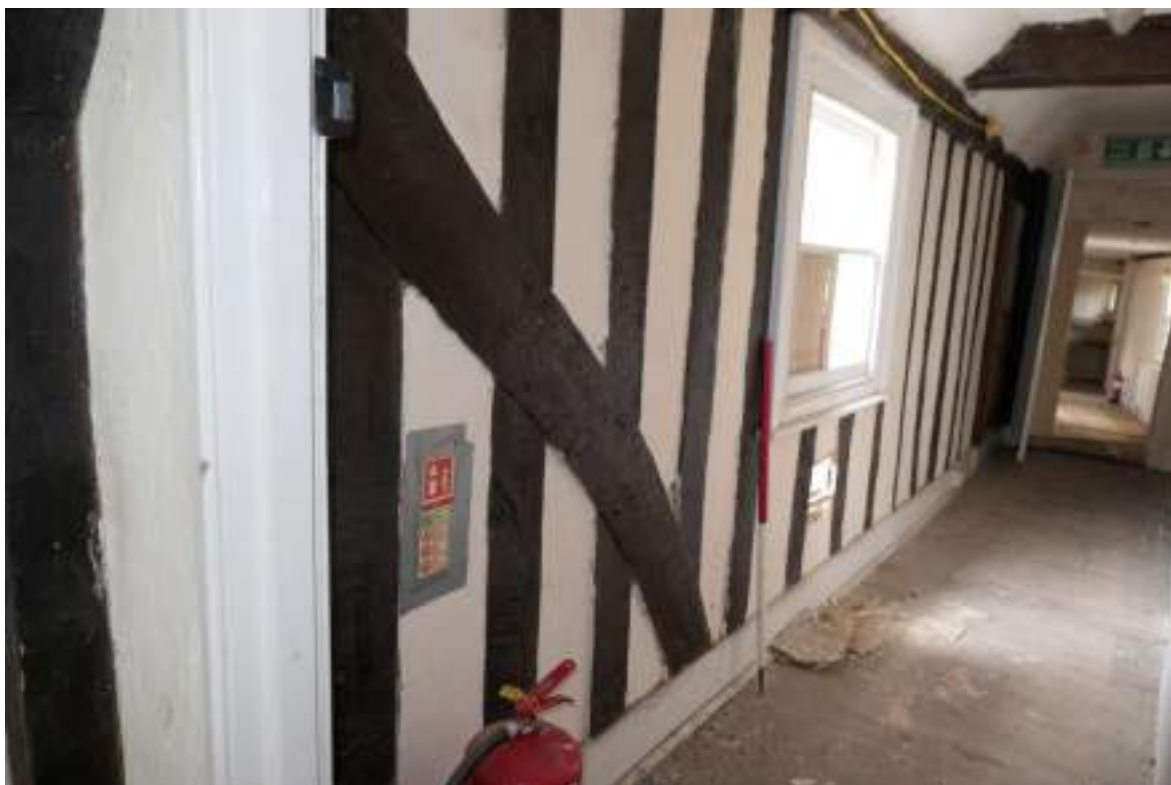
**Photograph 41** Detail of exposed timber-framing in south-eastern wall of corridor 4. Photograph taken facing south.

Exposed timber-framing is present along the south-eastern wall of corridor 4, for almost the entire length of the room (Photograph 42). The framing is built using a style called close studding and utilises concealed curved tension braces. Constructed from hand-sawn timbers, the frame is held together with timber pegs. A single intermediate post is visible, which has a jowled head (Photograph 44), as well as a lengthy wall-plate and a large tie-beam. An edge-halved scarf-joint is visible in the wall-plate, although its specific typology was not discernible (Photograph 43). The timber-framing has been repaired and altered in places. Two windows are present in the south-eastern wall, a four-light sash window and a three-light leaded casement window, although it is not obvious whether these represent later replacements or insertions. A number of doors are located in the north-western wall of corridor 4, which are mostly four-panel, but also include a plank and batten door. A single step is present at the north-eastern end of the corridor.

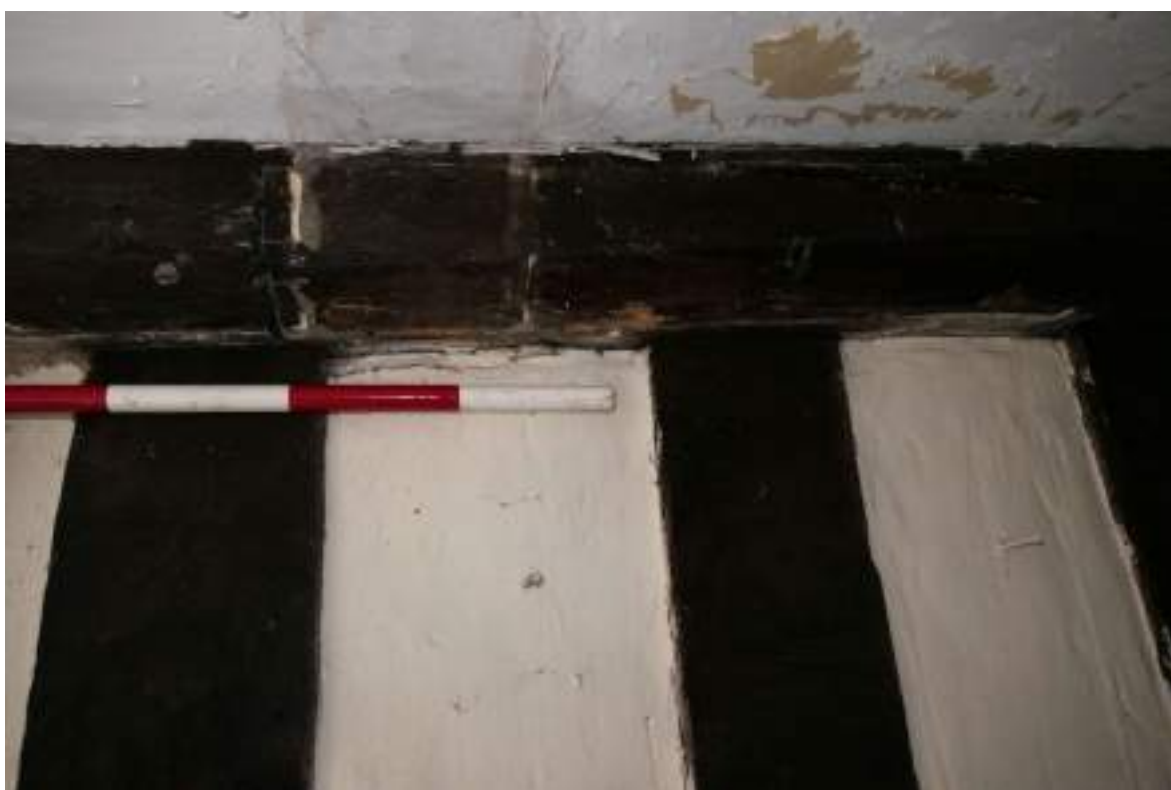
**Photograph 42** Detail of scarf-joint in wall-plate in south-eastern wall of corridor 4. Photograph taken facing south-east.
