**CAT Report 2267  
Issued May 2026**

**Historic building recording and archaeological  
excavation at Dorewards Hall, The Chase, Bocking,  
Essex, CM7 5LS**

**October 2025 and March 2026**

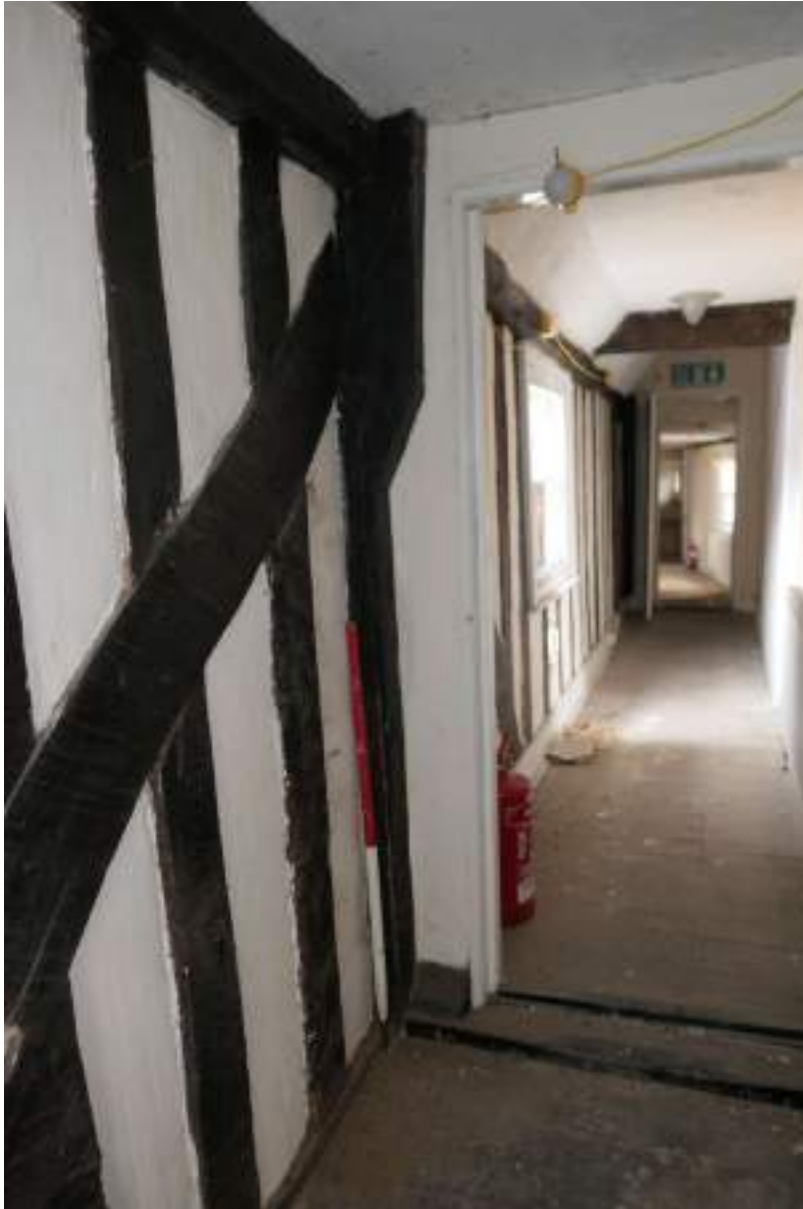
**Photograph 43** Detail of jowled post in south-eastern wall of corridor 4.  
Photograph taken facing south.

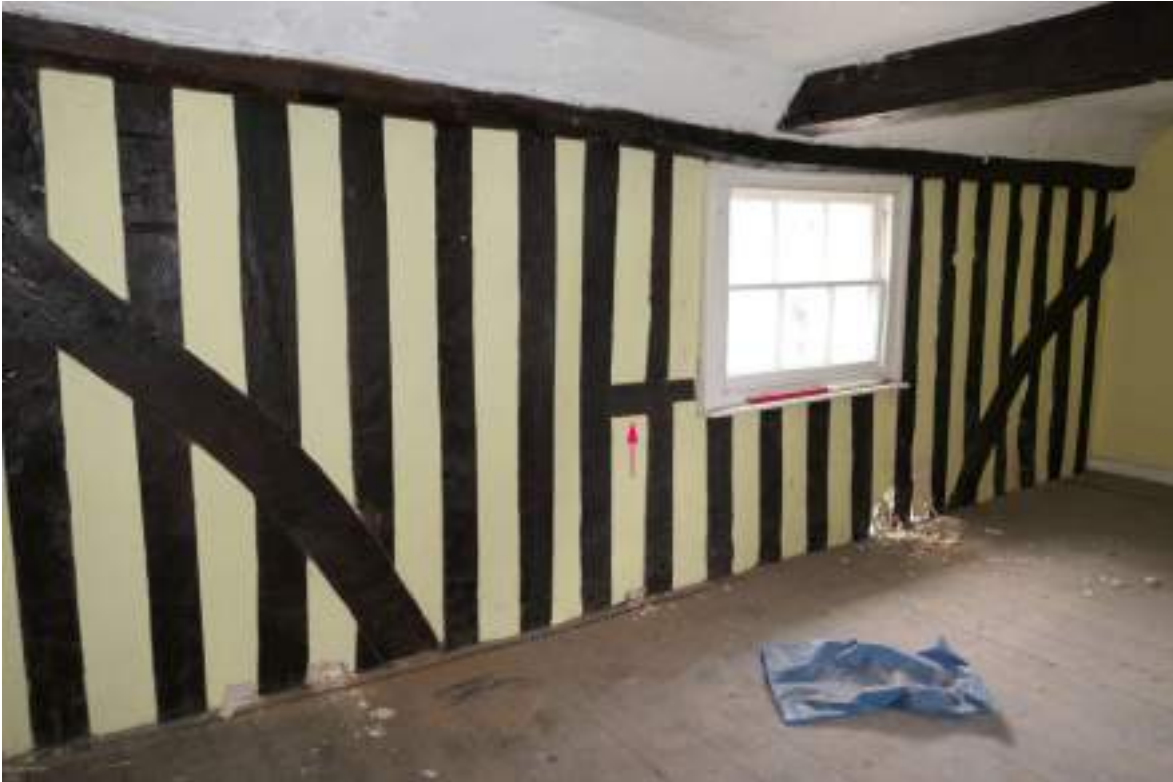
**Photograph 44** Detail of exposed timber-framing in north-western wall of bedroom 4. Pink arrow highlighting a horizontal rail likely associated with an original window. Photograph taken facing north.

The north-western wall of bedroom 4, located in range 5, has exposed timber-framing (Photograph 45). The framing is constructed from hand-sawn timbers and comprises a number of studs with concealed curved tension bracing. Adjacent to a six-light sash window, a central rail interrupts one of the studs, suggesting that the window is a replacement for an original mullion window (Photograph 45). A scarf-joint, in the wall-plate, has been reinforced with a metal plate, obscuring the typology of the joint (Photograph 46). A large tie-beam is present in the centre of the ceiling, which displays evidence it has been reused and has a metal strap added. A small cupboard space in the north-western wall of bedroom 4 was uncovered during the renovation works, adjacent to a fireplace opening which had also been sealed.

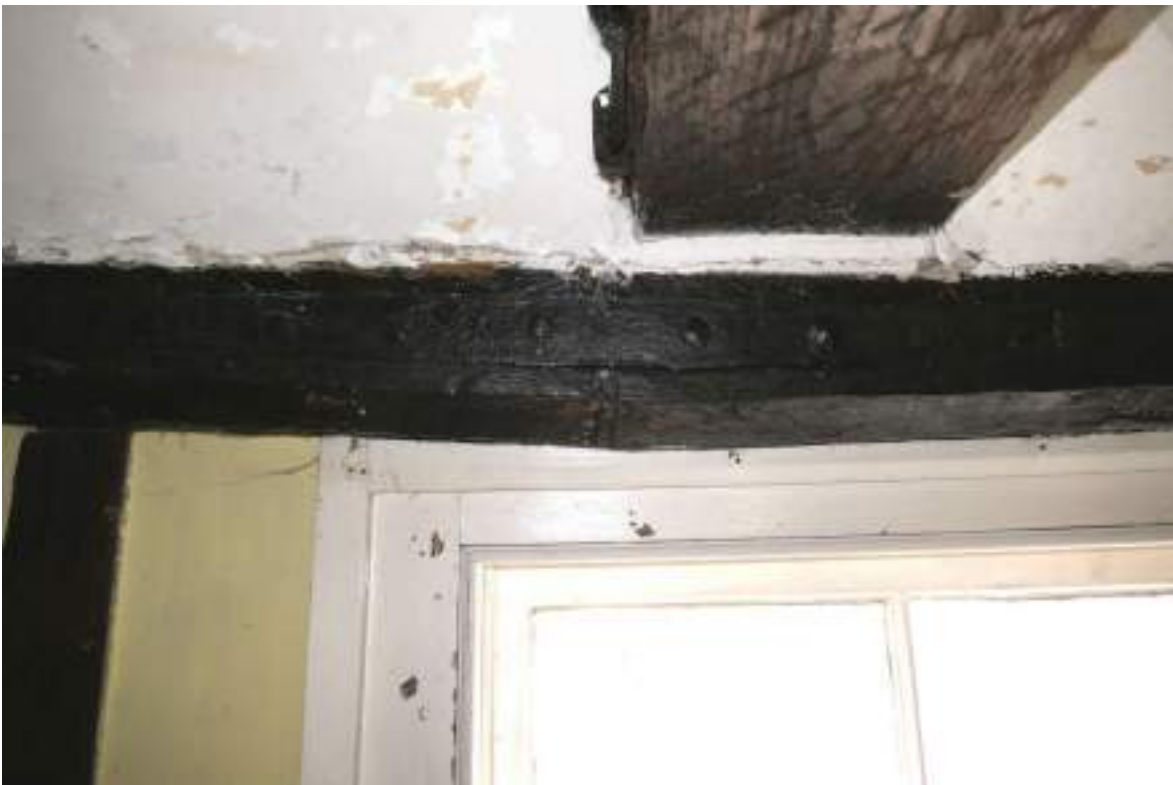
**Photograph 45** Detail of plated scarf-joint in north-western wall-plate in bedroom 4. Photograph taken facing north-west.

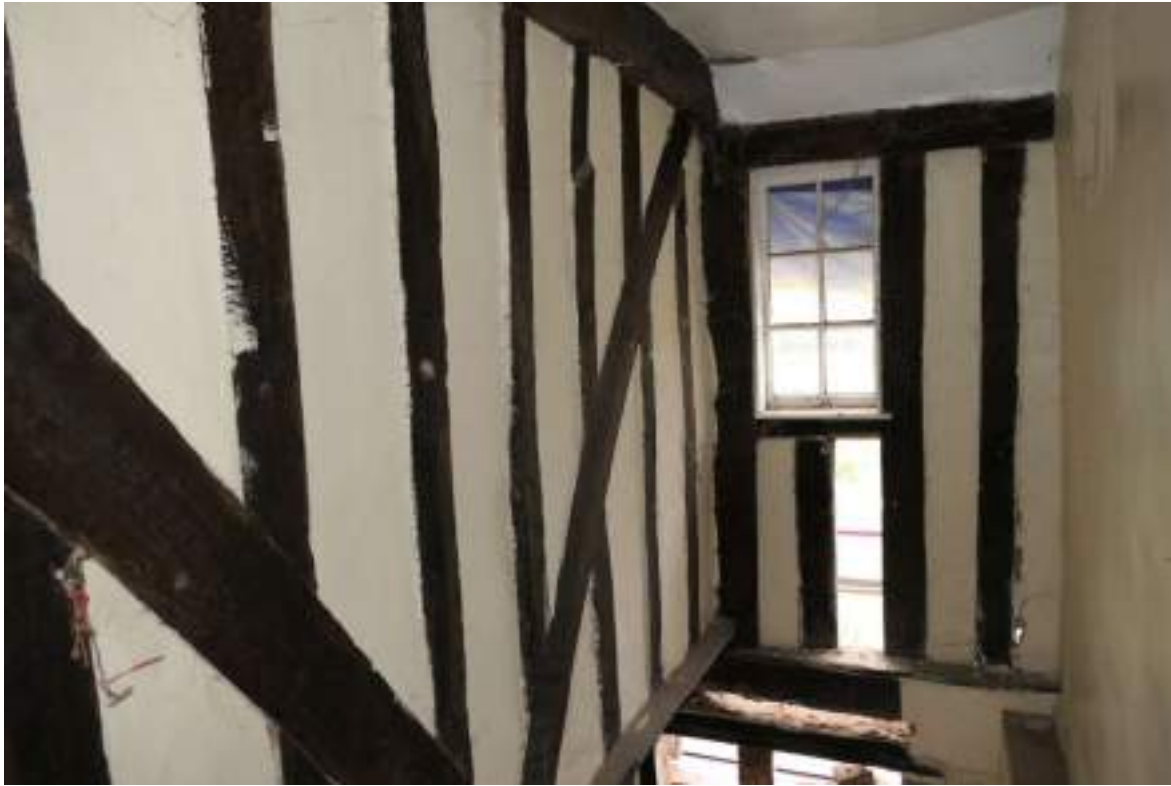
**Photograph 46** Interior of rear stairs. Photograph taken facing west north-west.

The rear stairs occupy the space between bedrooms 4 and 5, leading down to the office on the ground floor. Two walls of the stairwell have exposed timber-framing, which, similarly to the previously discussed framing, uses hand-sawn timbers with close studding and tension bracing (Photograph 47).

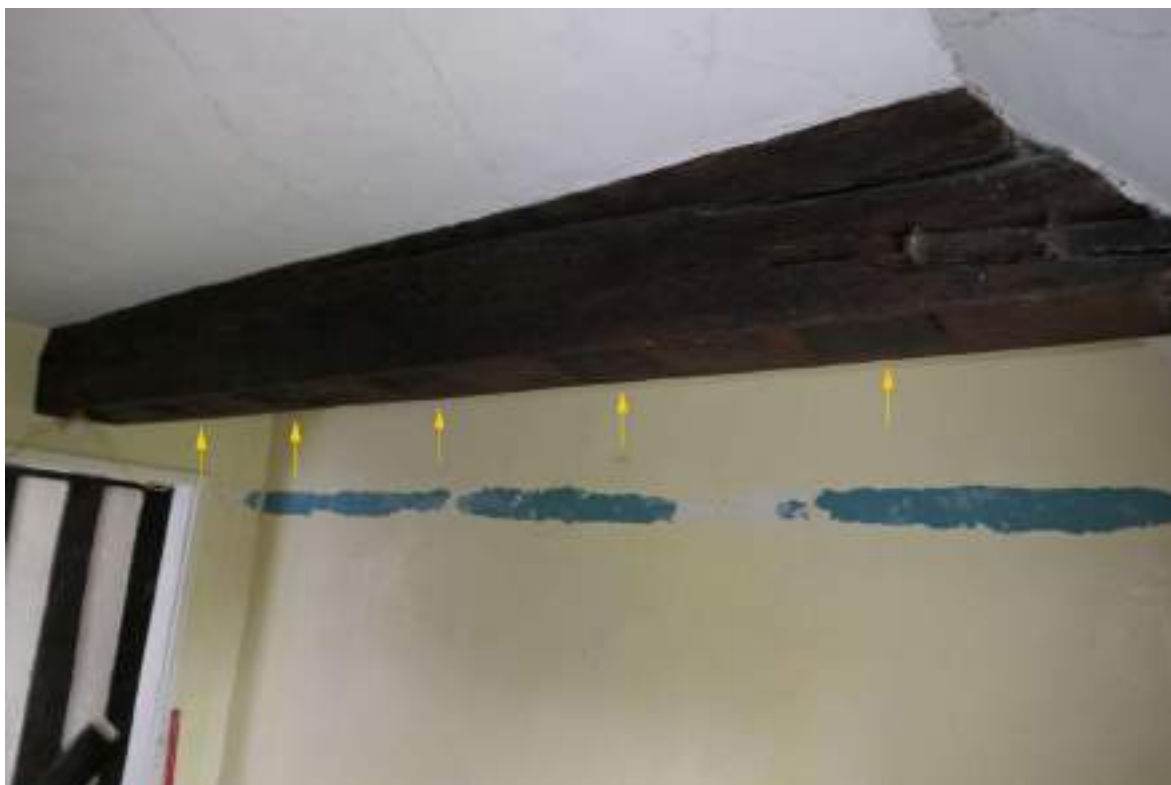
**Photograph 47** Detail of reused tie-beam in ceiling of bedroom 5, yellow arrows highlight shallow mortices. Photograph taken facing south.

Bedroom 5 has a large tie-beam in the ceiling, on the underside of which are a series of shallow mortices, which has been reinforced with an iron strap (Photograph 48). The wall-plate in the north-western wall is also exposed, within which is a possible scarf-joint (Photograph 49). A four-panel door is present in the south-eastern wall, while a plank and batten cupboard door is in the north-western. Adjacent to the cupboard door is a four-light sash window.

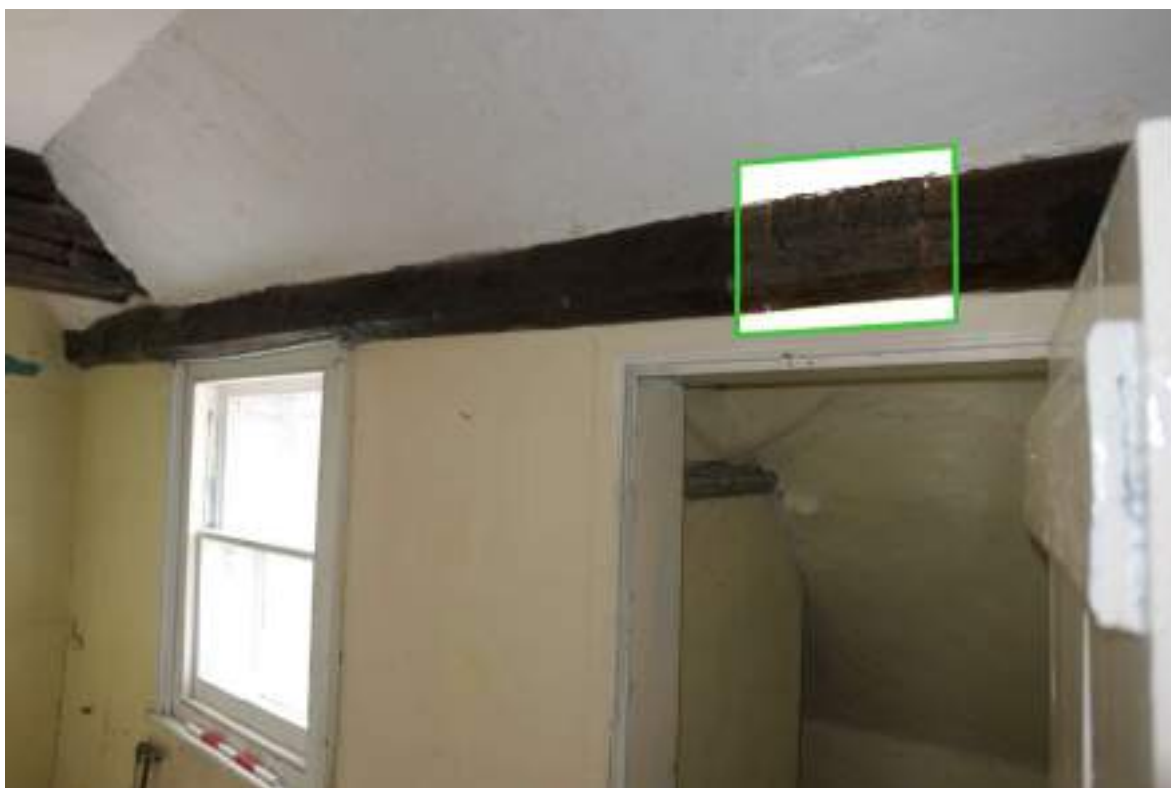
**Photograph 48** Detail of exposed wall-plate in north-western wall of bedroom 5. Probable scarf-joint highlighted in green. Photograph taken facing west north-west.

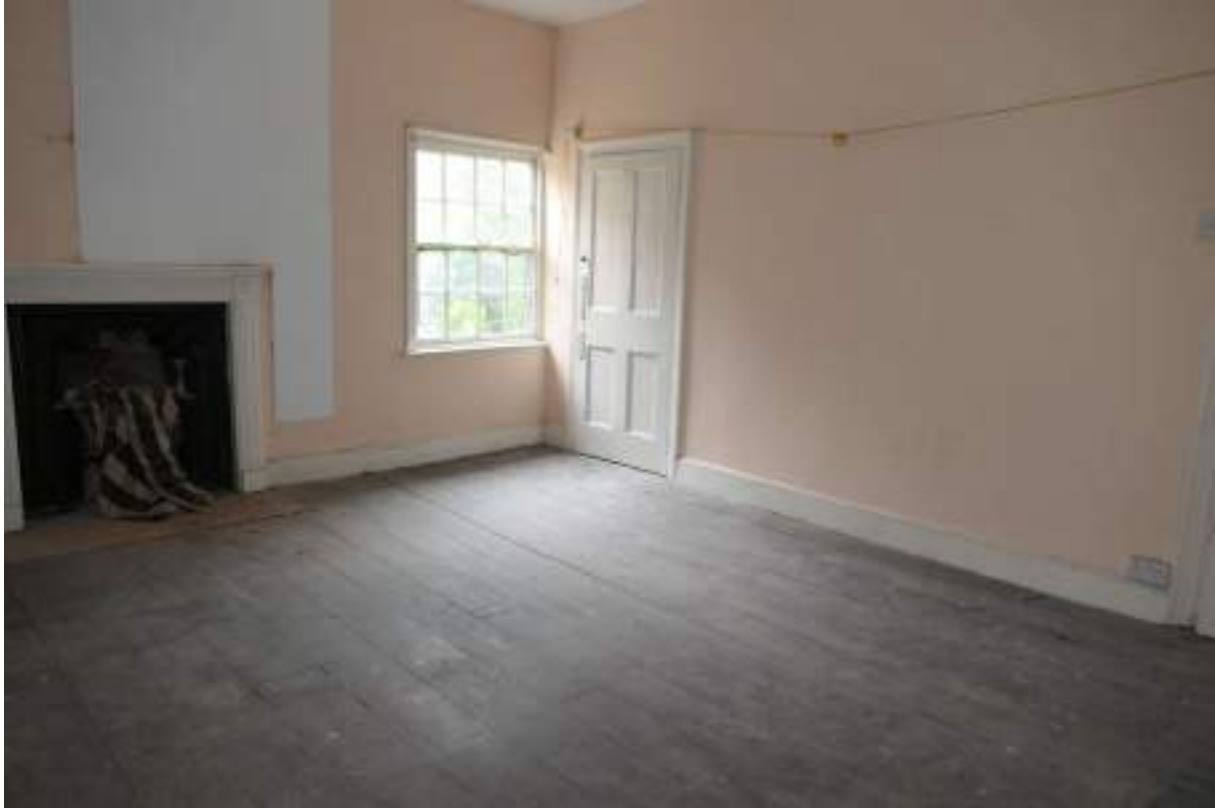
**Photograph 49** Interior of bedroom 6. Photograph taken facing east.

Bedroom 6 dominated the first floor of range 6 (Photograph 50). A wall-plate is visible in the north-western wall, the striations on the face of the timber are suggestive of mill-sawn lumber. A fireplace is located in the north-eastern wall, with a timber surround and an iron firebox, both of which have decorative detailing.

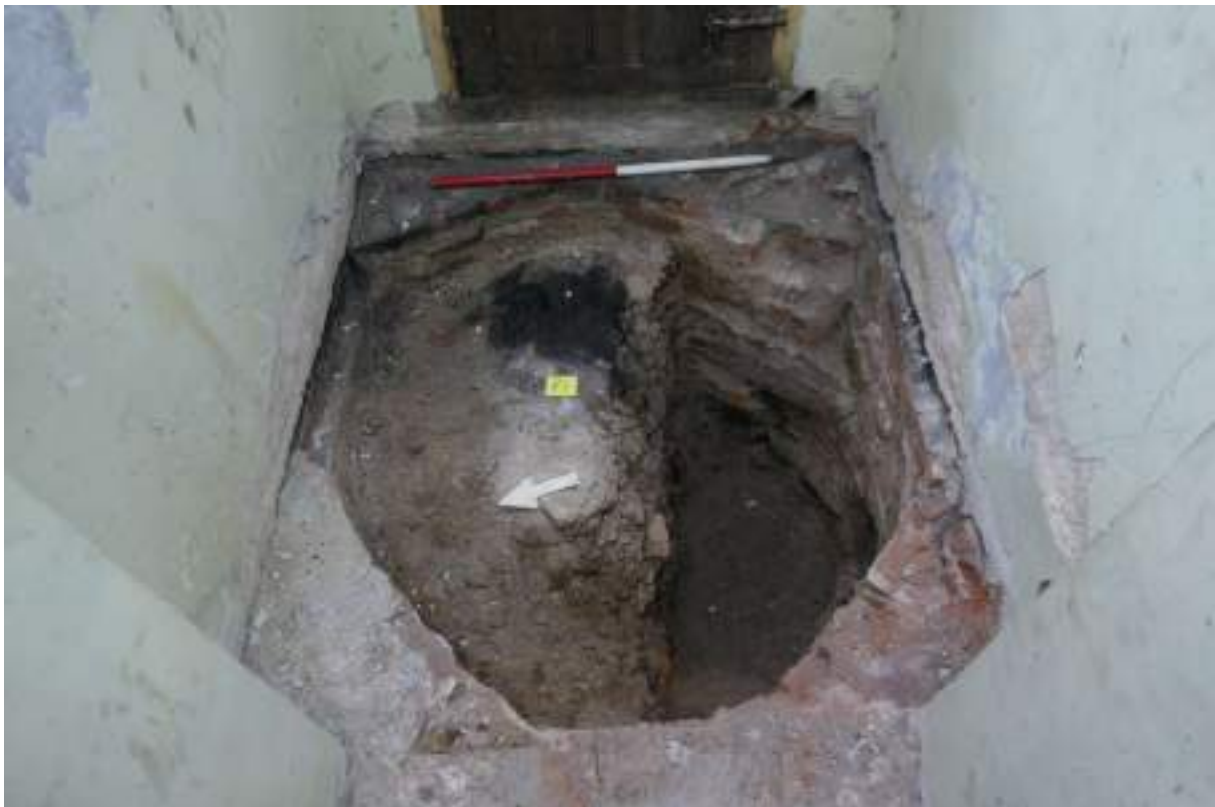
**Photograph 50** Well F1. Photograph taken facing east south-east.

The brick structure of F1 comprised red bricks with a dimension of 220 x 115 x 60mm bonded with Portland cement. It seems likely that F1 represents a brick-lined well. A small void, approximately 025m in diameter located 0.50m from the top of the brickwork, was observed in the side of the brickwork, the purpose of which is unknown.

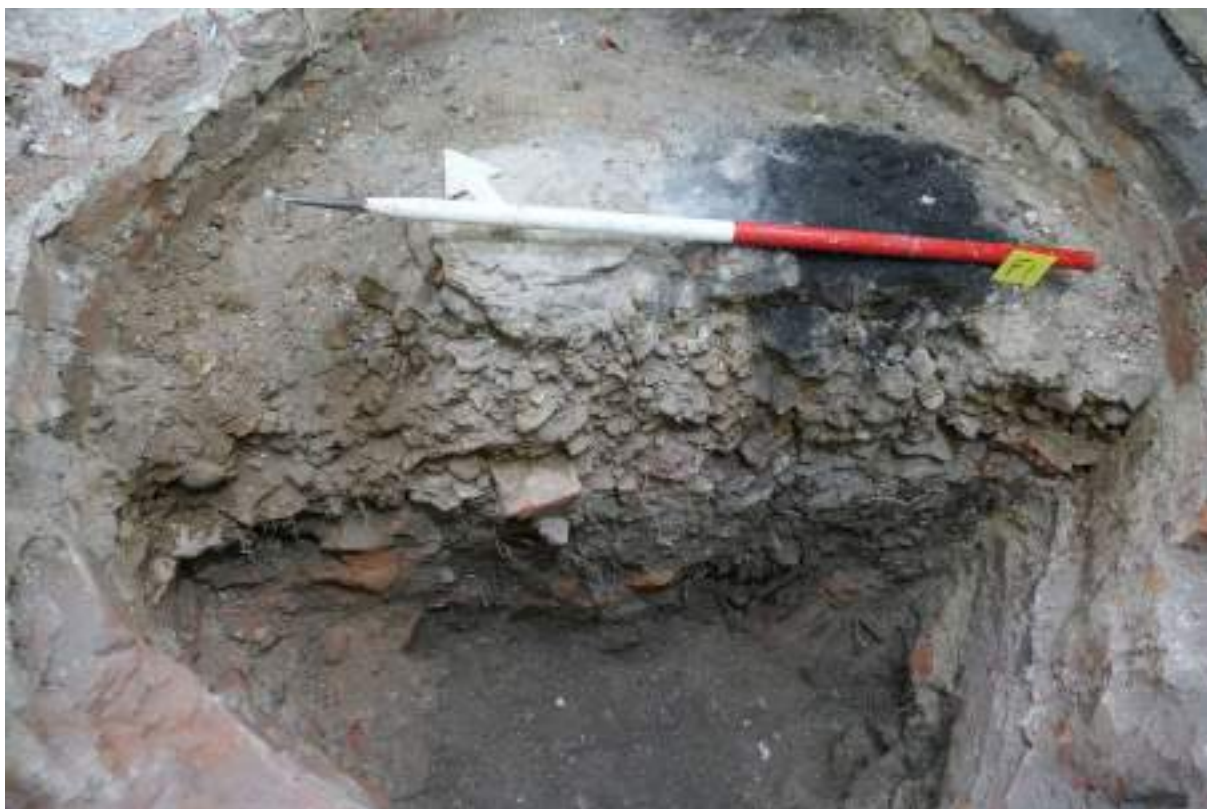
**Photograph 51** Well F1. Photograph taken facing east south-east.

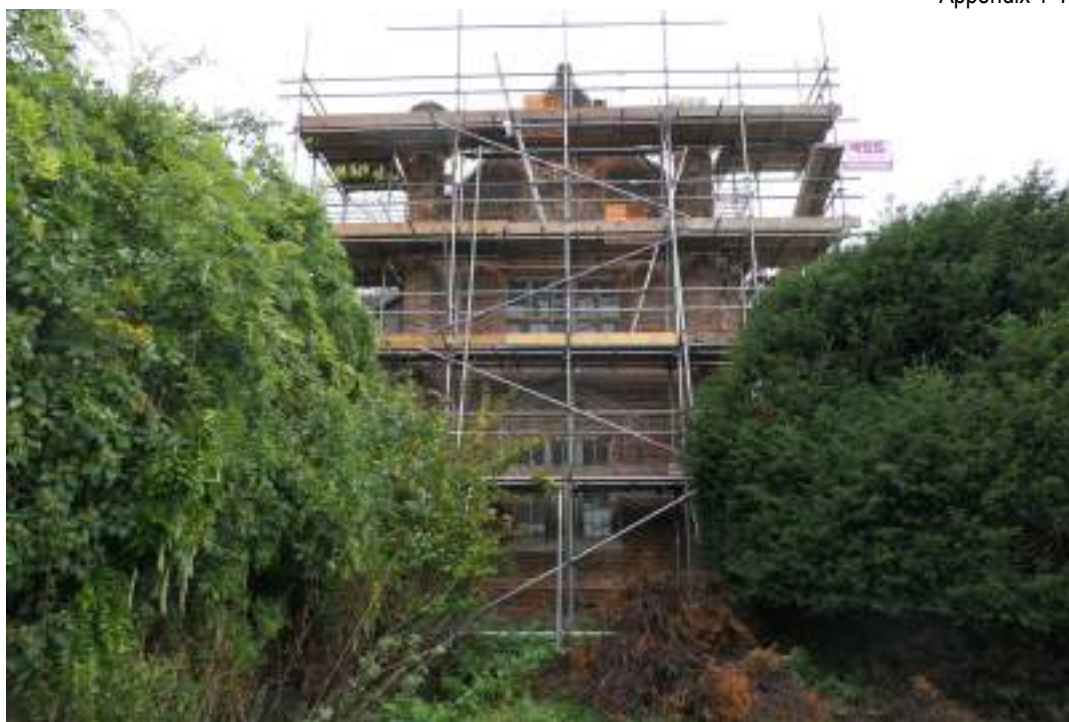
EEX62136\_Photograph\_001  
South-western elevation (range 3). Photograph taken facing north-east.

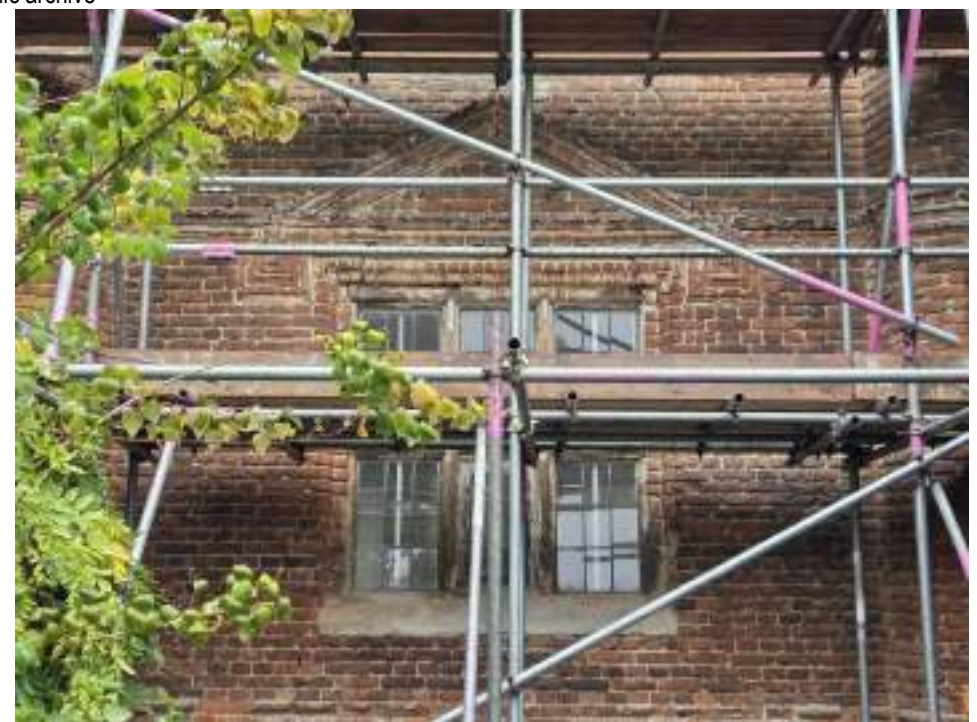
EEX62136\_Photograph\_002  
Detail of window in south-western elevation (range 3). Photograph taken facing north-east.

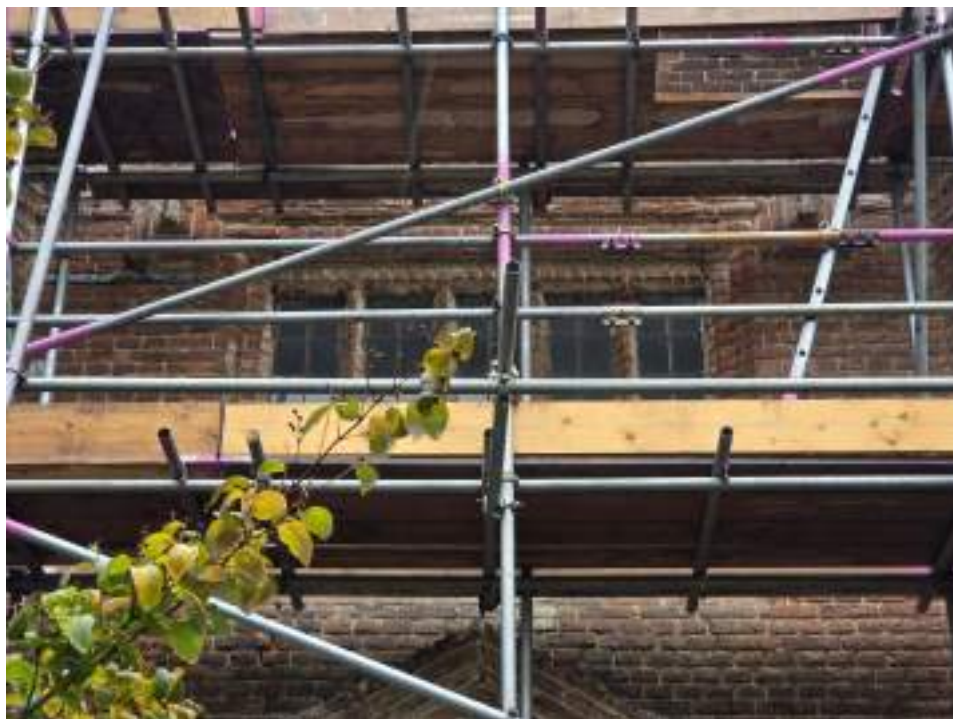
EEX62136\_Photograph\_003  
Detail of window in south-western elevation (range 3). Photograph taken facing north-east.

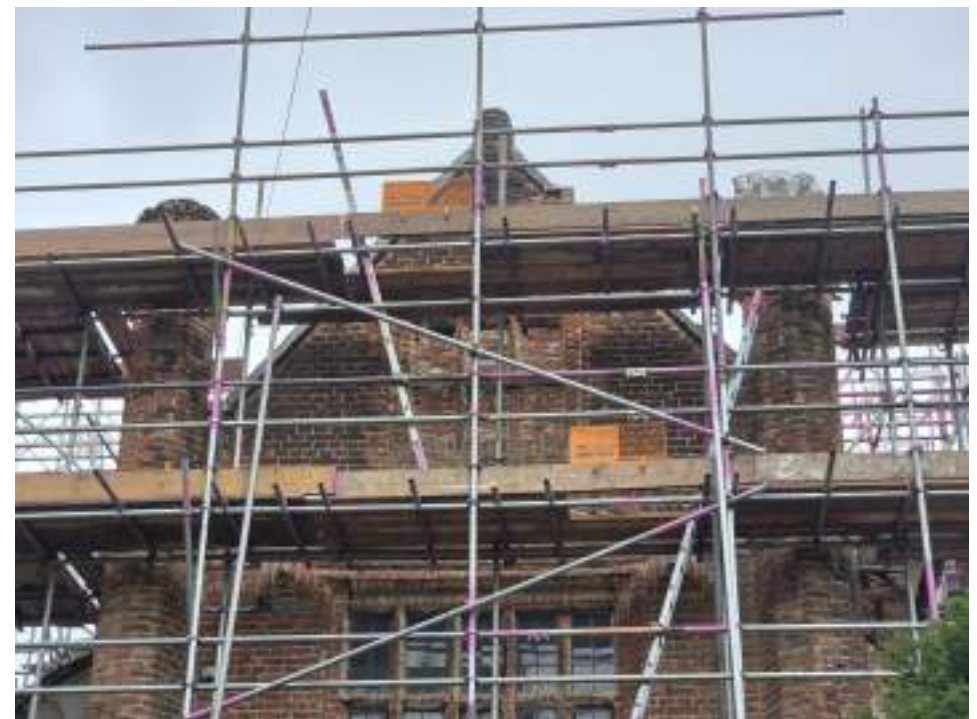
EEX62136\_Photograph\_004  
Detail of blocked window in south-western gable (range 3). Photograph taken facing north-east.

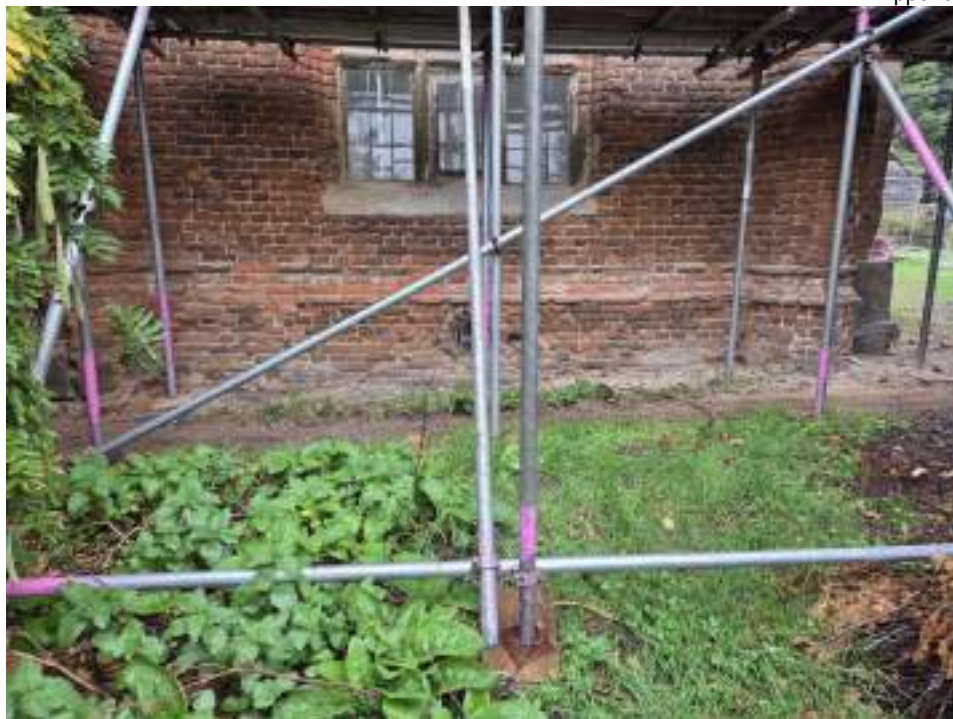
EEX62136\_Photograph\_005

Detail of oversailing brickwork on south-western elevation (range 3). Photograph taken facing north-east.

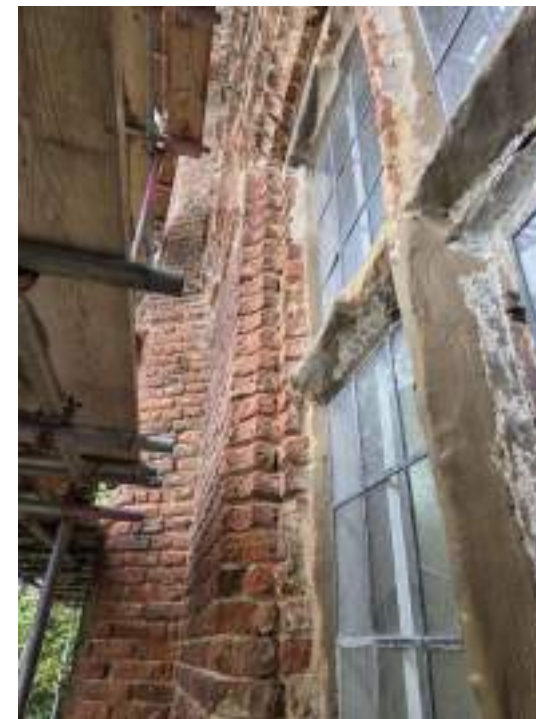
EEX62136\_Photograph\_006

Detail of decorative brickwork surrounding window in south-western elevation (range 3). Photograph taken facing north.

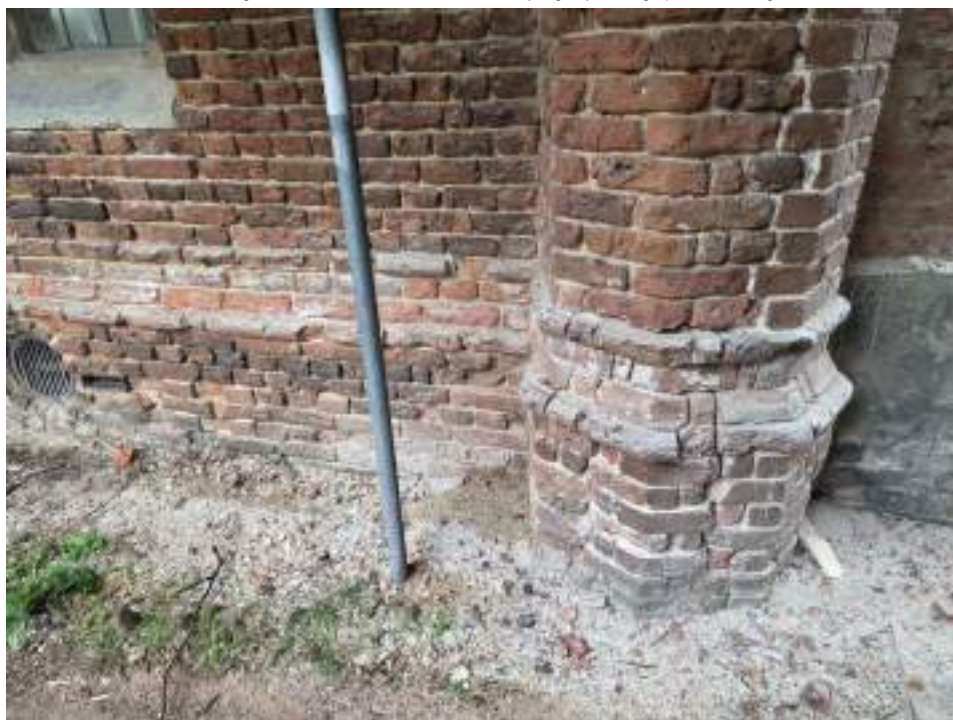
EEX62136\_Photograph\_007

Detail of oversailing brickwork in south-western elevation (range 3). Photograph taken facing north north-east.

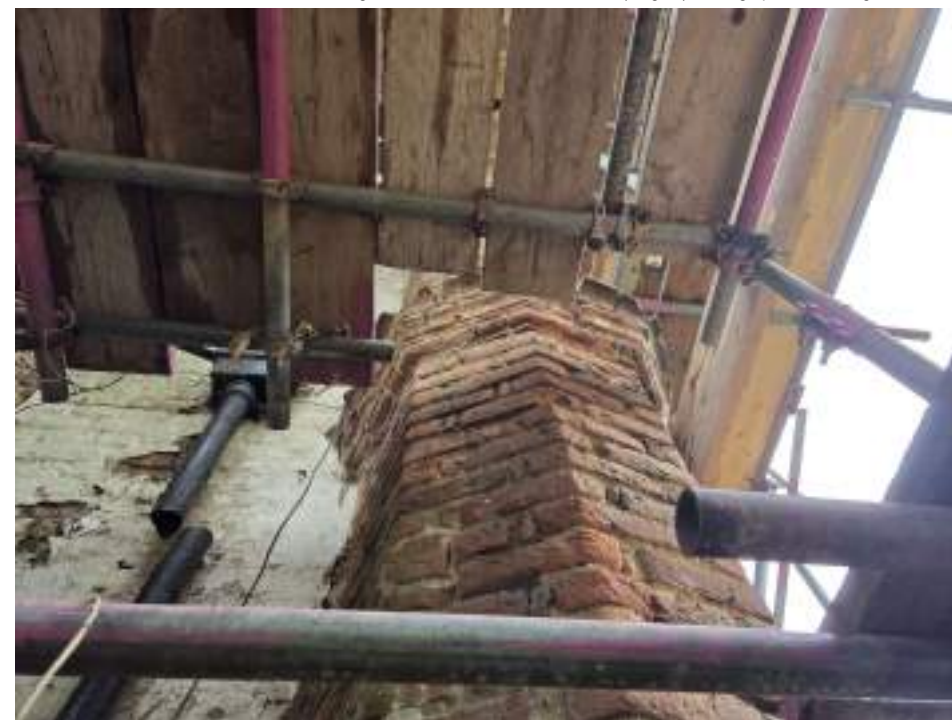
EEX62136\_Photograph\_008

Detail of oversailing brickwork of octagonal buttress on south-western elevation (range 3). Photograph taken facing north-east.

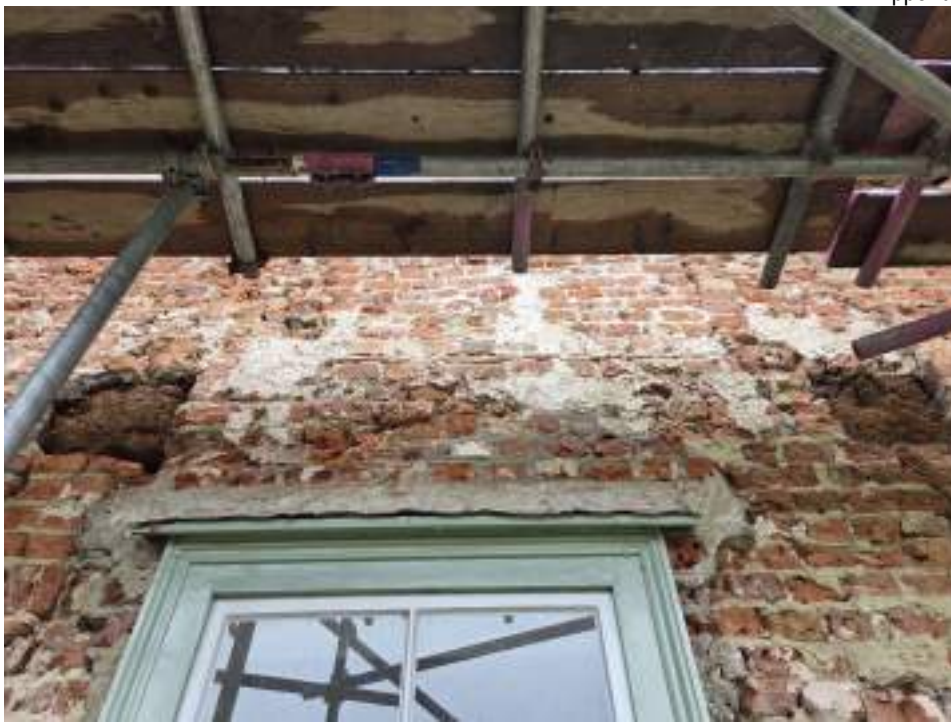
EEX62136\_PhotoGraph\_009  
Detail of tiles in the brickwork of the south-eastern elevation (range 3). Photograph taken facing north-west.

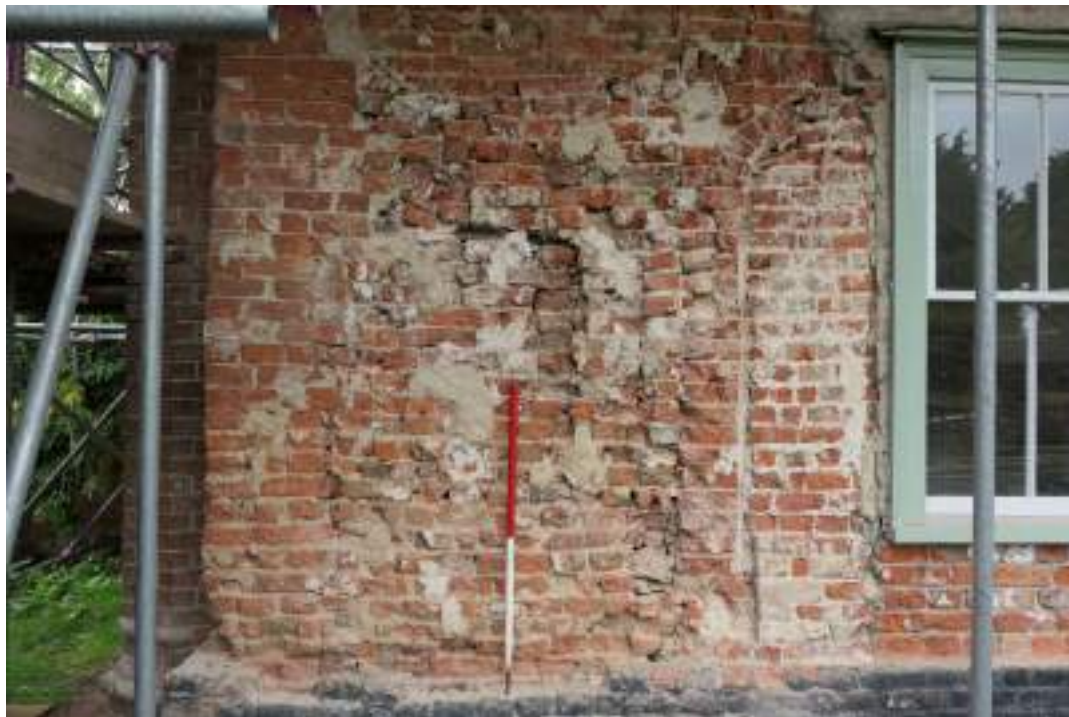
EEX62136\_PhotoGraph\_010  
Detail of brickwork in south-eastern elevation (range 3). Photograph taken facing north-west.

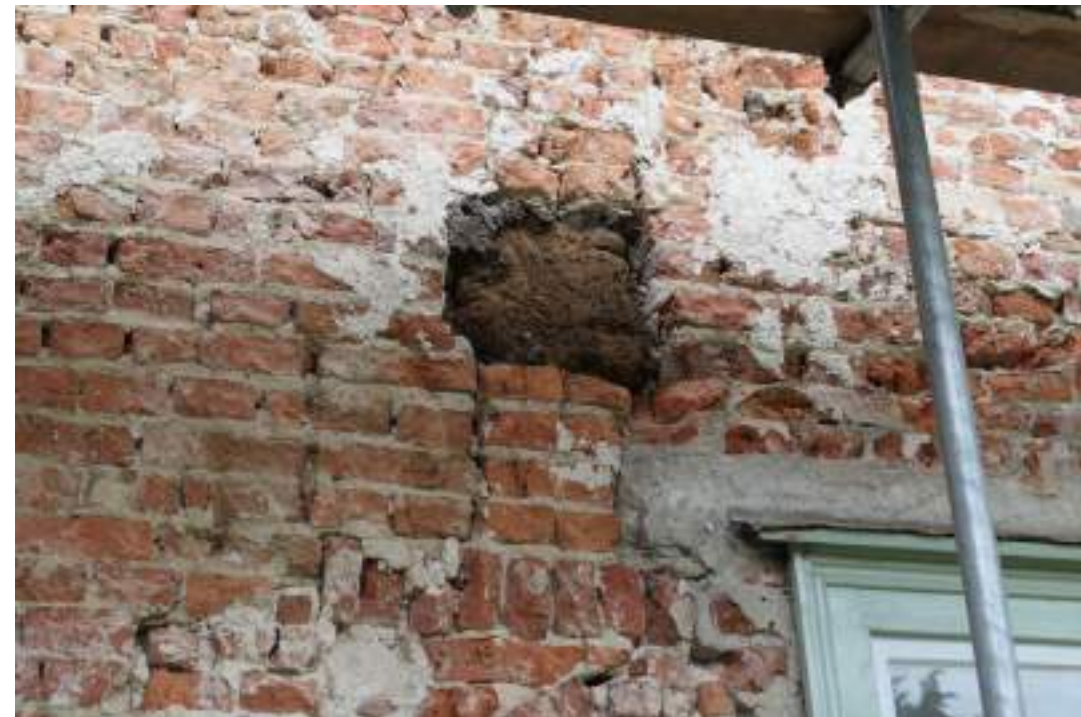
EEX62136\_PhotoGraph\_011  
Detail of brickwork in south-eastern elevation (range 3). Photograph taken facing north-west.

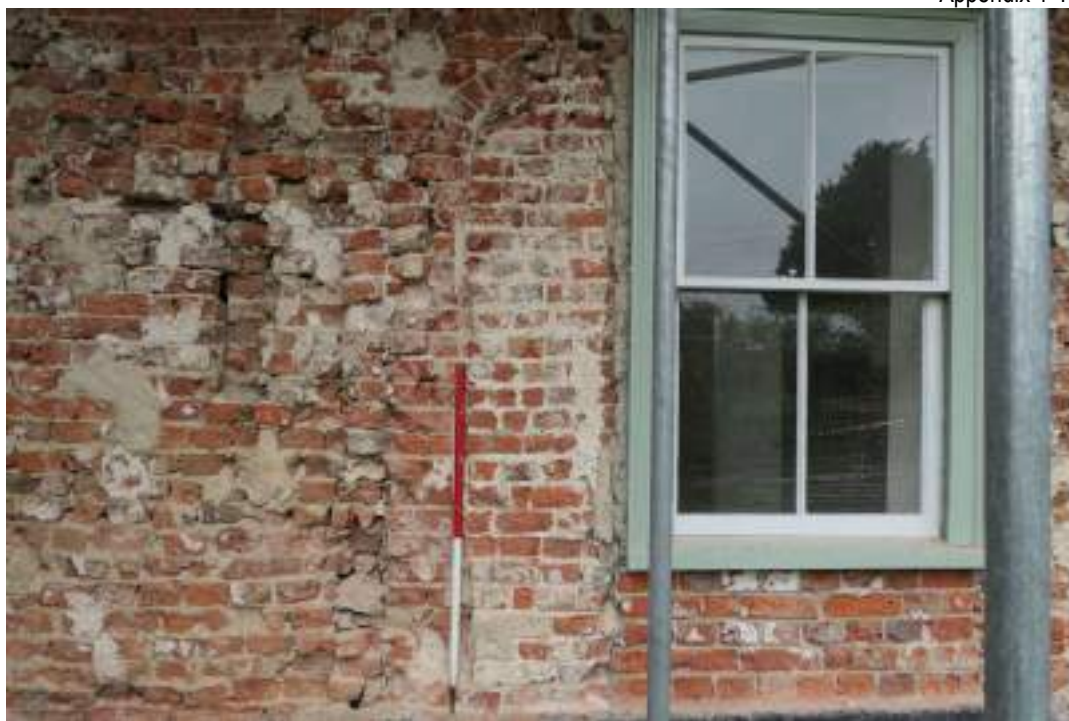
EEX62136\_PhotoGraph\_012  
Detail of exposed binding beam visible in south-eastern elevation (range 3). Photograph taken facing north north-west.

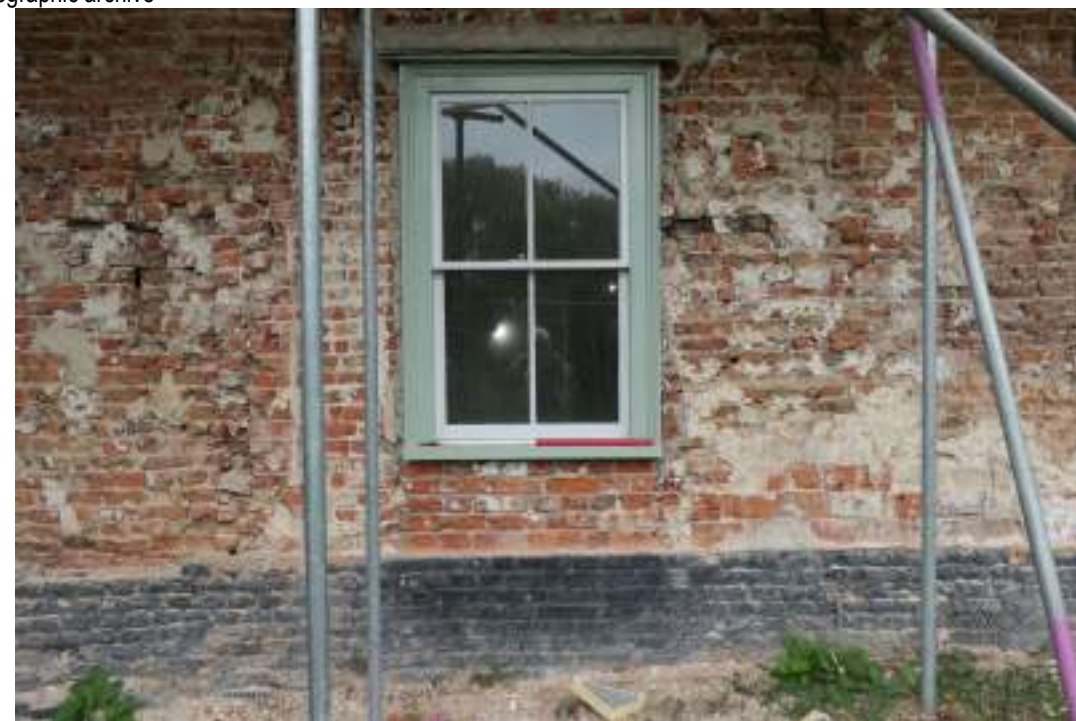
EEX62136\_PhotoGraph\_013  
Detail of blocked, partially surviving brick arch in south-eastern elevation (range 3). Photograph taken facing north-west.

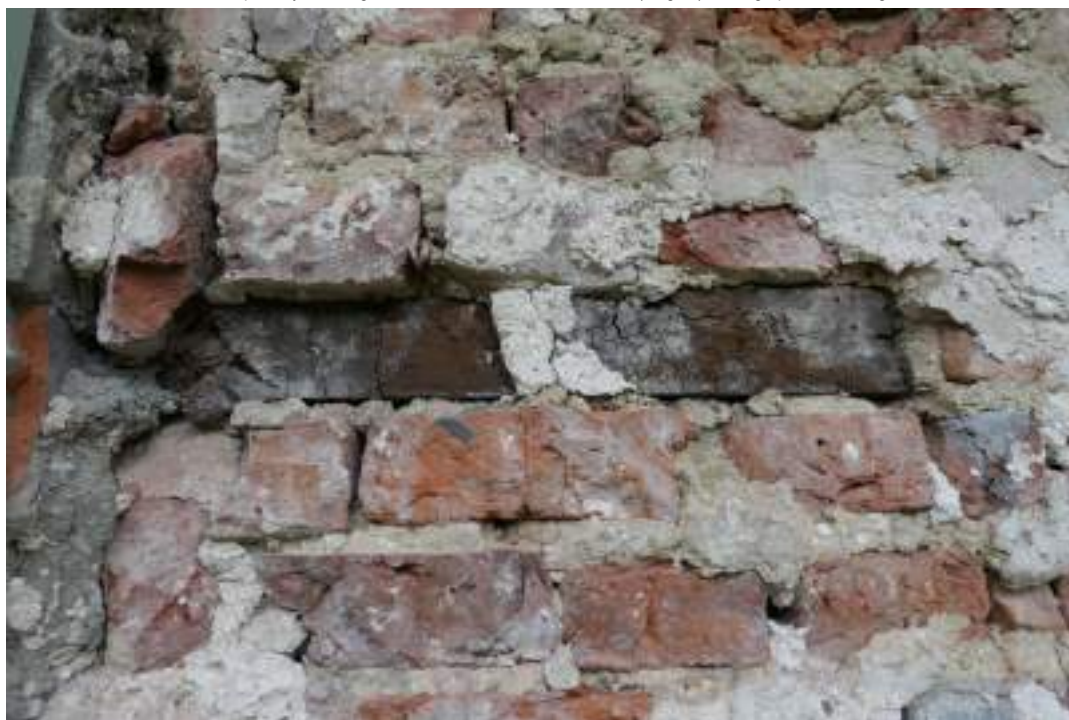
EEX62136\_PhotoGraph\_014  
Detail of brickwork and window in south-eastern elevation (range 3). Photograph taken facing north-west.

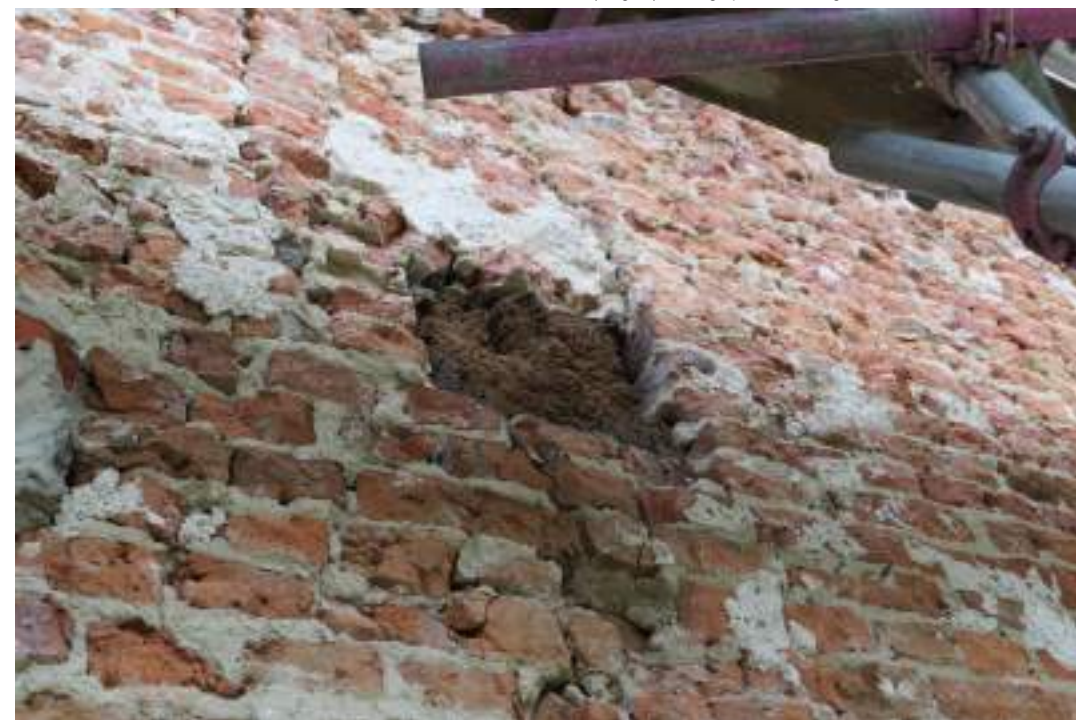
EEX62136\_PhotoGraph\_015  
Detail of exposed timber in brickwork of south-eastern elevation (range 3). Photograph taken facing north-west.

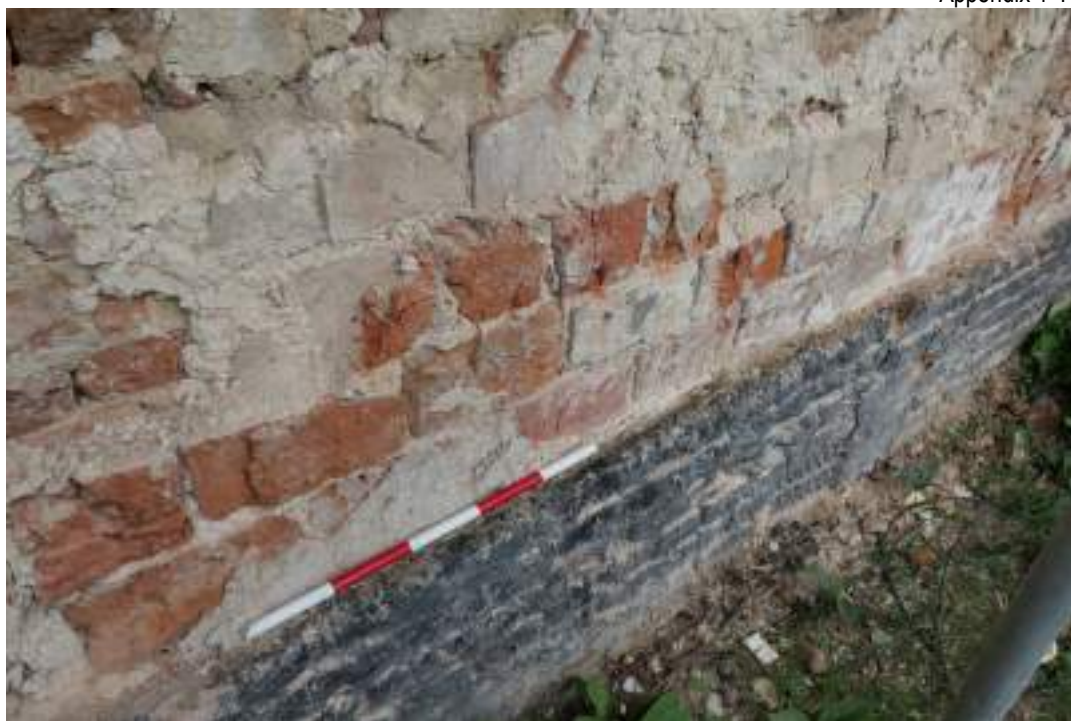
EEX62136\_PhotoGraph\_016  
Detail of exposed binding beam in brickwork of south-eastern elevation (range 3). Photograph taken facing north.

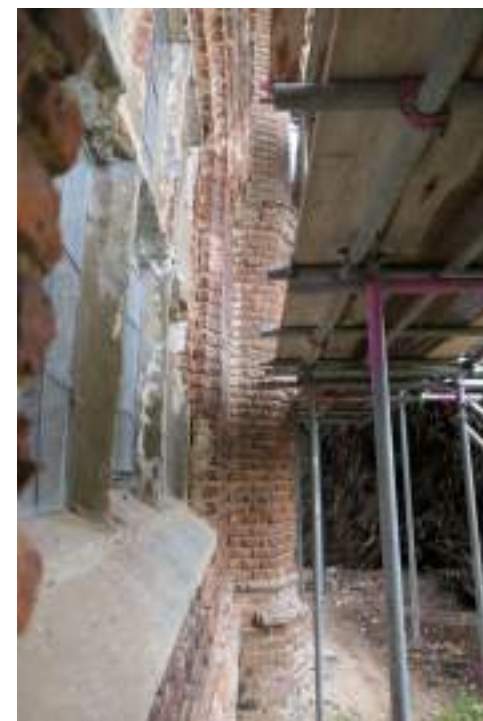
EEX62136\_Photograph\_017  
Detail of bricks laid on-edge in brickwork and plinth of south-eastern elevation (range 3). Photograph taken facing north.

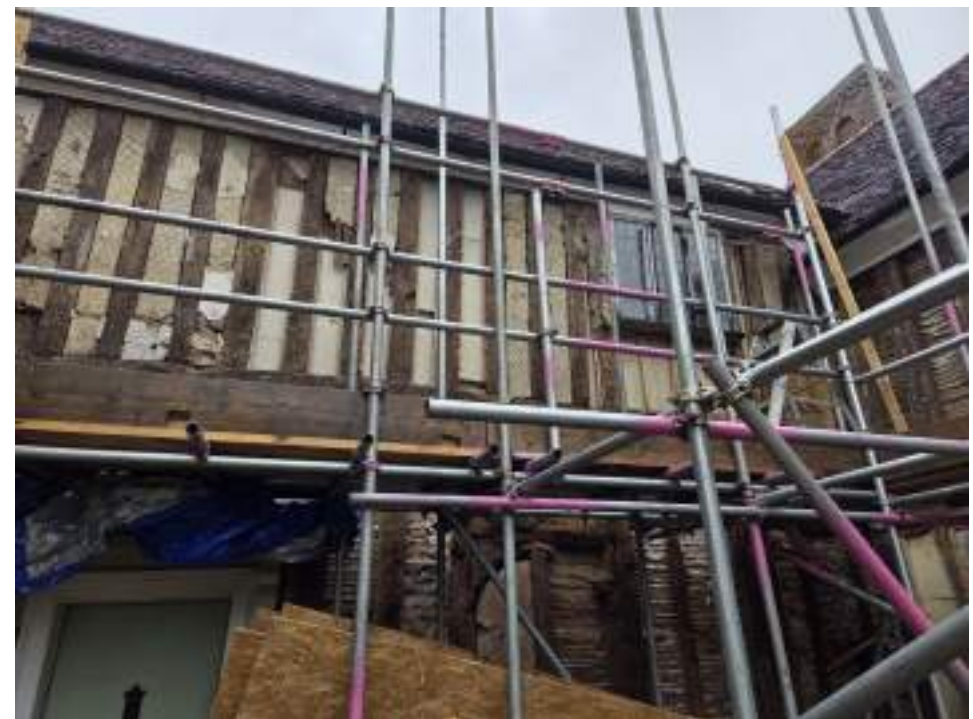
EEX62136\_PhotoGraph\_023  
Detail of timber-framing of south-eastern elevation (range 5). Photograph taken facing north-west.
