**CAT Report 2267  
Issued May 2026**

**Historic building recording and archaeological  
excavation at Dorewards Hall, The Chase, Bocking,  
Essex, CM7 5LS**

**October 2025 and March 2026**

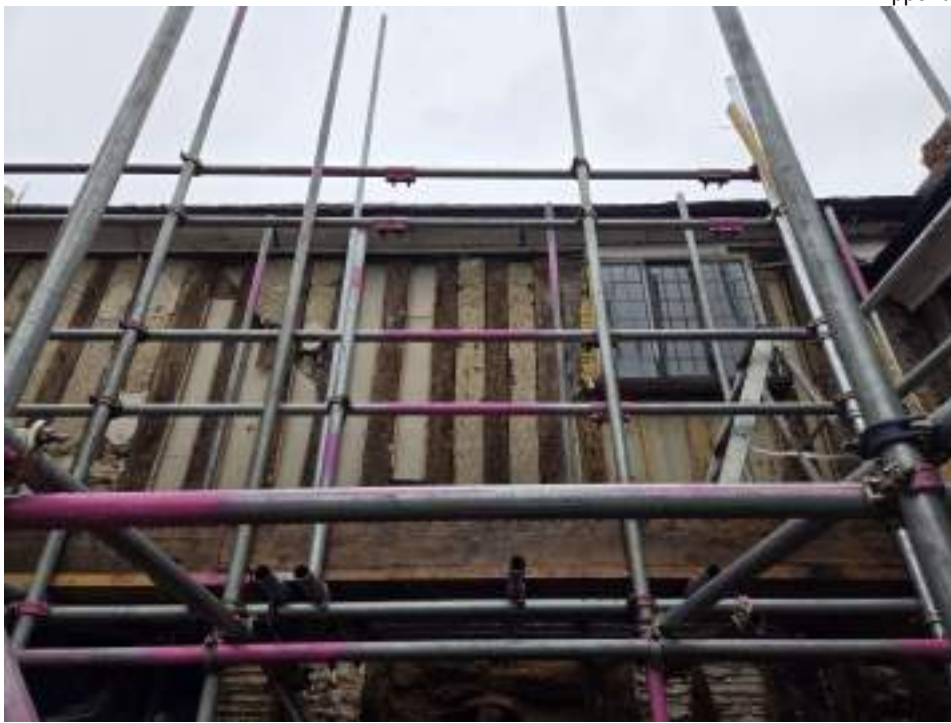
EEX62136\_PhotoGraph\_024  
Detail of exposed timber-framing on upper register of south-eastern elevation (range 5). Photograph taken facing north north-west.

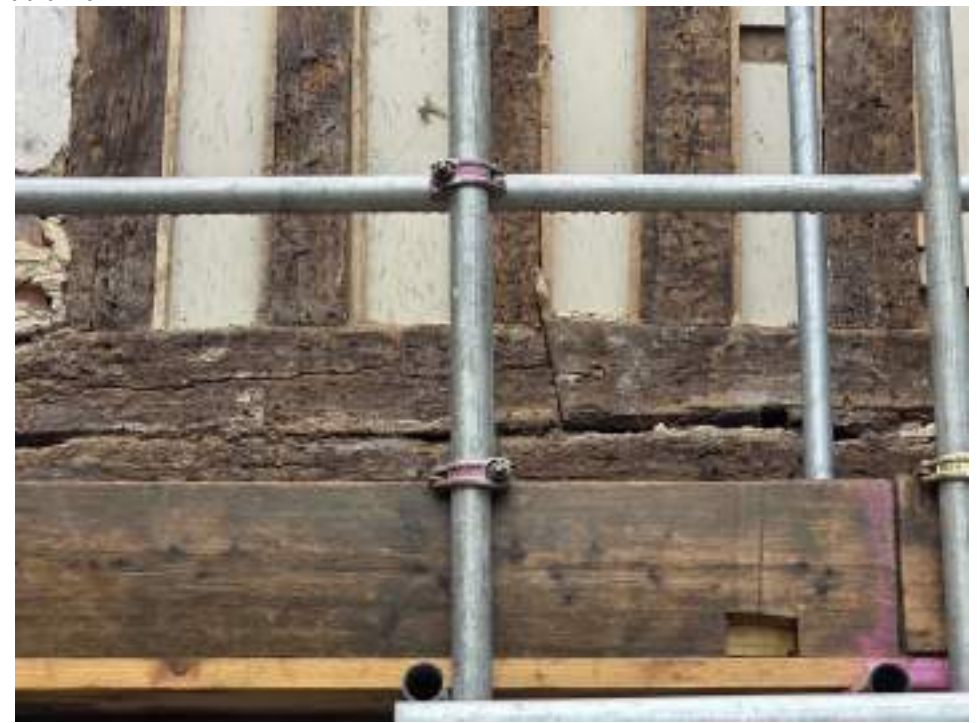
EEX62136\_Photograph\_025  
Detail of upper register timber-framing of south-eastern elevation (range 5). Photograph taken facing north-west.

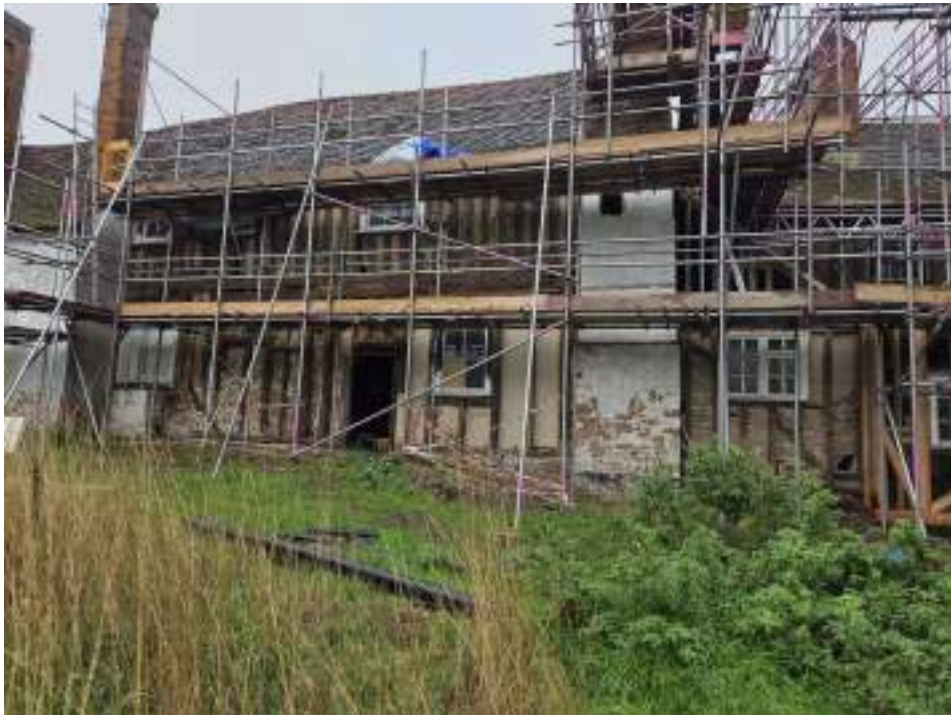
EEX62136\_Photograph\_026  
Detail of scarf-joint in girding beam and possible carpenters marks on studs in south-eastern elevation (range 5). Photograph taken facing north-west.

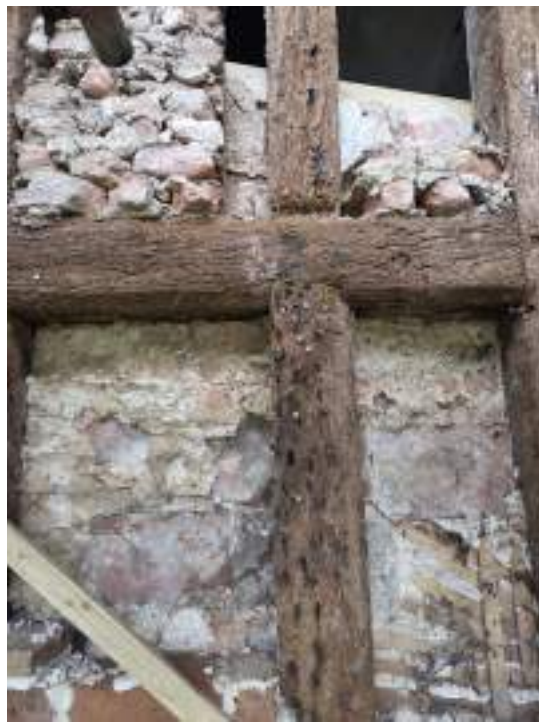
EEX62136\_Photograph\_028  
Detail of exposed timber-framing of north-western elevation (range 5). Photograph taken facing south-east.

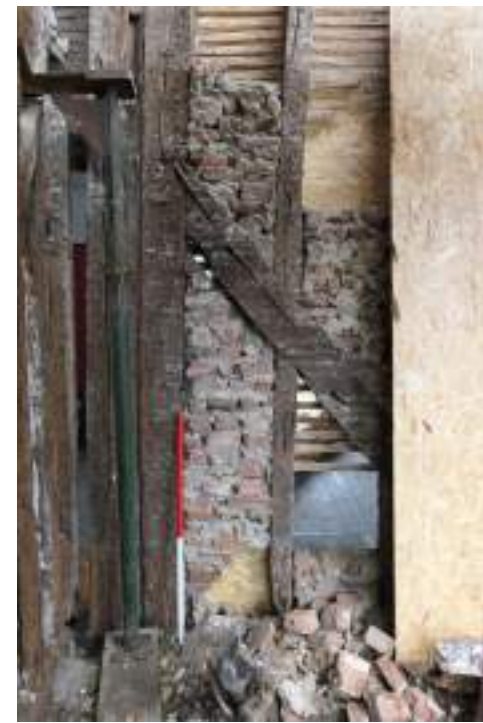
EEX62136\_PhotoGraph\_029

Detail of pegtiles used for noggin in north-western elevation (range 5). Photograph taken facing south-east.

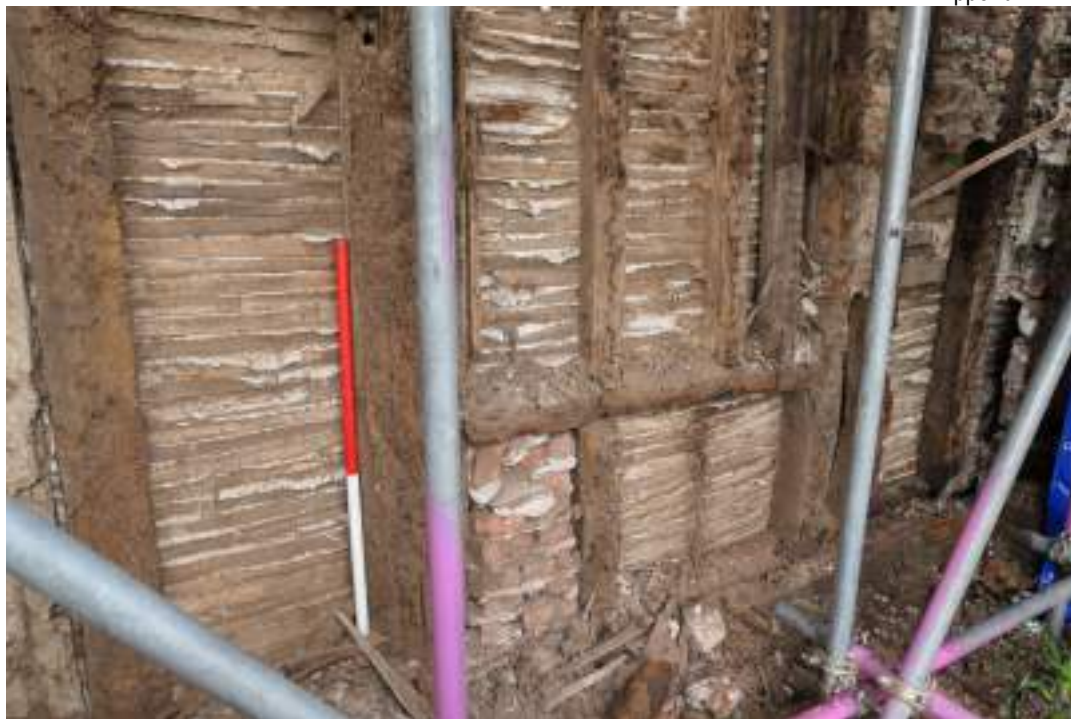
EEX62136\_PhotoGraph\_032

Detail of medieval doorway in south-eastern elevation (range 5). Photograph taken facing north-west.

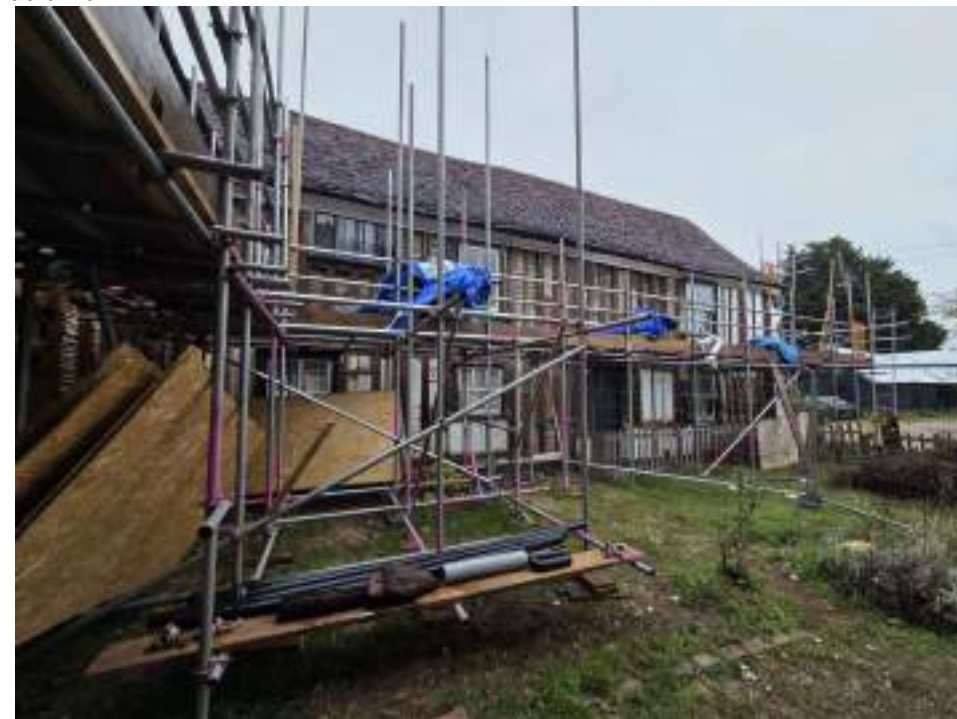
EEX62136\_PhotoGraph\_033  
Detail of exposed timber-framing in south-eastern elevation (range 5). Photograph taken facing north.

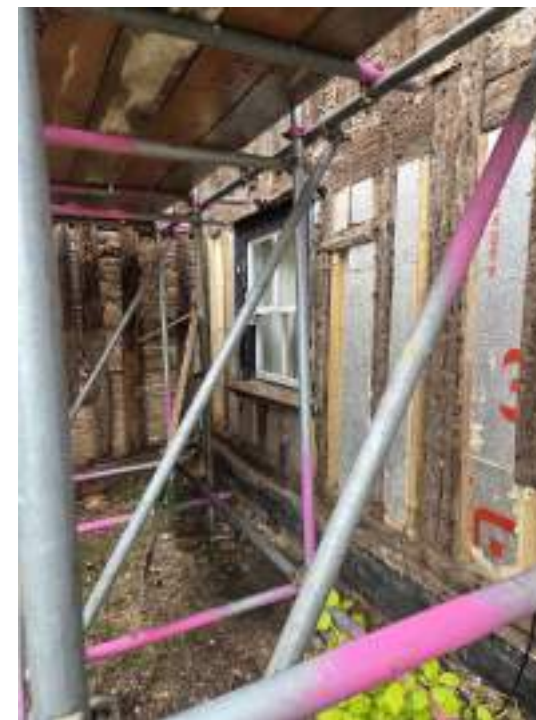
EEX62136\_PhotoGraph\_035  
Detail of exposed timber-framing in south-western elevation (range 7). Photograph taken facing east.

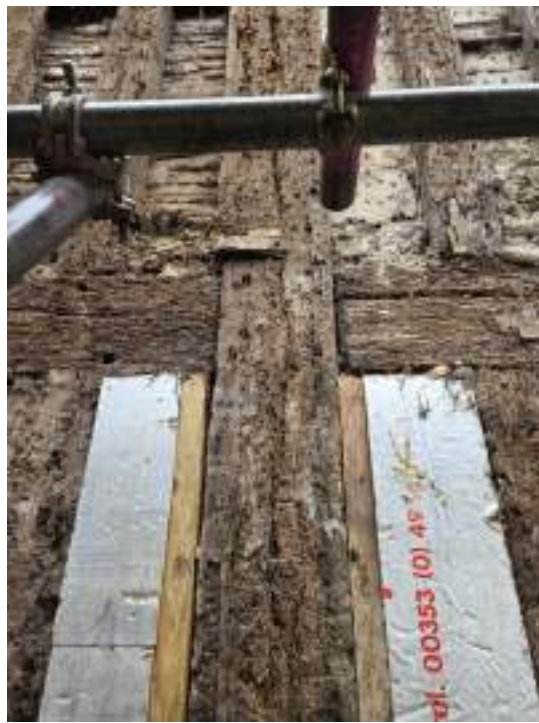
EEX62136\_PhotoGraph\_036  
Detail of exposed timber-framing of south-western elevation (range 7). Photograph taken facing north.

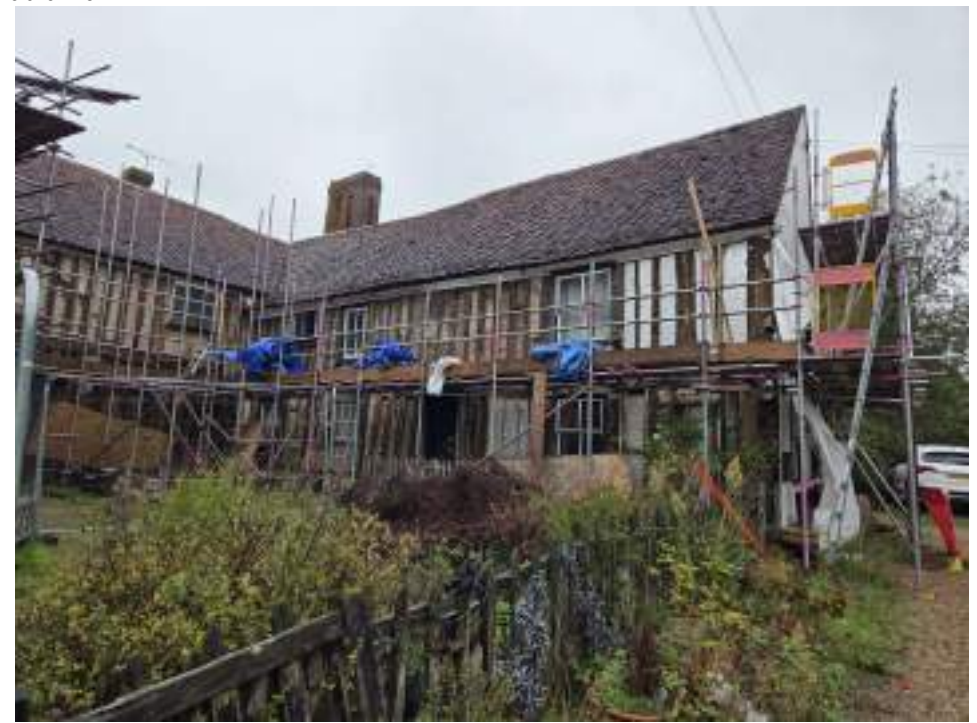
EEX62136\_Photograph\_037

Detail of intermediate post interrupting girding beam with an iron strap in south-western elevation (range 7). Photograph taken facing north-east.

Along the south-western elevation of range 7 (Photograph 13) are a number of studs, which are interrupted by a central girding beam. A series of intermediate posts set along the elevation interrupt the girding beam, which have added iron straps (Photograph 14). The framing has been constructed from hand-sawn timbers, with areas of modern repair. Several sash windows are present in both registers, although it is not immediately evident if they represent insertions or larger replacements.

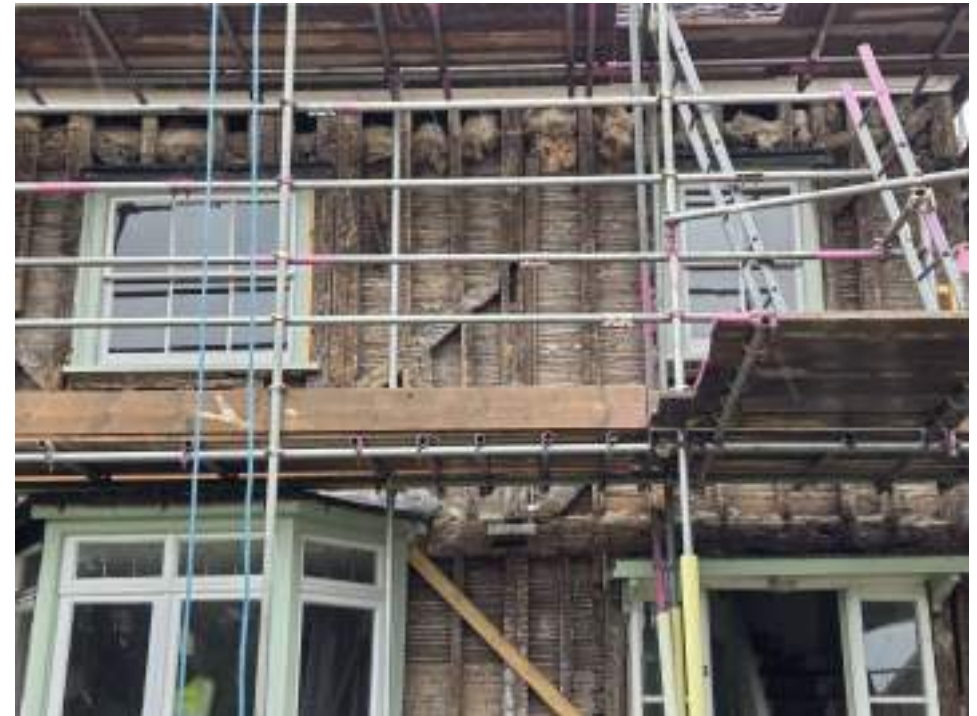
EEX62136\_Photograph\_039

Detail of exposed timber-framing of upper register of north-eastern elevation (range 4). Photograph taken facing west south-west.

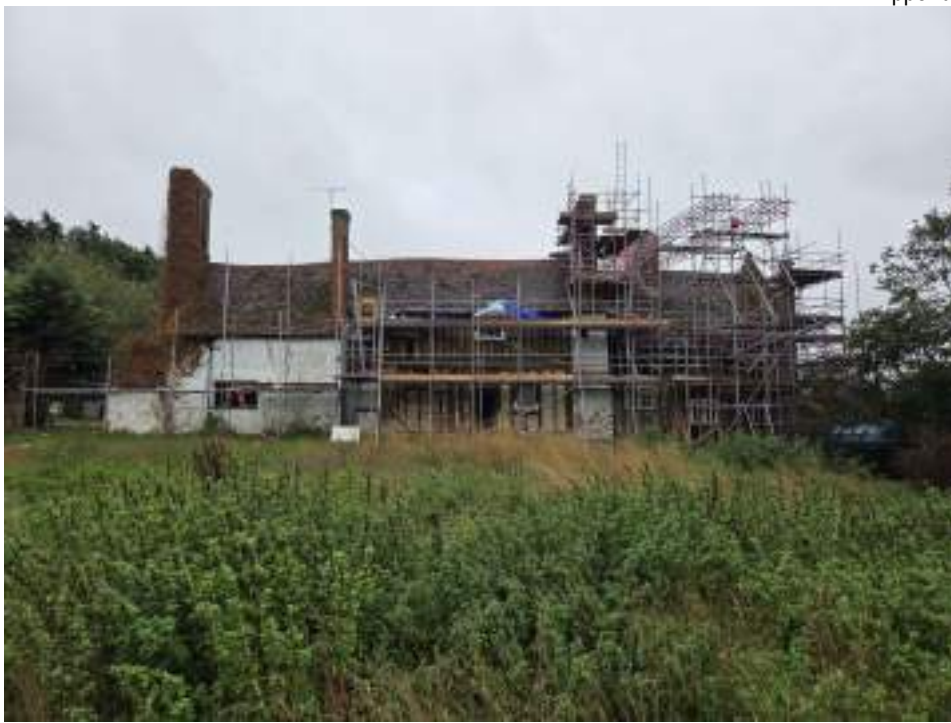
EEX62136\_Photograph\_040

Detail of exposed timber-framing, with reused timbers, of south-eastern elevation (range 4). Photograph taken facing north-west.

Ranges 4 and 5 are both timber-framed on the south-eastern elevation, comprising hand-sawn hard wood. The timber-framing of range 4, which has a number of timbers which display evidence of reuse (Photograph 5), appears to utilise primary bracing. A large girding beam interrupts the only intermediate post in the framing and numerous repairs are evident throughout. Some red brick nogging is present at ground floor level. The framing is supported on a red brick plinth (brick dimensions: 215-220 x 105-110 x 60-65mm) laid in English bond. A canted bay window has been inserted into the elevation adjacent to a modern entrance. On the first floor are two inserted timber-framed sash-windows, one six-light and one four-light.

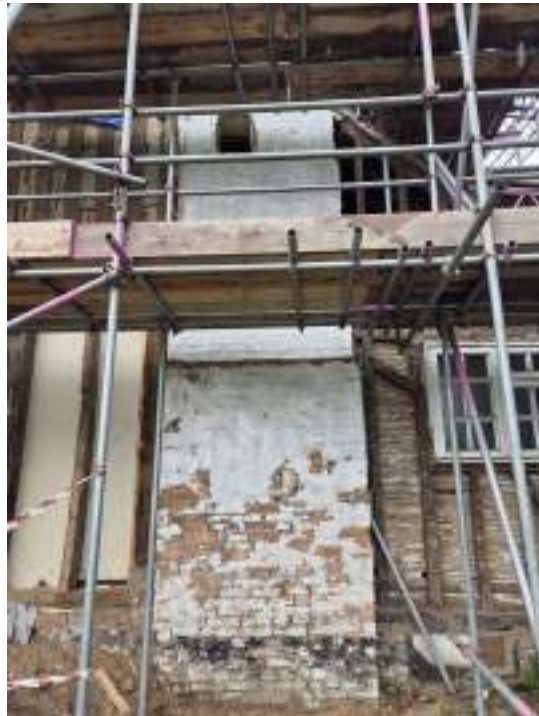
EEX62136\_PhotoGraph\_042  
Detail of exposed timber-framing of north-western elevation (range 2). Photograph taken facing south-east.

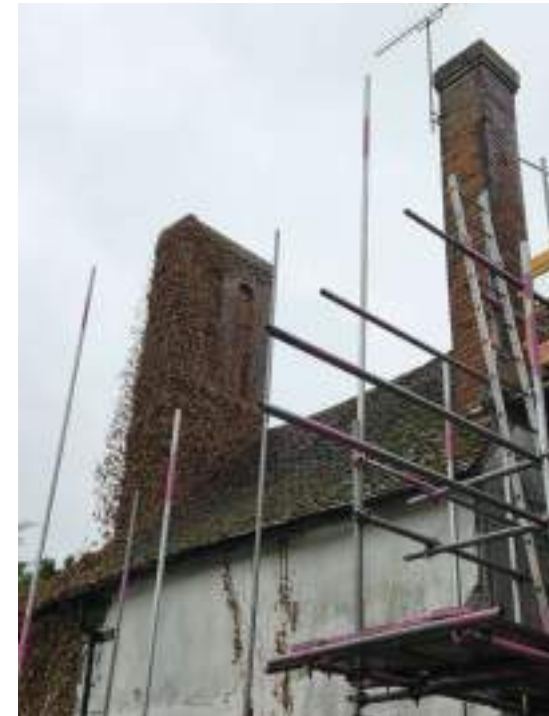
EEX62136\_PhotoGraph\_043  
Detail of brickwork of chimney in north-western elevation (range 2). Photograph taken facing south-east.

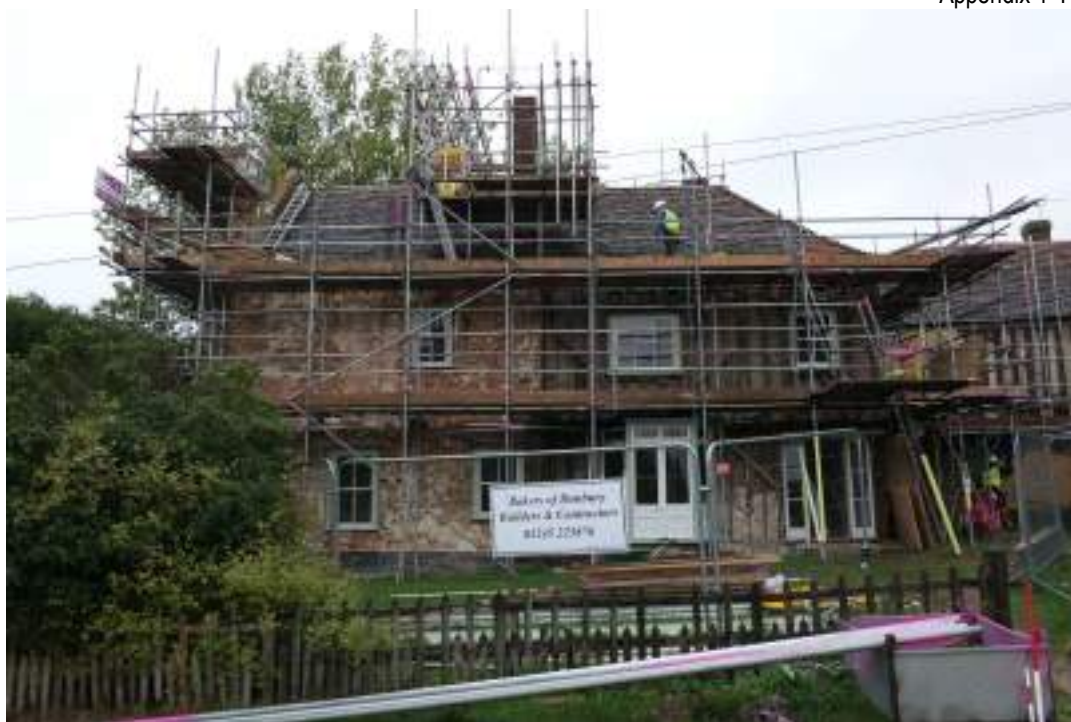
EEX62136\_PhotoGraph\_044  
Detail of chimneys visible from the north-western elevation (range 6). Photograph taken facing east.

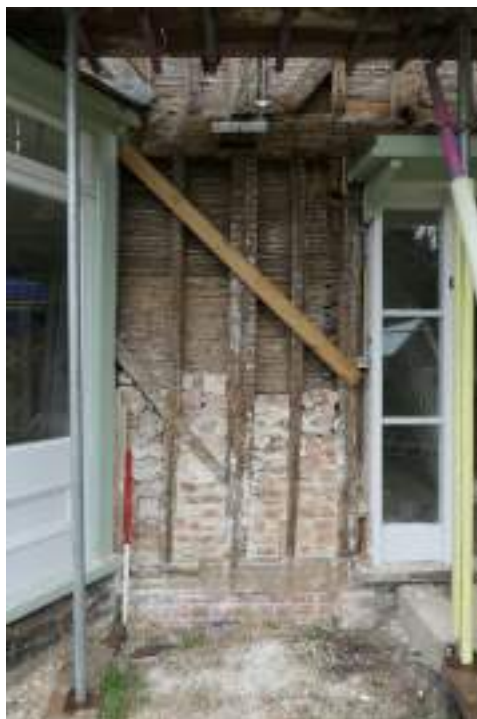
EEX62136\_Photograph\_046  
Detail of exposed timber-framing in south-eastern elevation (range 4). Photograph taken facing north-west.

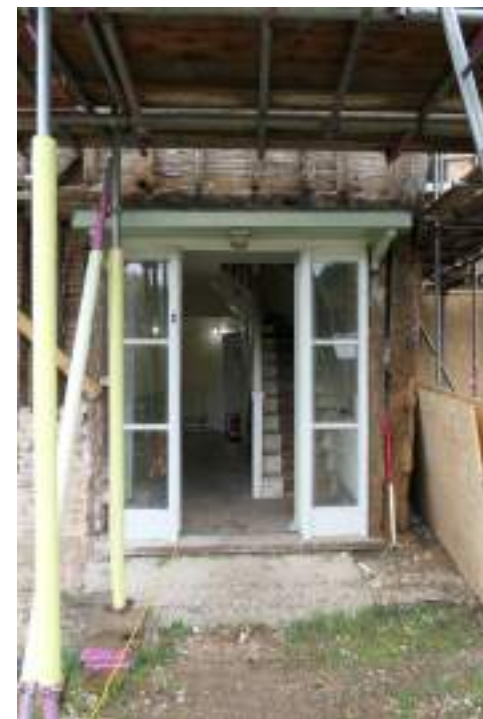
EEX62136\_Photograph\_047  
Detail of timber-framing in south-eastern elevation (range 4). Photograph taken facing north-west.

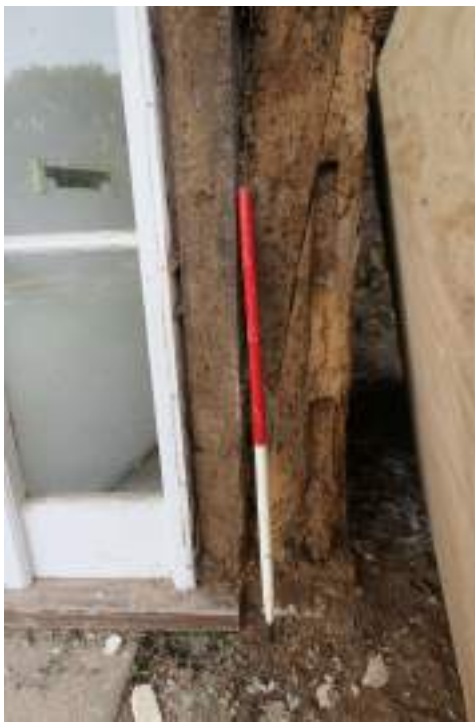
EEX62136\_Photograph\_048  
Detail of door in south-eastern elevation (range 4). Photograph taken facing north-west.

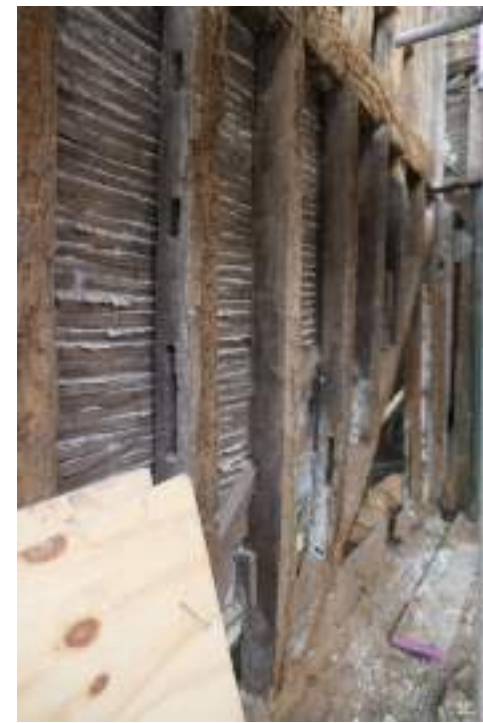
EEX62136\_Photograph\_050  
Detail of exposed timber-framing, with reused stud, in north-eastern elevation (range 4). Photograph taken facing west.

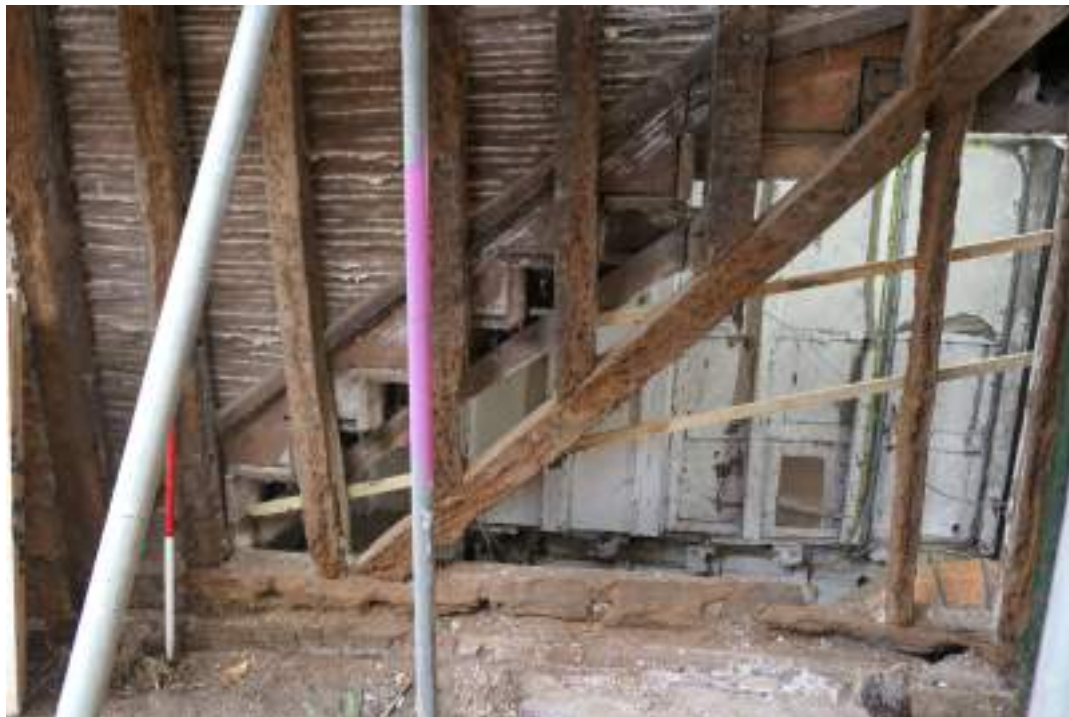
EEX62136\_Photograph\_051  
Detail of exposed timber-framing in north-eastern elevation (range 4). Photograph taken facing south-west.

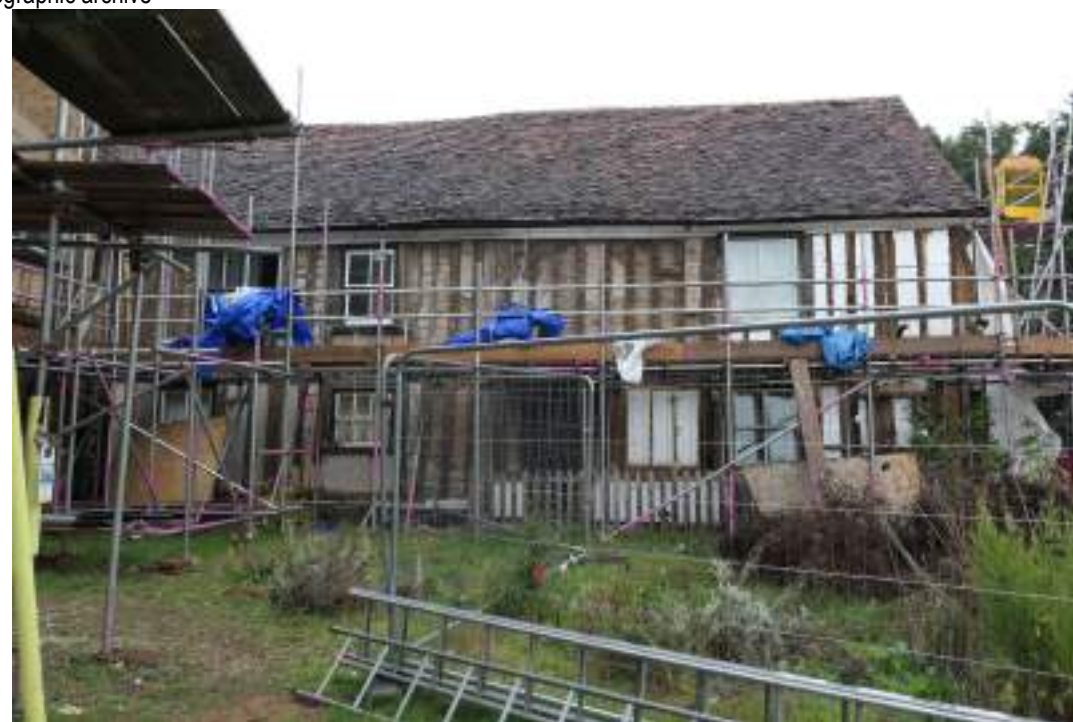
EEX62136\_Photograph\_054  
South-western elevation (range 7). Photograph taken facing north-east.

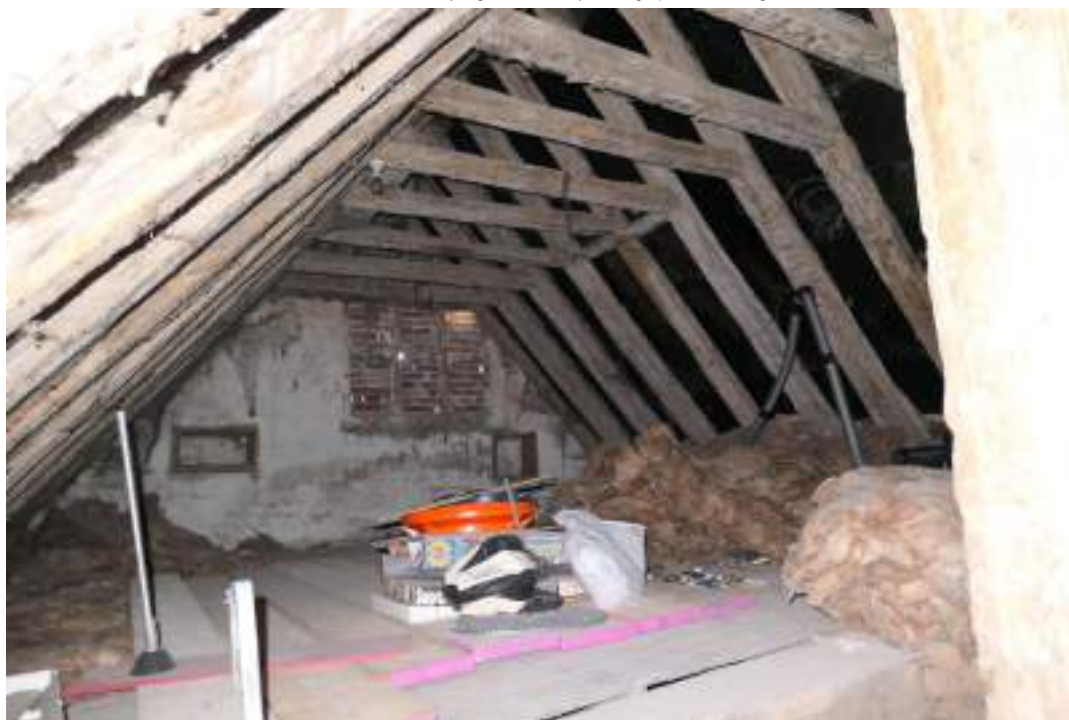
EEX62136\_Photograph\_055  
Detail of roof construction above range 3. Photograph taken facing west.

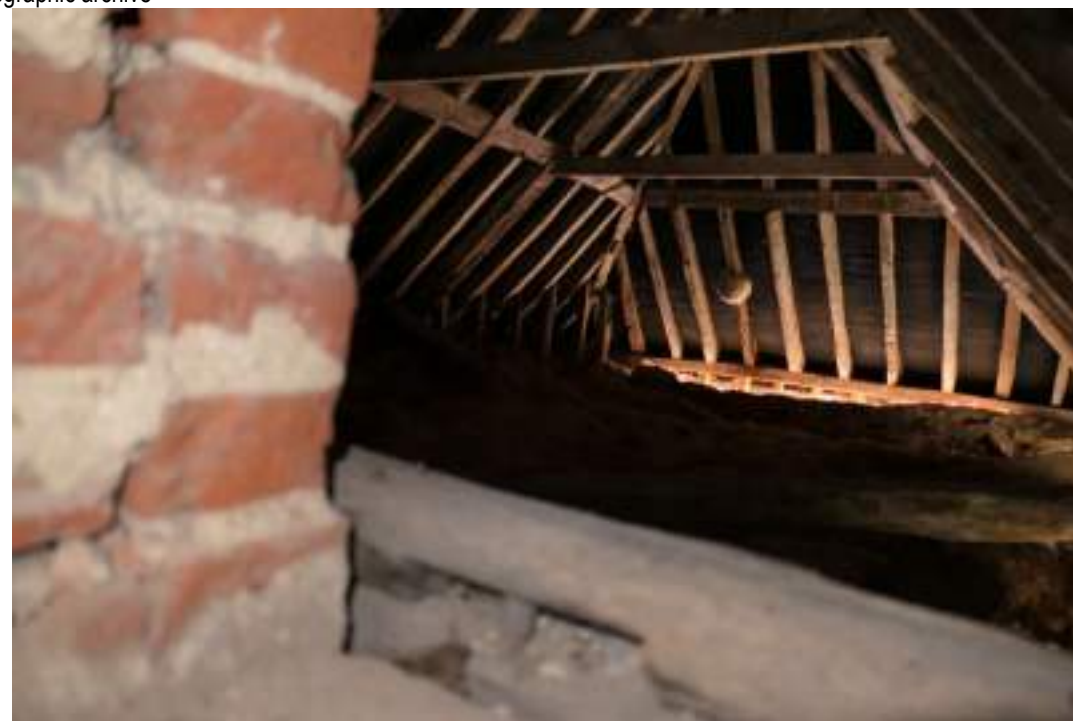
EEX62136\_Photograph\_058  
Detail of roof construction above range 4. Photograph taken facing north.

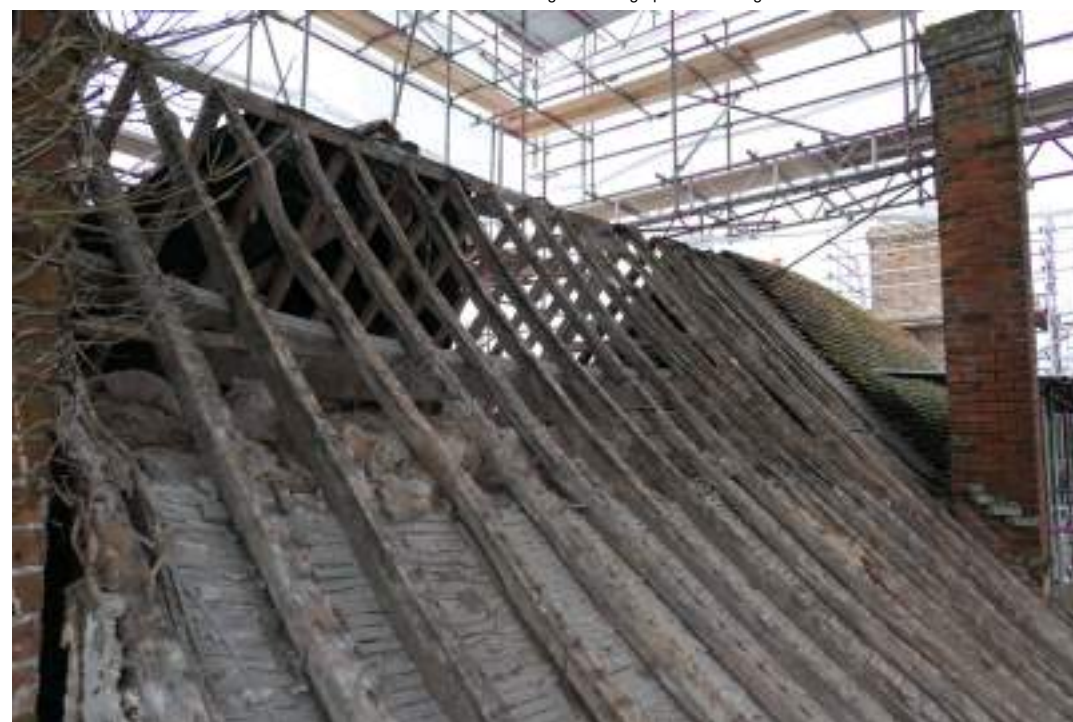
EEX62136\_Photograph\_060  
Detail of roof structure above range 6. Photograph taken facing south.

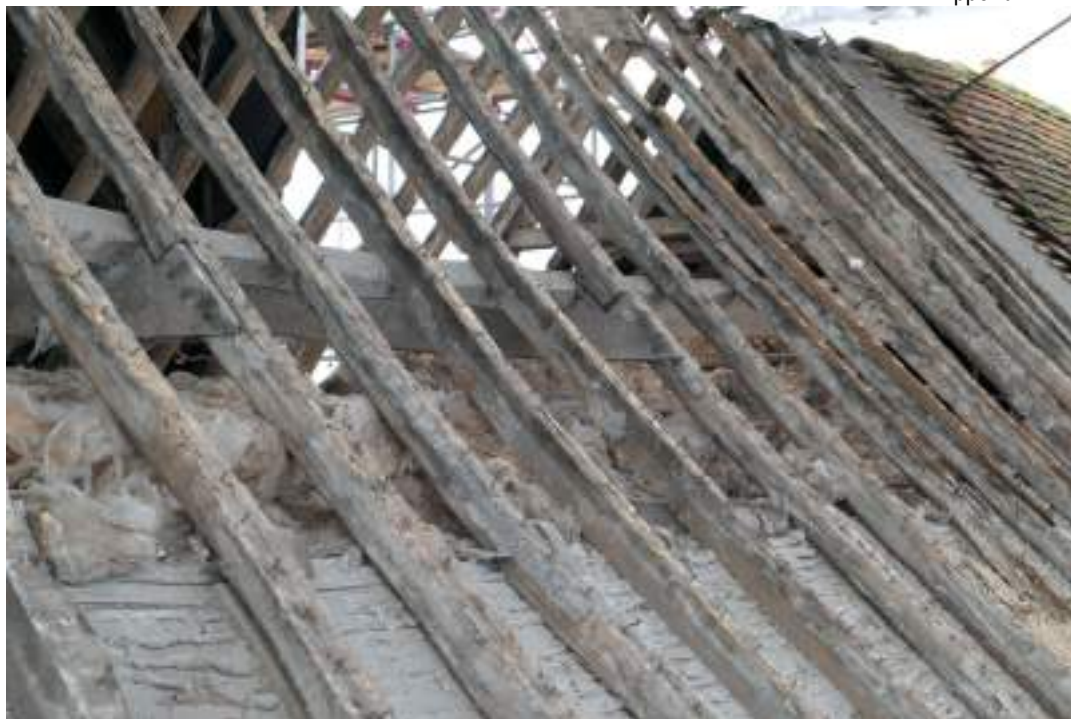
EEX62136\_Photograph\_061  
Detail of lap-dovetail joints securing collars in roof of range 6. Photograph taken facing south.

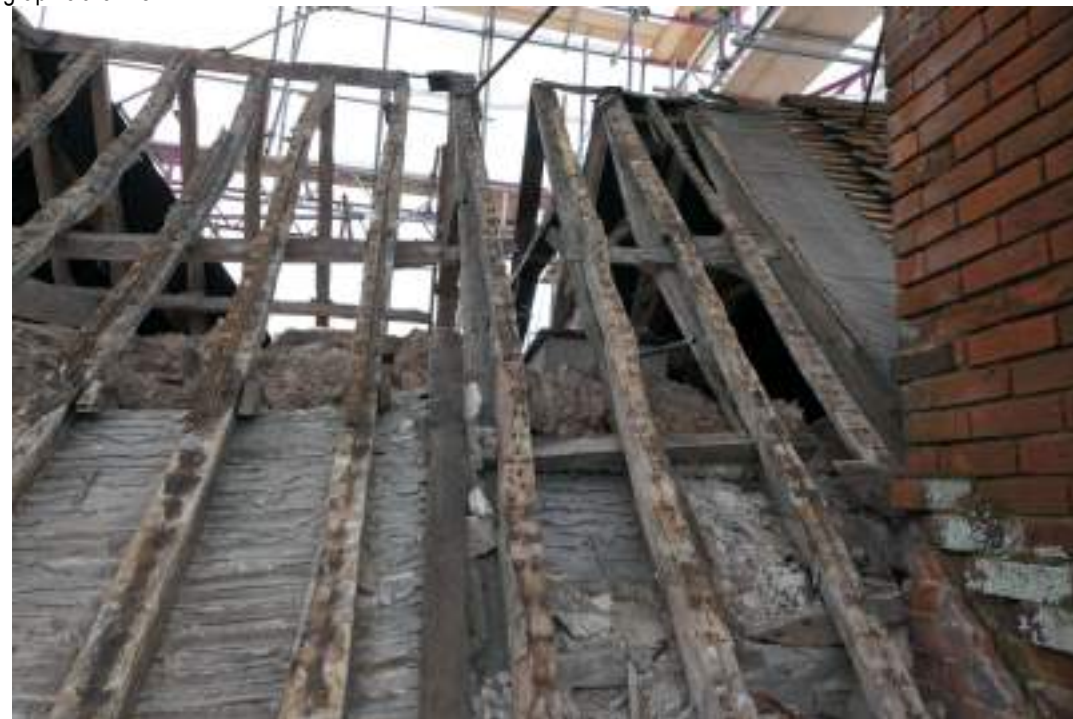
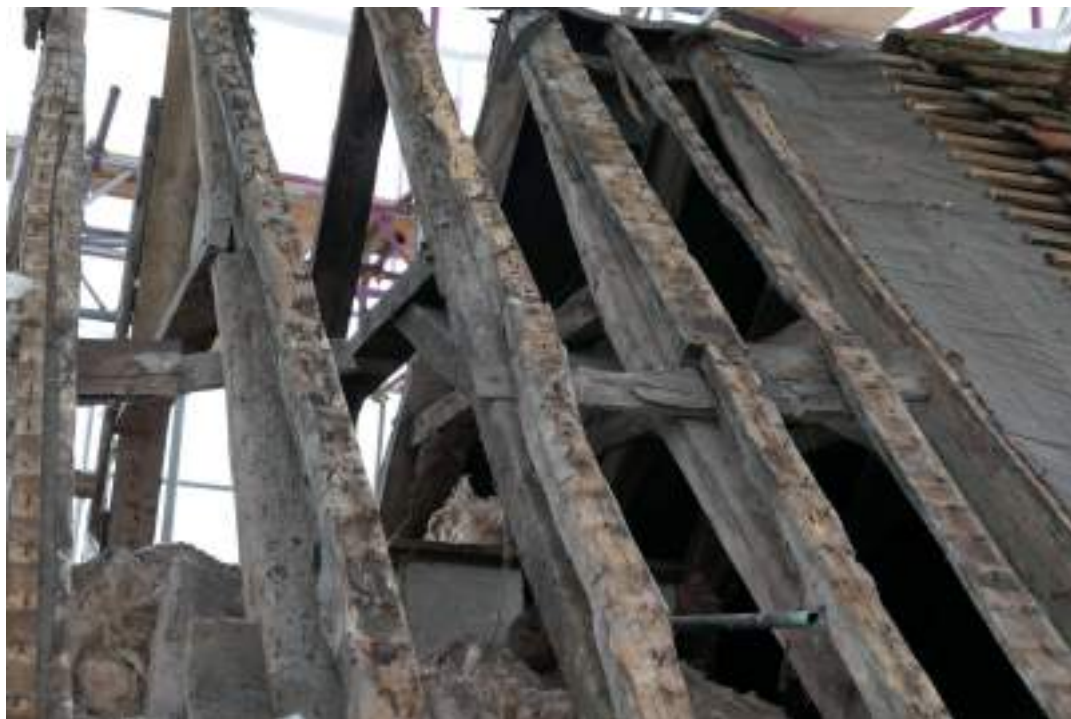
EEX62136\_Photograph\_062  
Detail of roof construction above range 5. Photograph taken facing south south-east.

EEX62136\_Photograph\_063  
Detail of roof construction above range 5. Photograph taken facing south south-east.

**Photograph 20** Detail of roof construction above range 5. Green arrow highlighting blackened timbers and yellow arrow highlighting the void in the blackening, likely caused by a central purlin. Photograph taken facing south south-east.

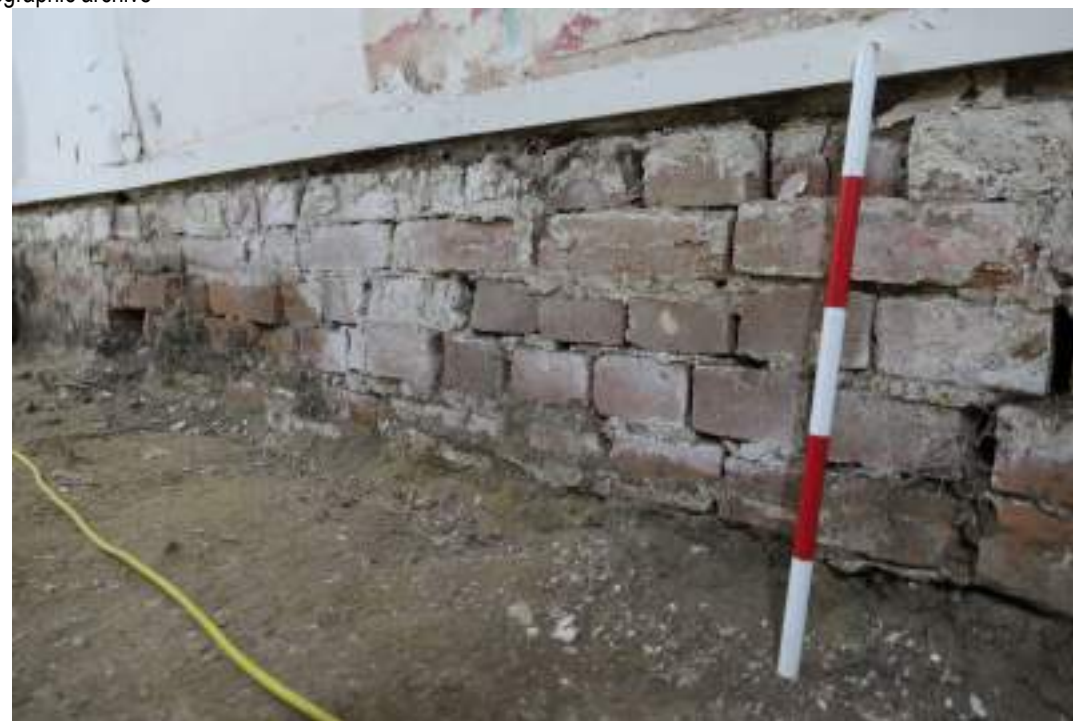
EEX62136\_Photograph\_074  
Detail of brick plinth visible in south-eastern wall of corridor 2. Photograph taken facing east south-east.

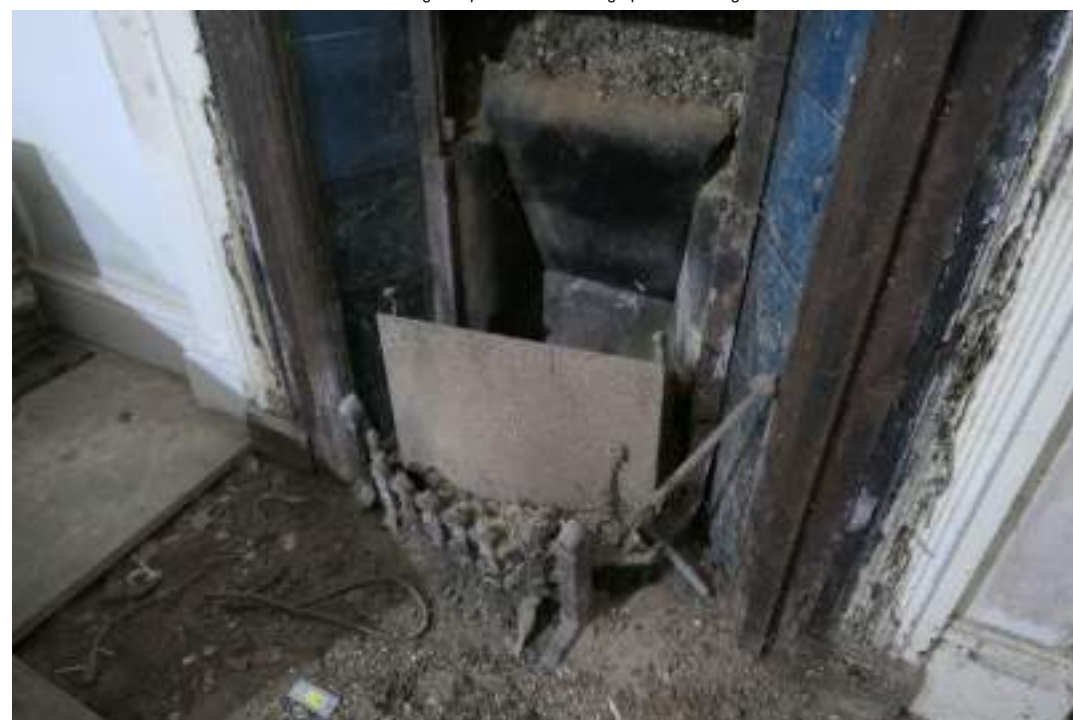
EEX62136\_Photograph\_084  
Detail of fire grate in fireplace in north-western wall of spare room 2. Photograph taken facing west north-west.

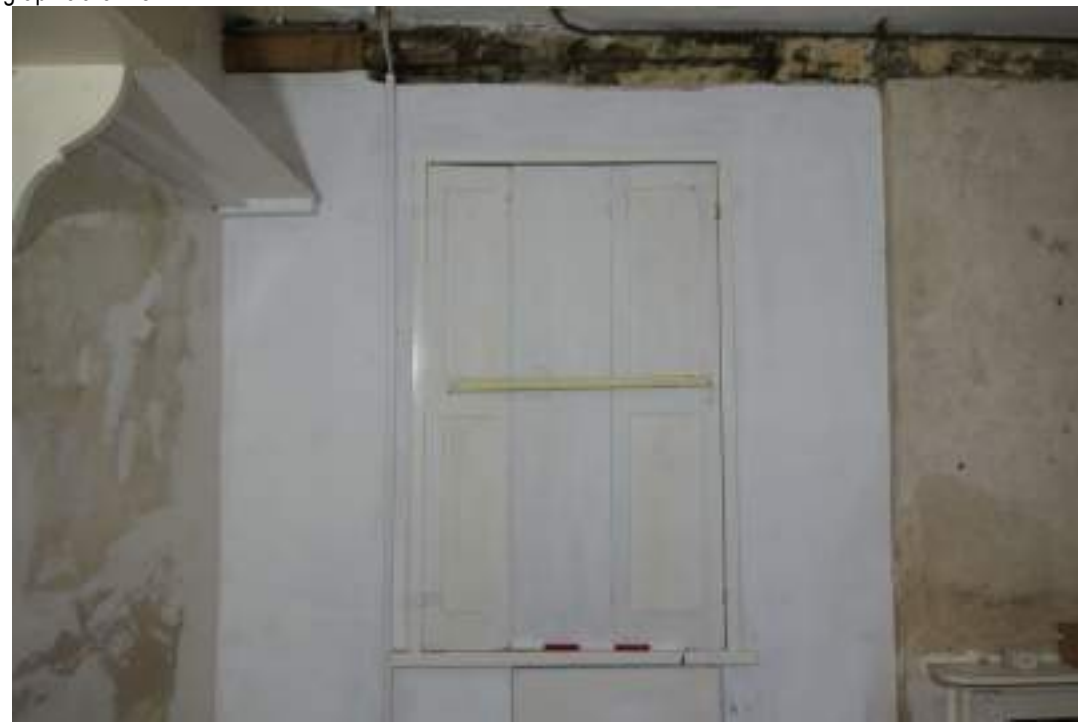
EEX62136\_PhotoGraph\_086

Detail of window shutters and exposed wall-plate in north-western wall of spare room 2. Photograph taken facing north-west.

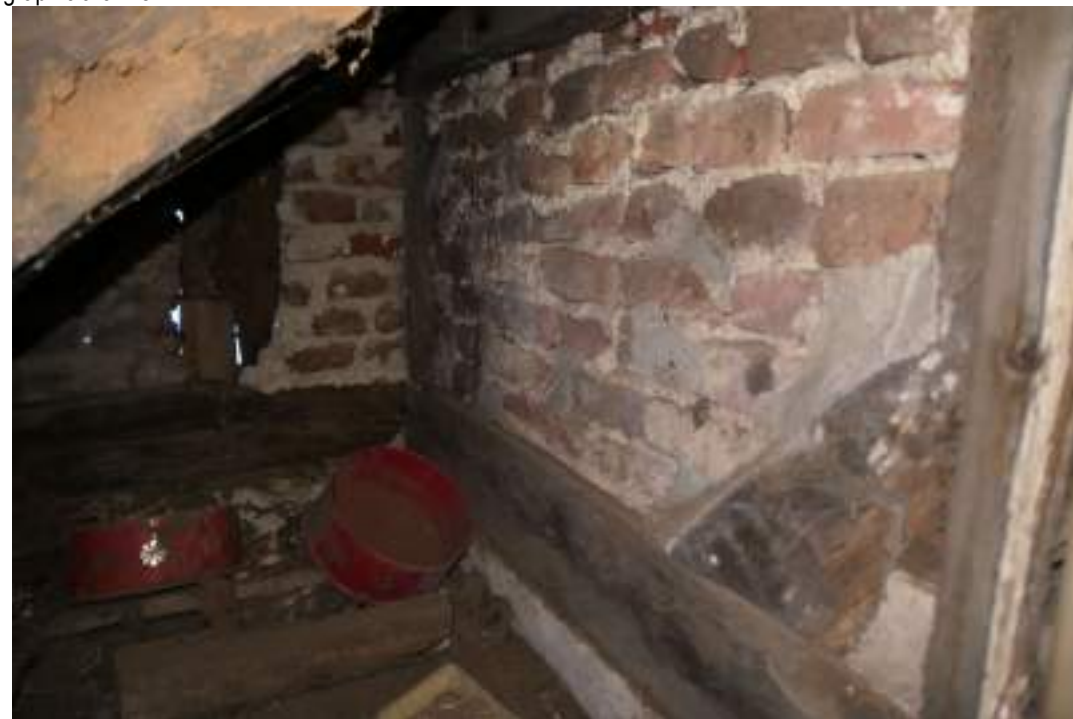
EEX62136\_Photograph\_089  
Detail of rear stairs from beneath. Photograph taken facing north-west.

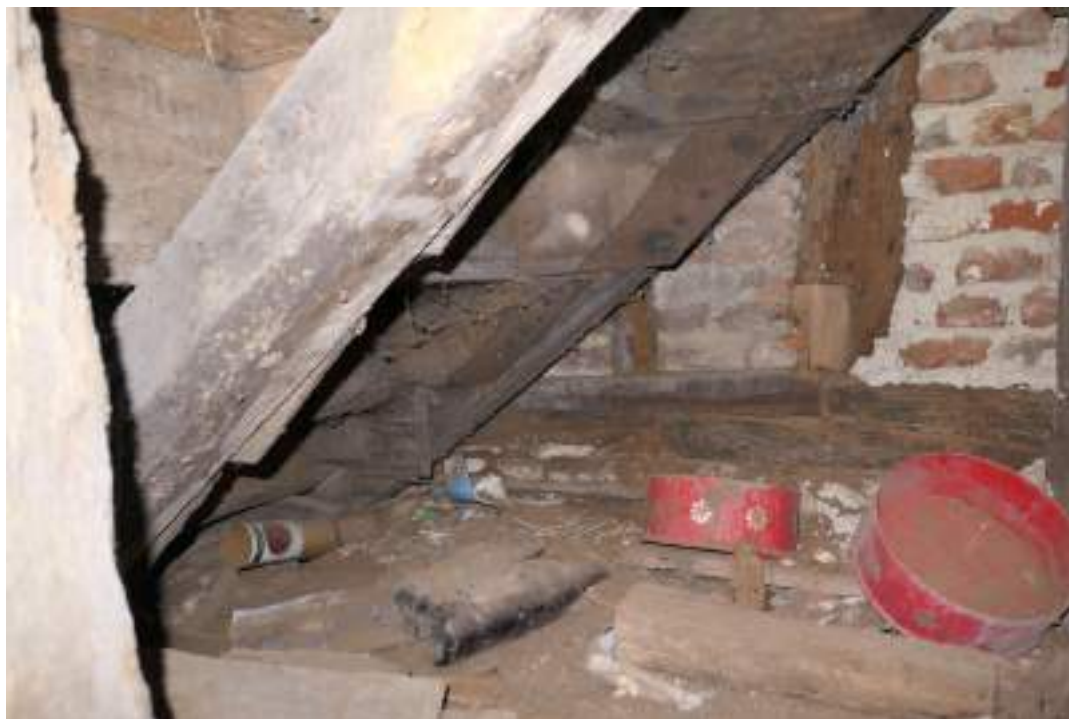
EEX62136\_Photograph\_090  
Detail of brickwork beneath rear stairs. Photograph taken facing north.

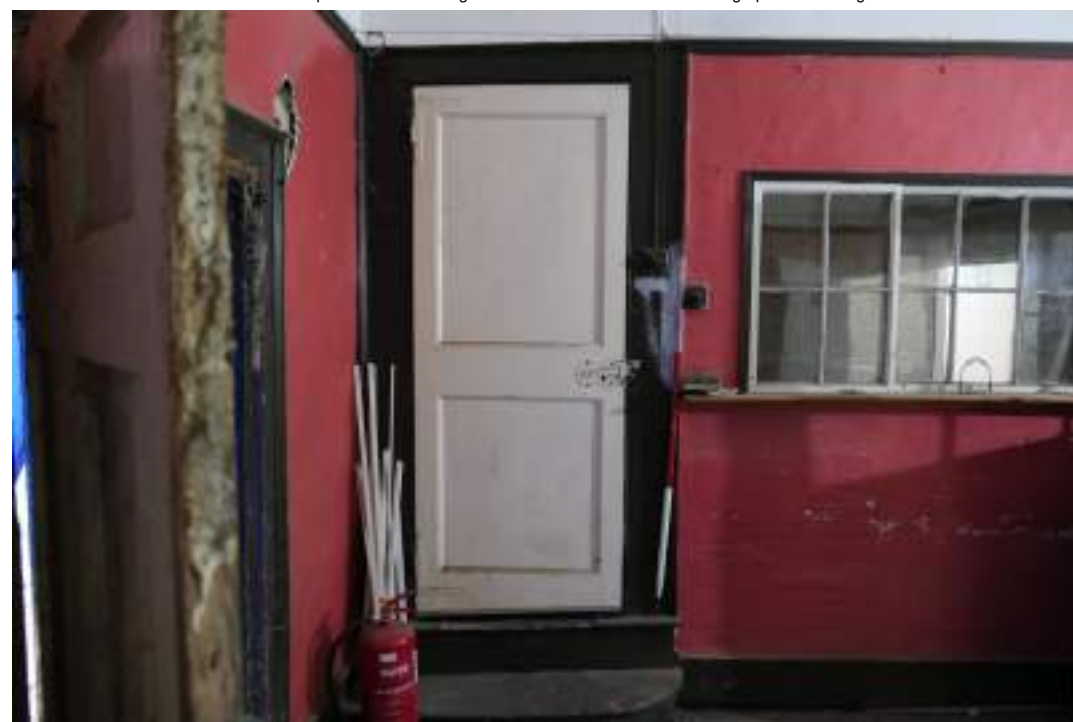
EEX62136\_Photograph\_099  
Detail of door in north-western wall of office. Photograph taken facing north-west.
