**CAT Report 2267  
Issued May 2026**

**Historic building recording and archaeological  
excavation at Dorewards Hall, The Chase, Bocking,  
Essex, CM7 5LS**

**October 2025 and March 2026**

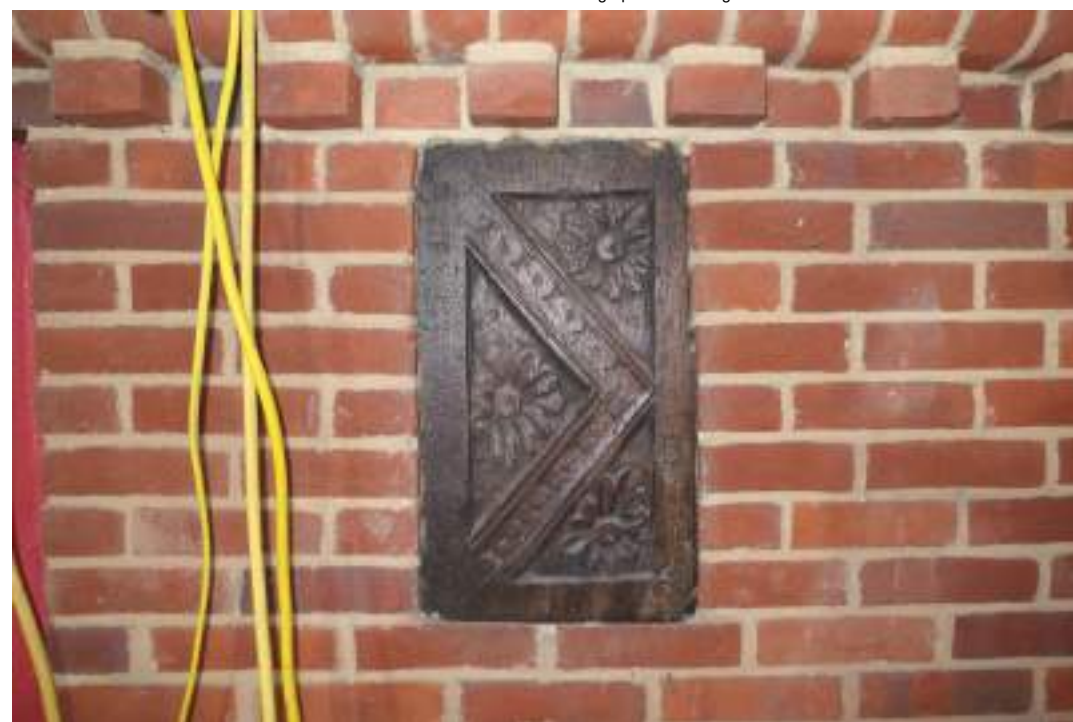
EEX62136\_Photograph\_103  
Detail of fireplace in south-western wall of office. Photograph taken facing south-west.

The office occupies the south-western end of range 5 (Photograph 32). The plaster has been removed from the north-western wall of the office, exposing the laths and some of the timber-framing beneath. The timbers are mostly hand-sawn, except for in areas of modern repair, some of which are reused (Photograph 33). A primary brace is visible in the framing, along with brick nogging. Windows are present in three walls, two of which are four-light sash windows and the third a ten-light horizontal sash window. Six doors are also set across the room, which are largely either two, four and six-panel, with one vertically planked door. Each door has a timber surround, with differing levels of decoration. A large brick fireplace dominates the south-western wall; it has two carved timber panels embedded into the brickwork and dentil detailing along the mantle. The opening has a curved arch and a brick-lined hearth.

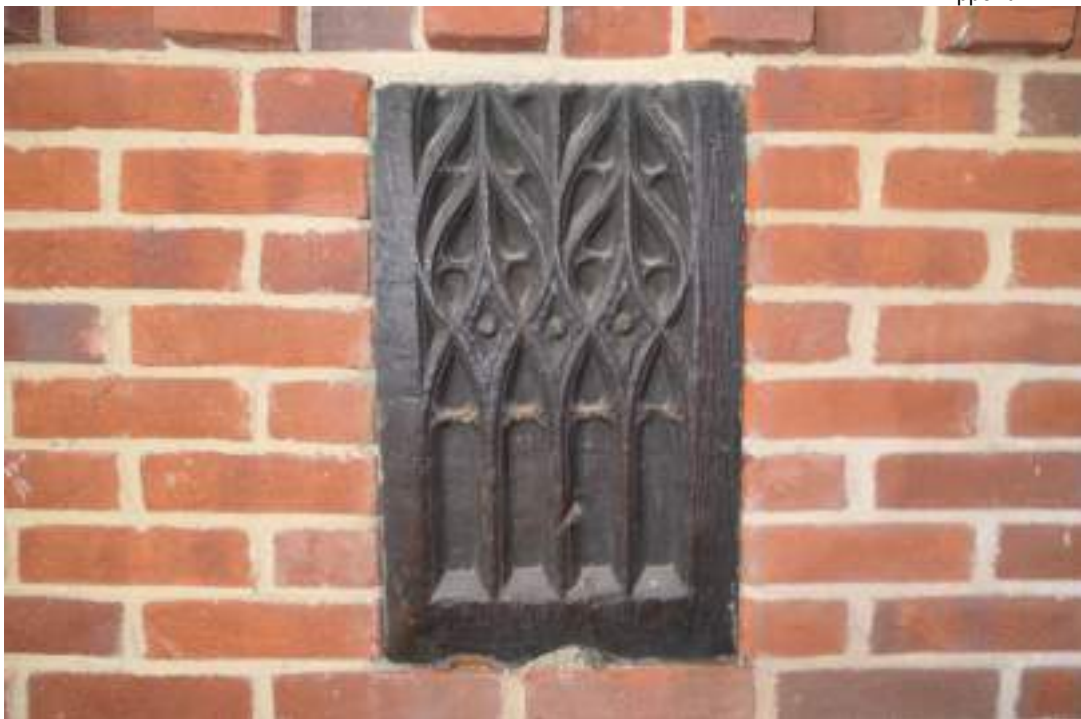
EEX62136\_Photograph\_104  
Detail of carved plaque in fireplace in south-western wall of office. Photograph taken facing south-west.

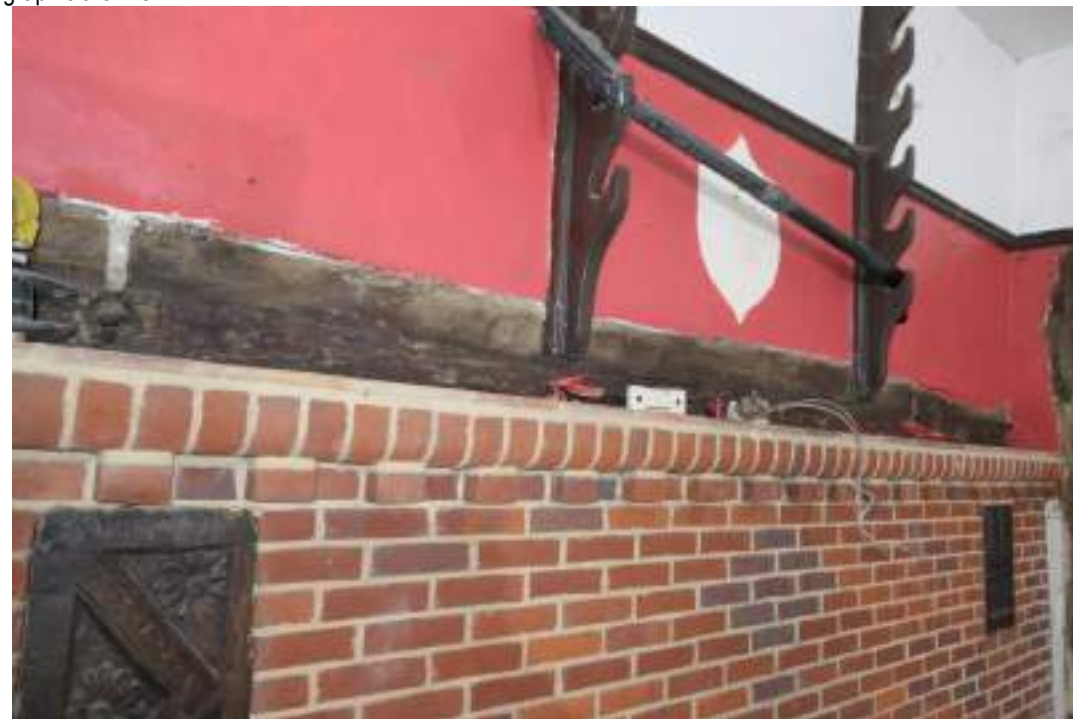
EEX62136\_Photograph\_105  
Detail of carved plaque in fireplace in south-western wall of office. Photograph taken facing south-west.

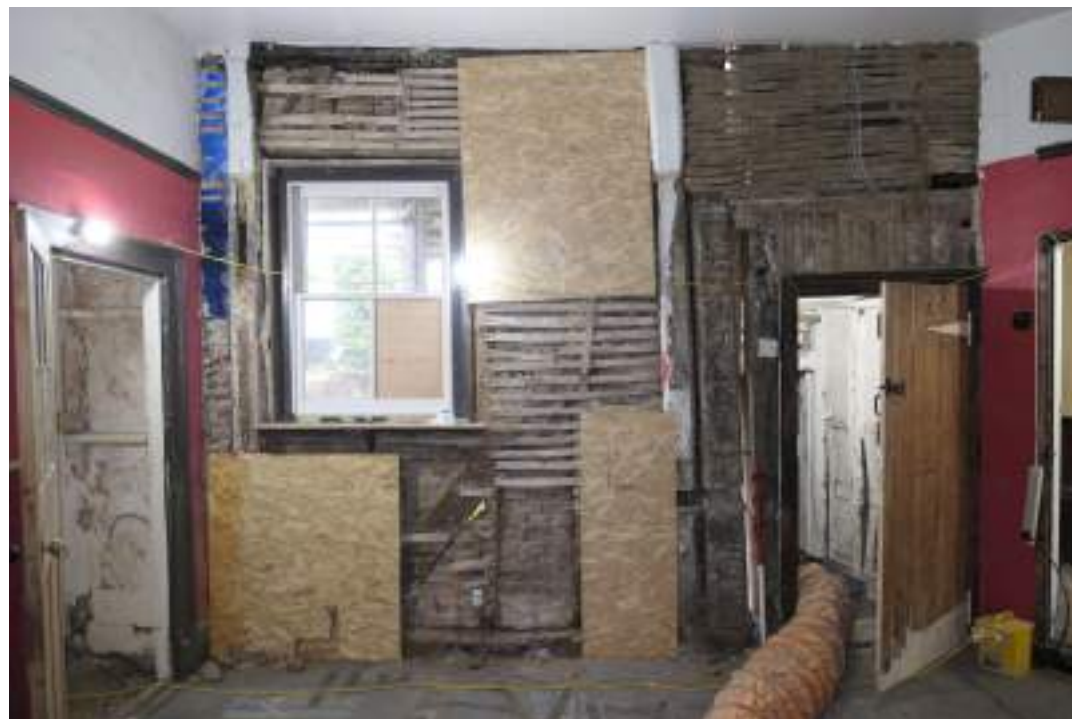
EEX62136\_Photograph\_106  
Detail of exposed timber mantle in south-western wall of office. Photograph taken facing west.

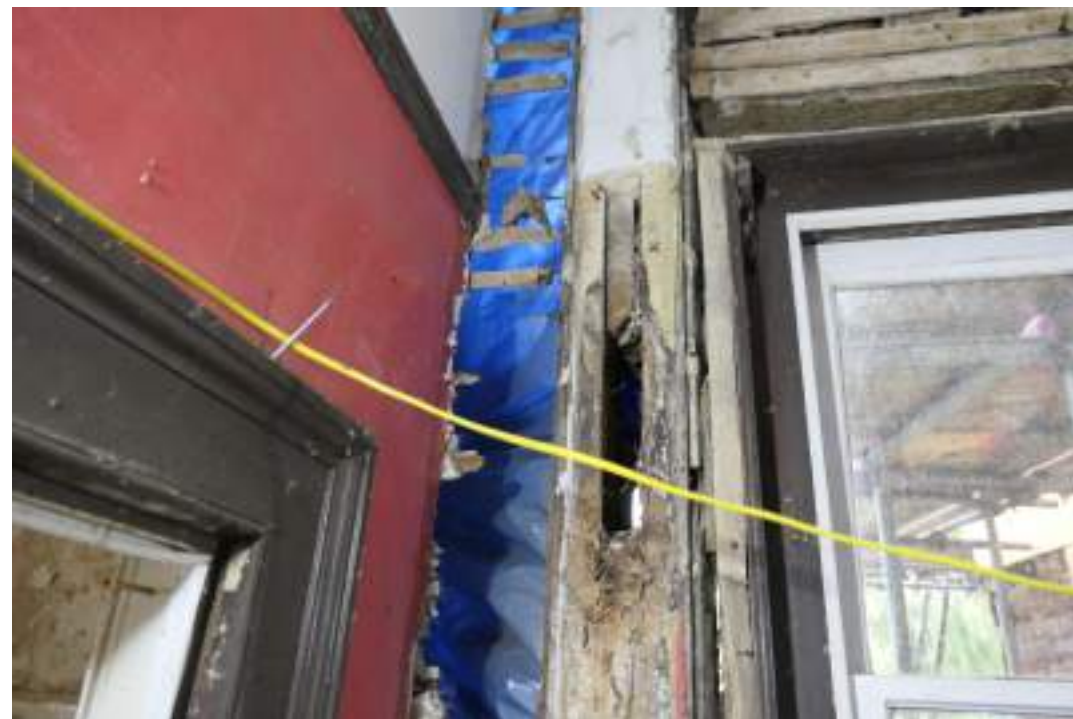
EEX62136\_Photograph\_107  
Detail of exposed timber-framing in south-eastern wall of office. Photograph taken facing south-east.

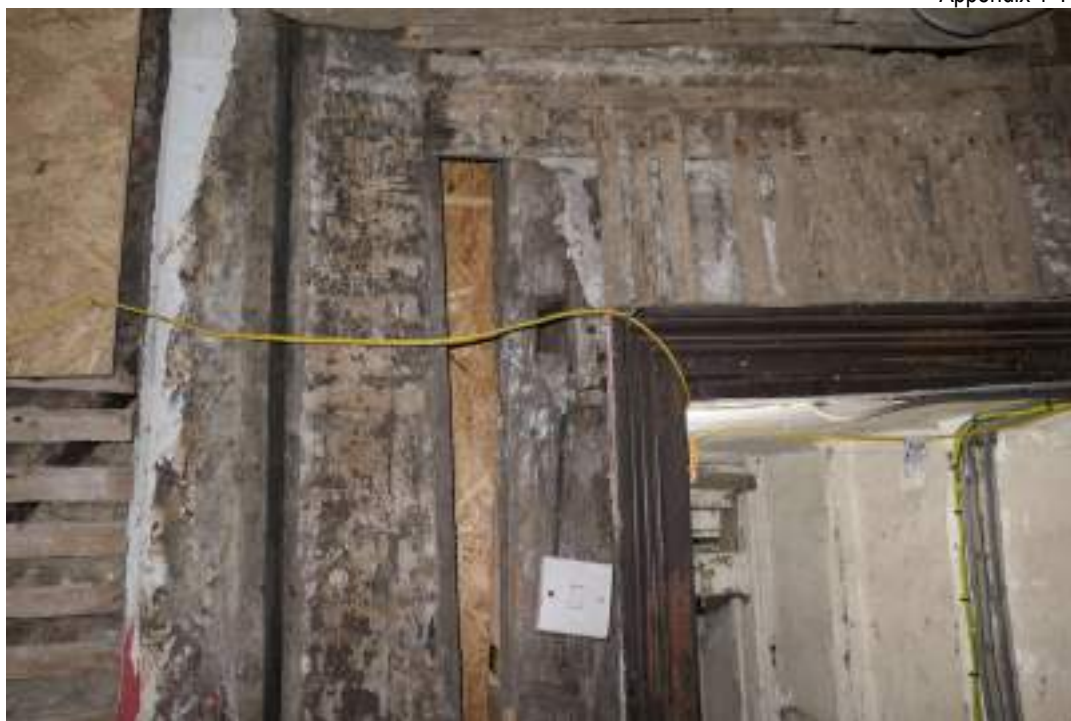
EEX62136\_Photograph\_108  
Detail of empty mortice on post in south-eastern wall of office. Photograph taken facing south south-west.

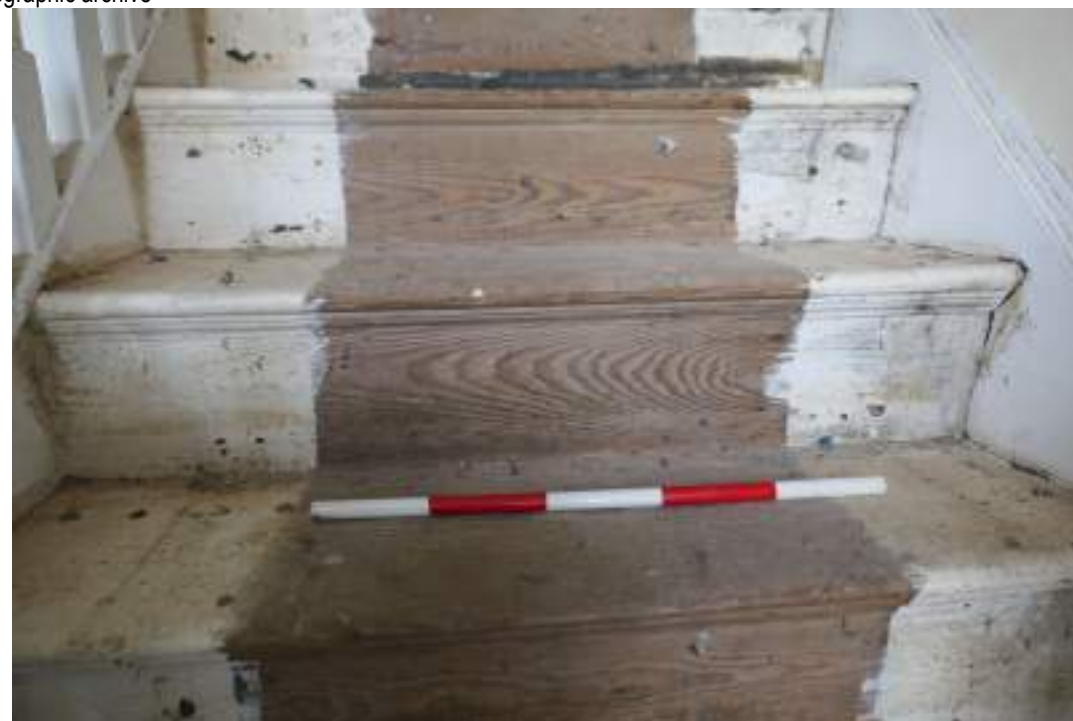
EEX62136\_PhotoGraph\_113  
Detail of staircase in entrance hall. Photograph taken facing north.

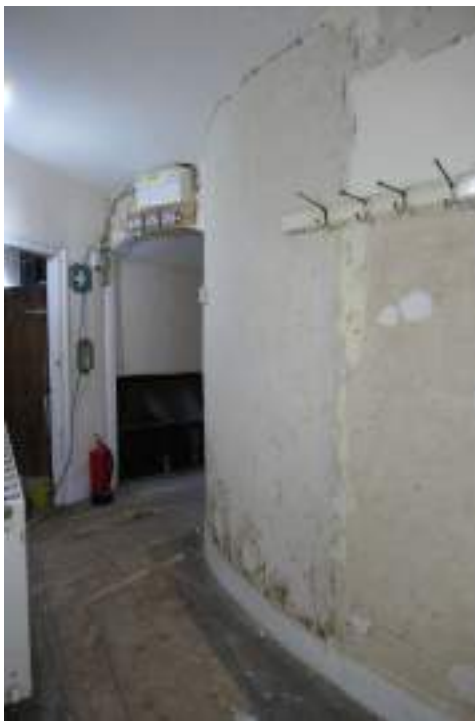
EEX62136\_PhotoGraph\_116  
Detail of arched doorway between entrance hall and corridor 1. Photograph taken facing north-west.

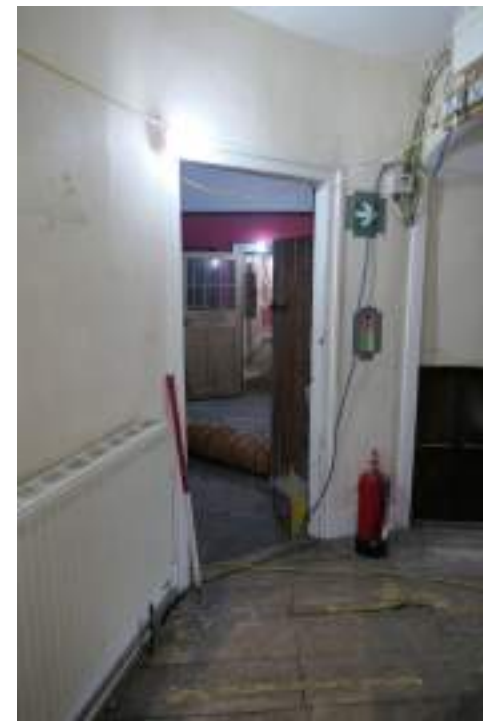
EEX62136\_Photograph\_117  
Detail of curved wall in corridor 1. Photograph taken facing east.

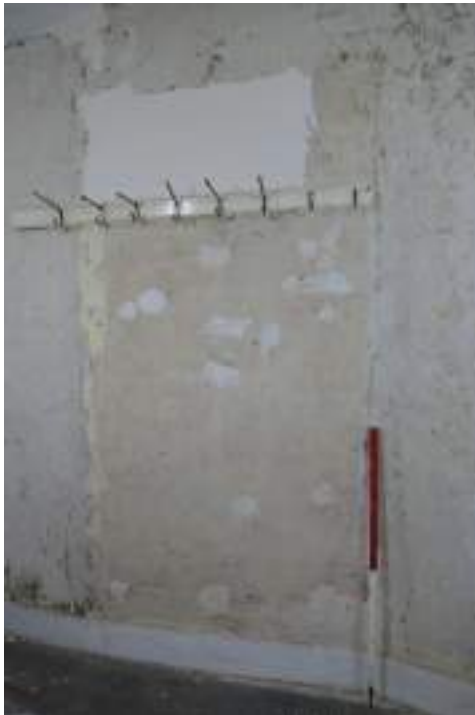
EEX62136\_Photograph\_118  
Detail of doorway in northern wall of corridor 1. Photograph taken facing north-east.

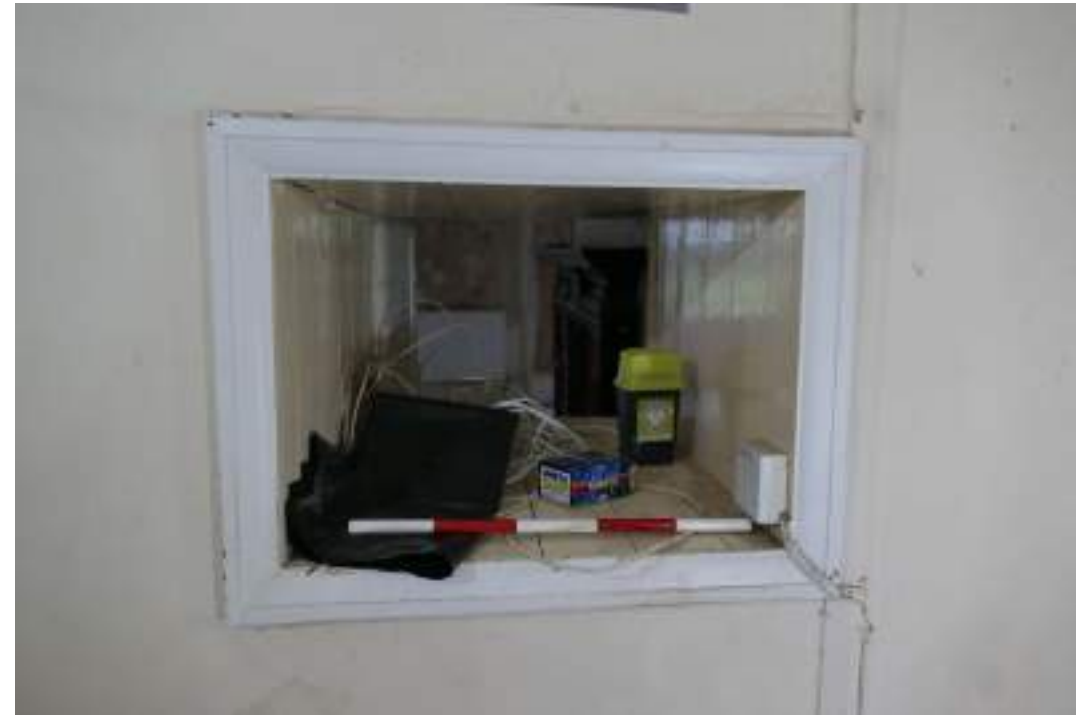
EEX62136\_Photograph\_119  
Detail of blocked doorway in south-eastern wall of corridor 1. Photograph taken facing east south-east.

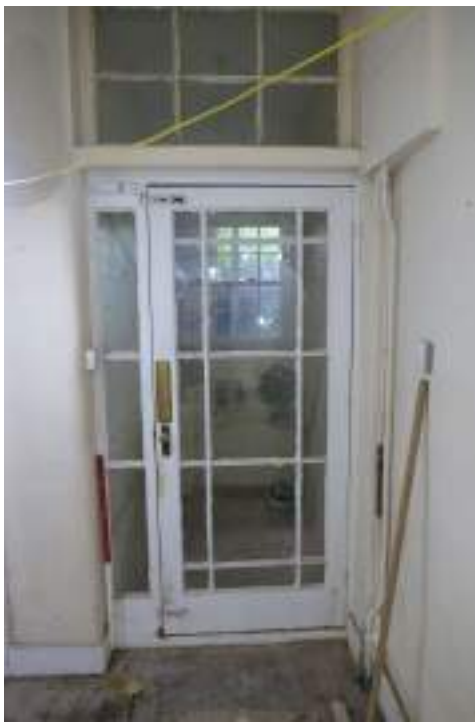
EEX62136\_Photograph\_124  
Detail of door in north-western wall of corridor 1. Photograph taken facing north.

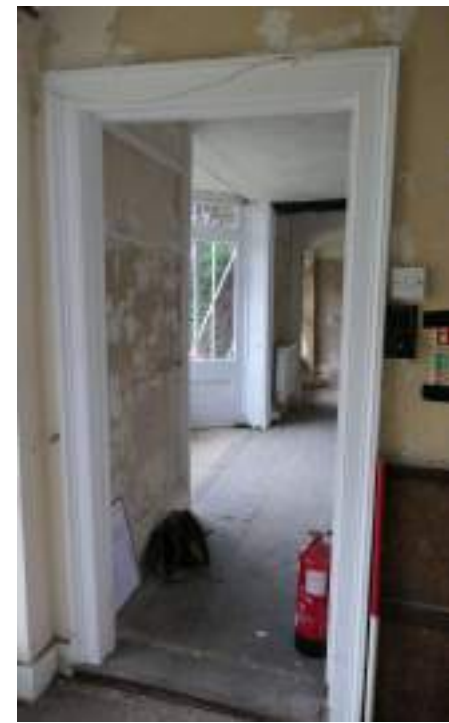
EEX62136\_Photograph\_125  
Detail of door to pantry (inaccessible). Photograph taken facing south-west.

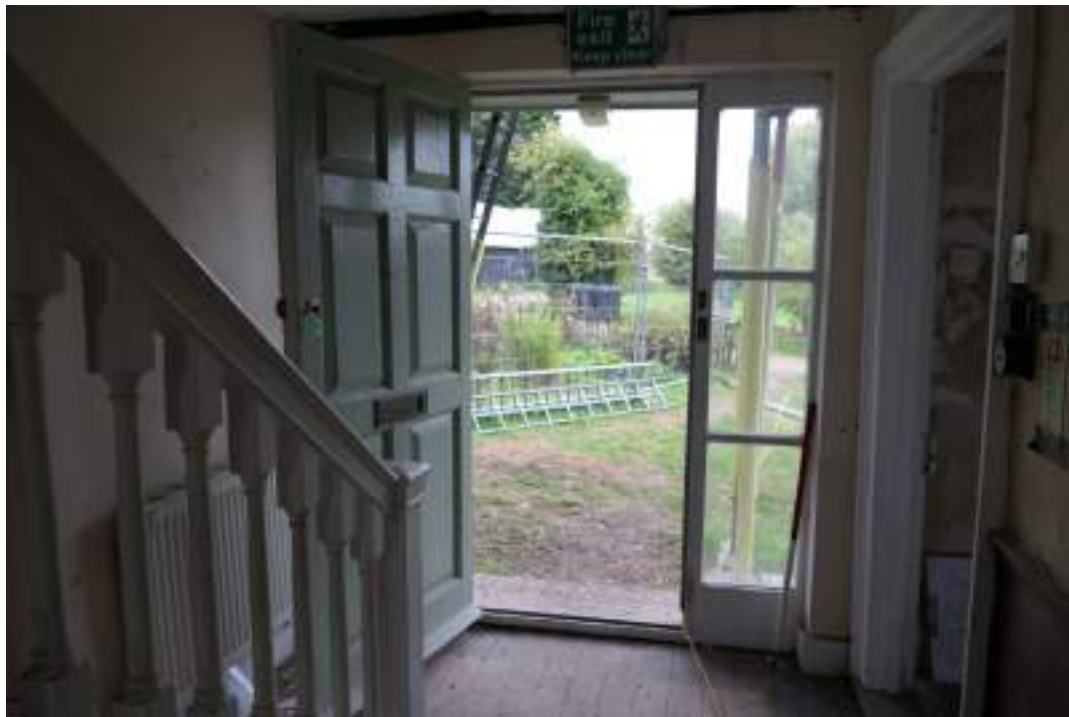
EEX62136\_Photograph\_126  
Detail of door in south-western wall of entrance hall. Photograph taken facing south-west.

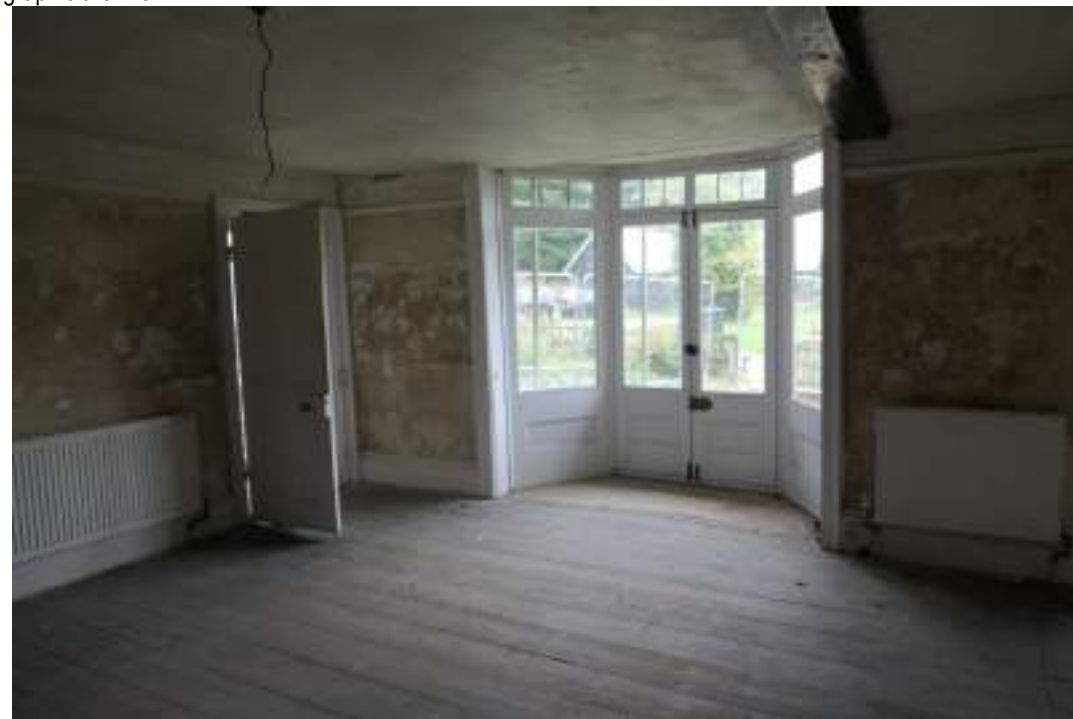
EEX62136\_Photograph\_129  
Interior of living room. Photograph taken facing north.

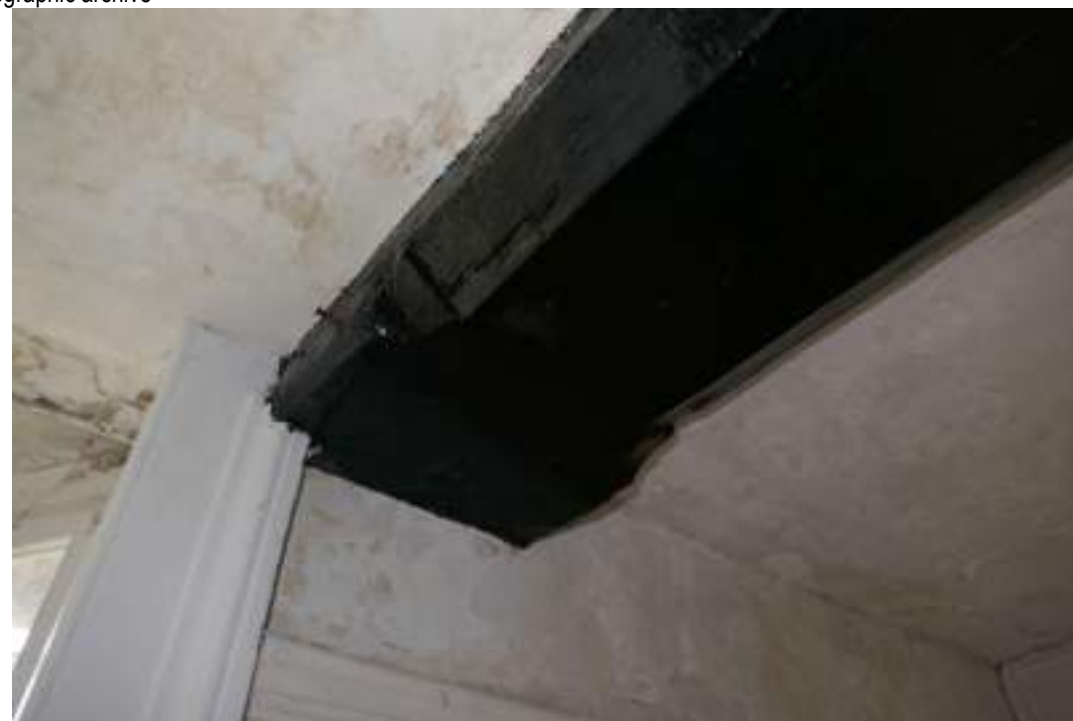
EEX62136\_Photograph\_137  
Detail of arch in north-western wall in living room. Photograph taken facing north-west.

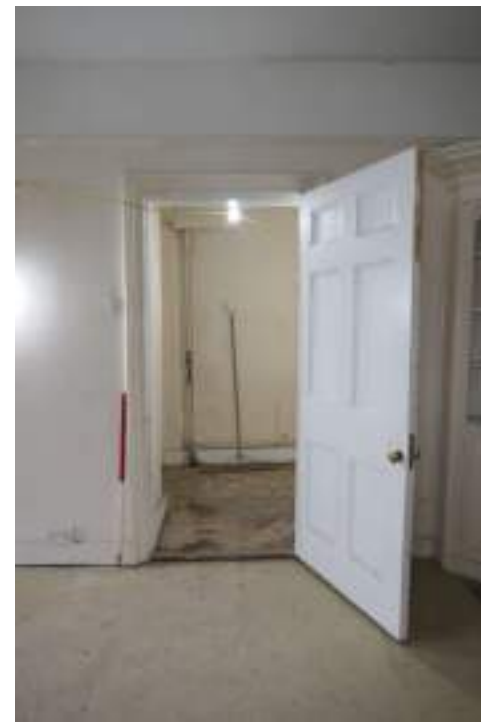
EEX62136\_Photograph\_149  
Detail of in-built cuboard in dining room. Photograph taken facing north.

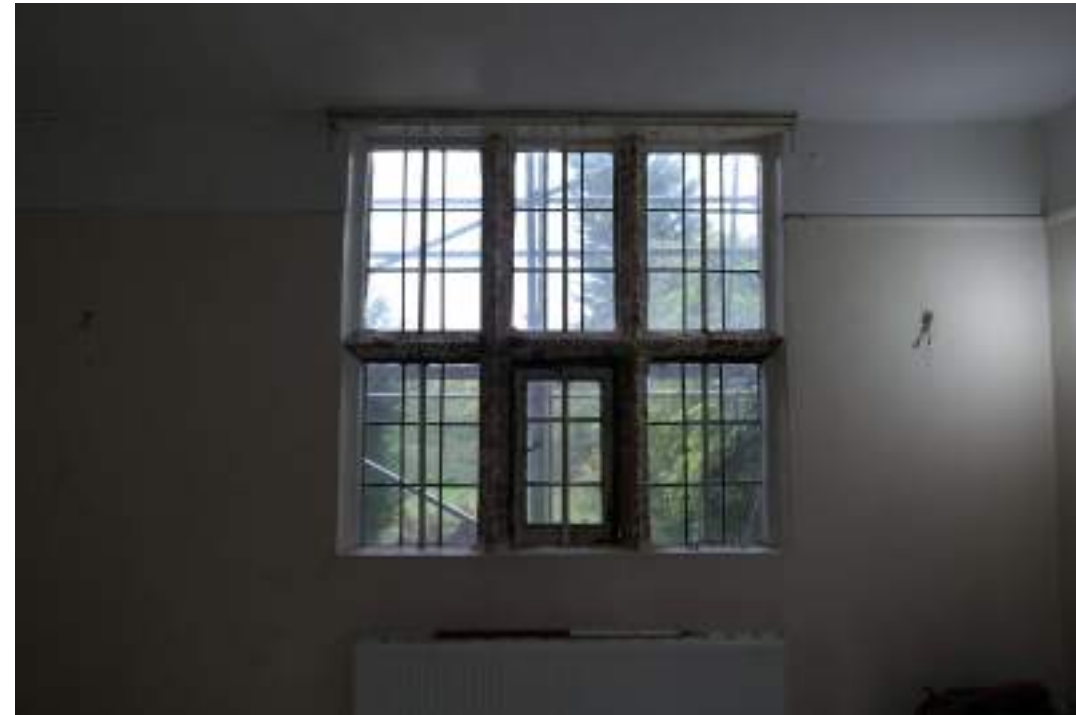
EEX62136\_Photograph\_151  
Detail of window in south-eastern wall of dining room. Photograph taken facing south-east.

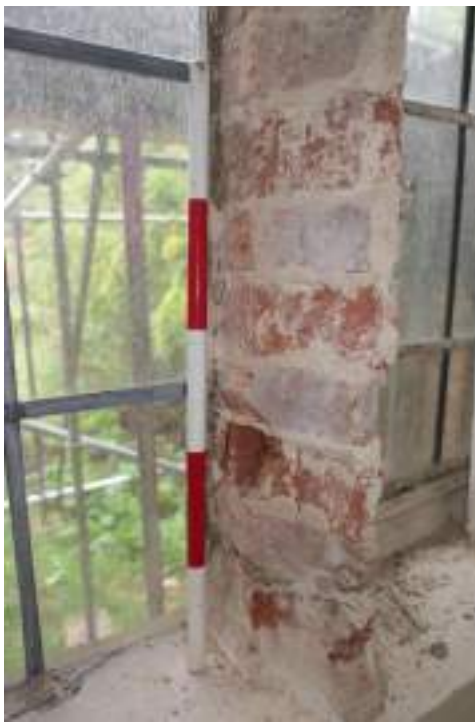
EEX62136\_Photograph\_152  
Detail of window in south-western wall of dining room. Photograph taken facing south-west.

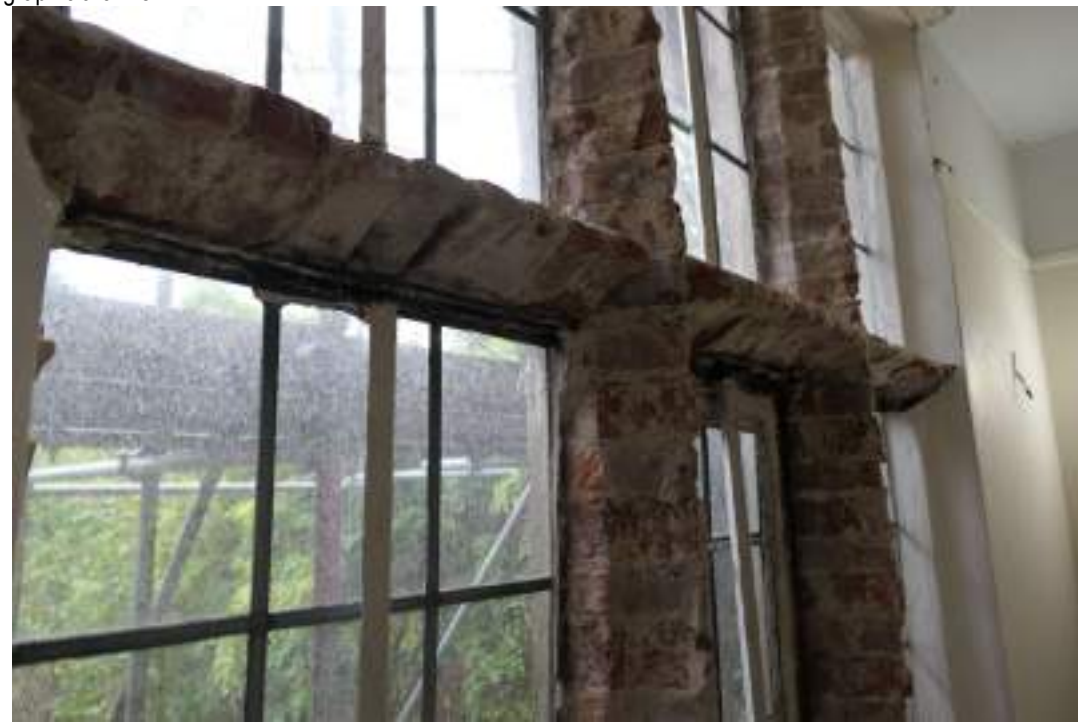
EEX62136\_PhotoGraph\_153  
Detail of brick mullion in window in south-western wall of dining room. Photograph taken facing west.

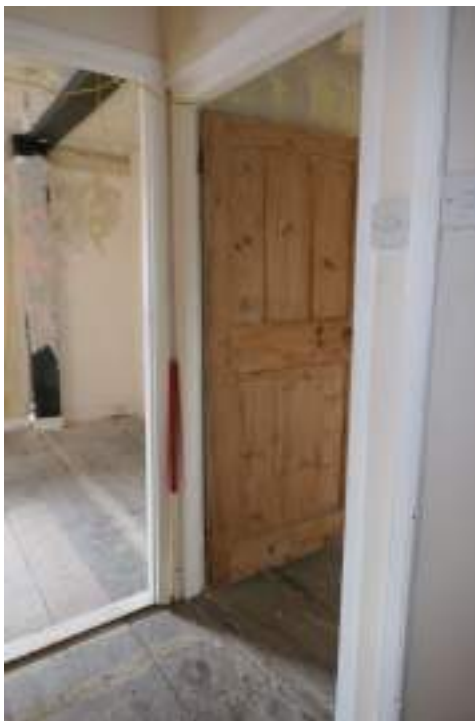
EEX62136\_Photograph\_160  
Detail of door in south-eastern wall of corridor 3. Photograph taken facing south-east.

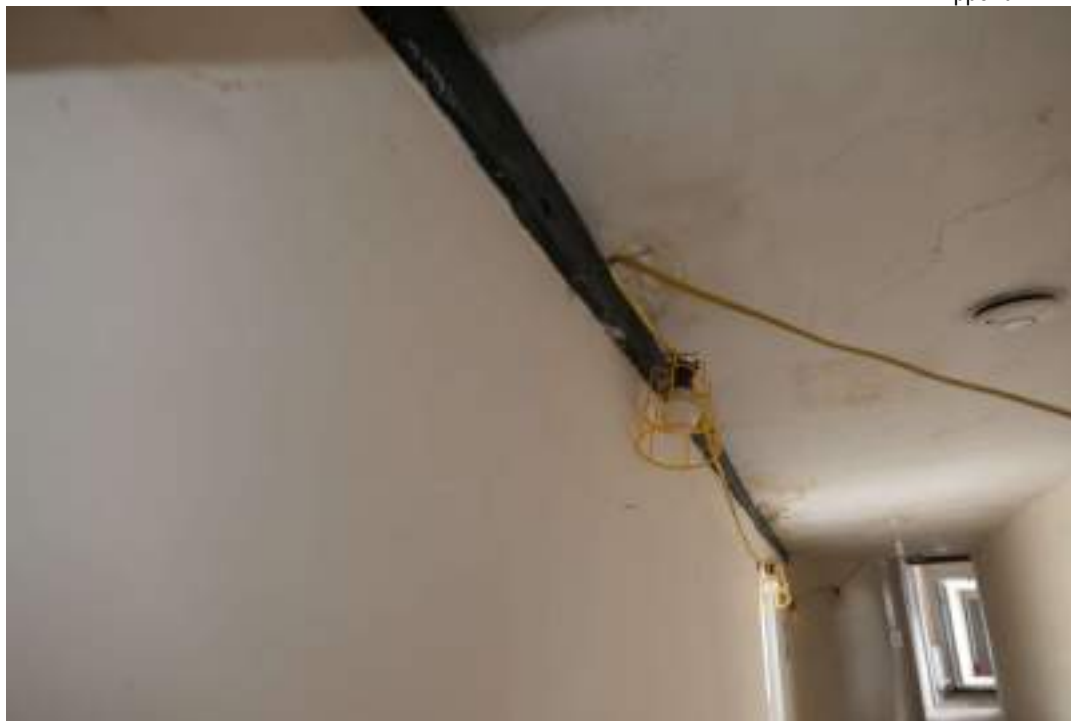
EEX62136\_Photograph\_168  
Detail of exposed wall-plate in cupboard in corridor 3. Photograph taken facing west north-west.

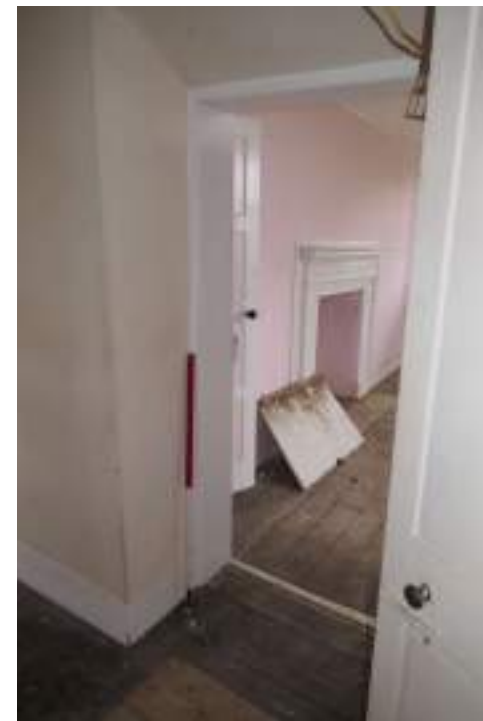
EEX62136\_Photograph\_170  
Detail of doorway in south-eastern wall of corridor 3. Photograph taken facing east.

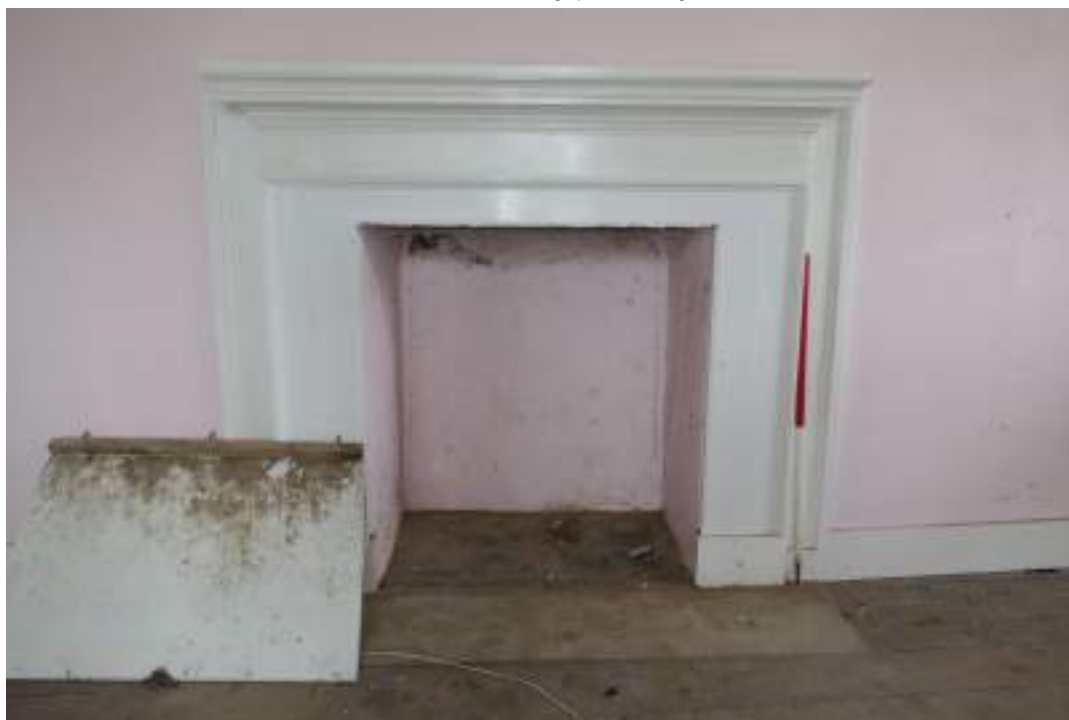
EEX62136\_Photograph\_175  
Detail of fireplace in north-eastern wall of bedroom 1. Photograph taken facing north-east.

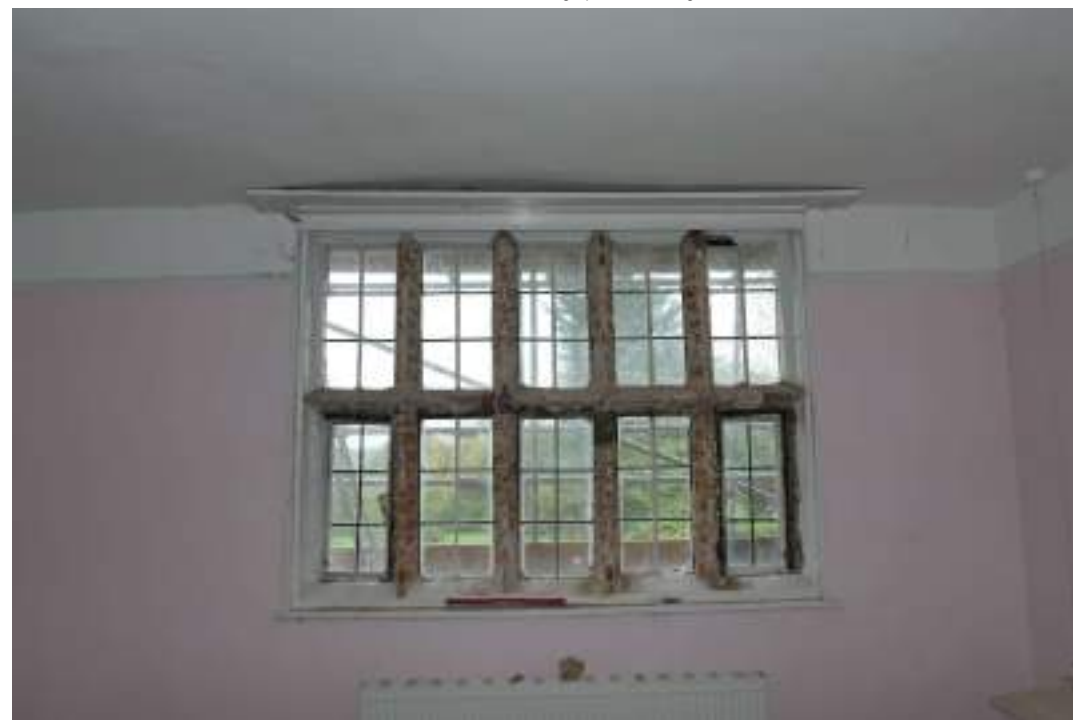
EEX62136\_Photograph\_176  
Detail of window in the south-western wall of bedroom 1. Photograph taken facing south-west.

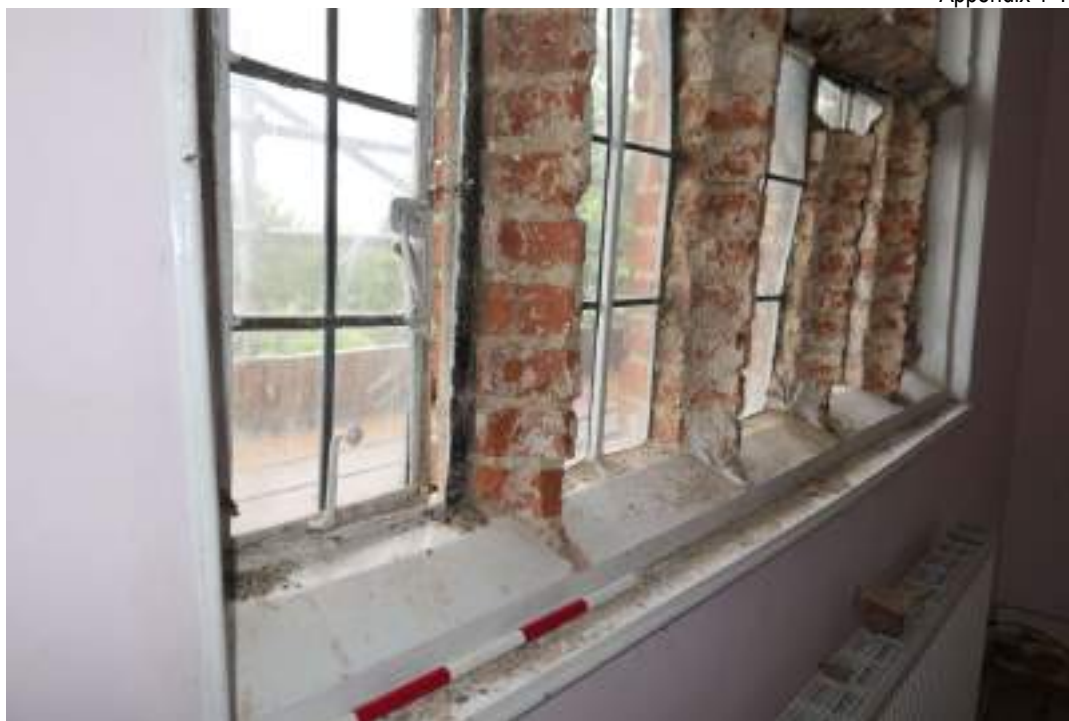
EEX62136\_Photograph\_177

Detail of brick mullions in window in south-western wall of bedroom 1. Photograph taken facing west.

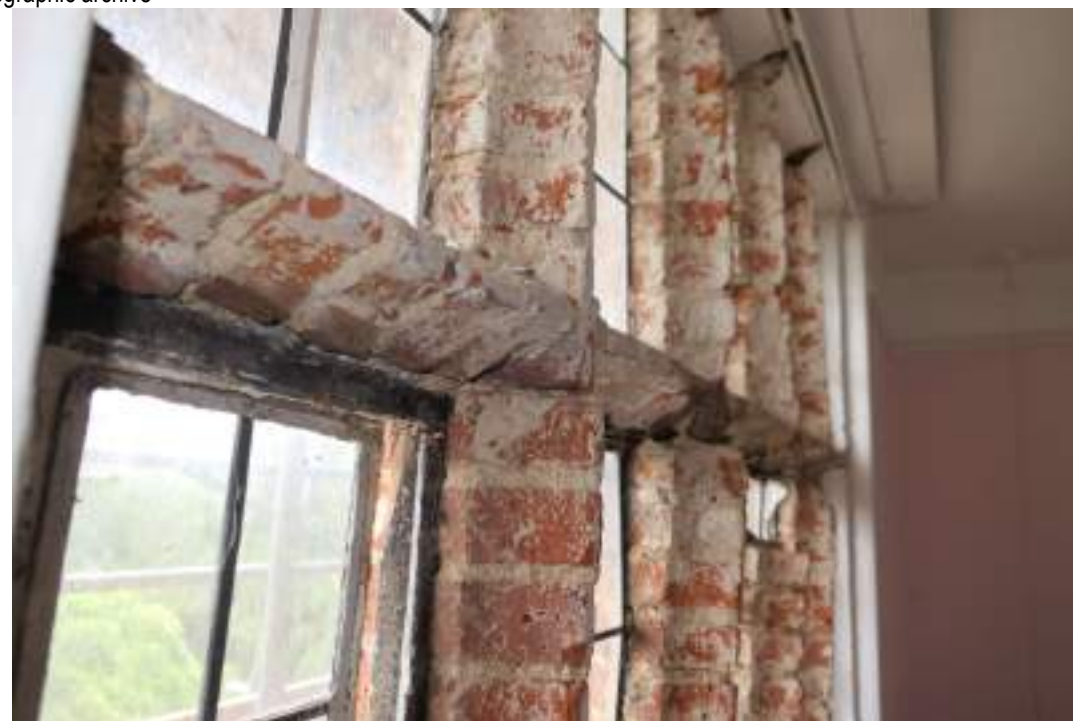
EEX62136\_Photograph\_178

Detail of brick mullions and transom in window in south-western wall of bedroom 1. Photograph taken facing west.

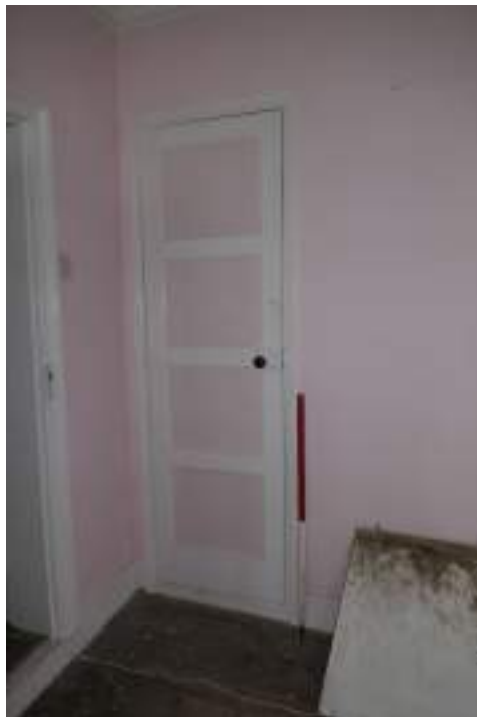
EEX62136\_Photograph\_179

Detail of cupboard door in north-eastern wall of bedroom 1. Photograph taken facing north north-east.

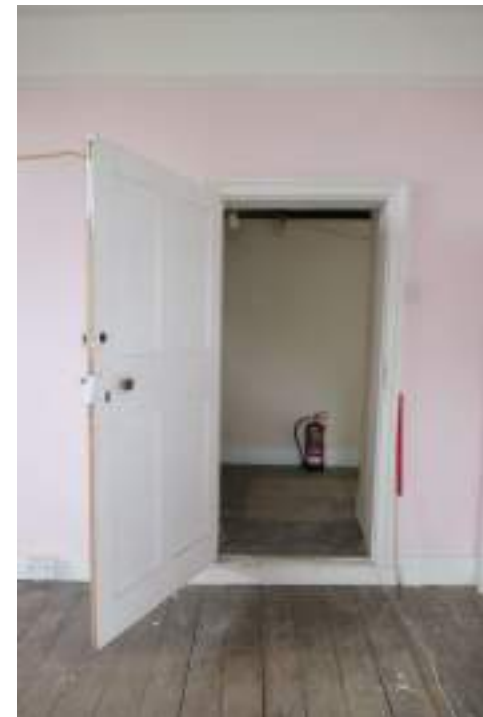
EEX62136\_Photograph\_180

Detail of door in north-western wall of bedroom 1. Photograph taken facing north-west.

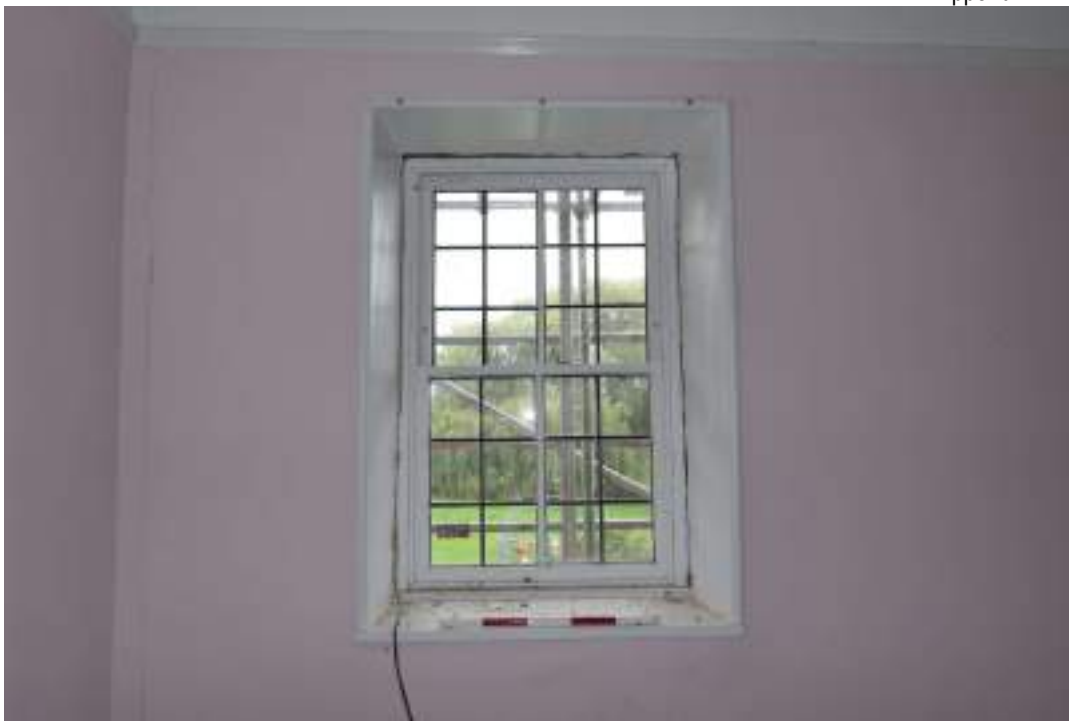
EEX62136\_Photograph\_181  
Detail of window in south-eastern wall of bedroom 1. Photograph taken facing south-east.

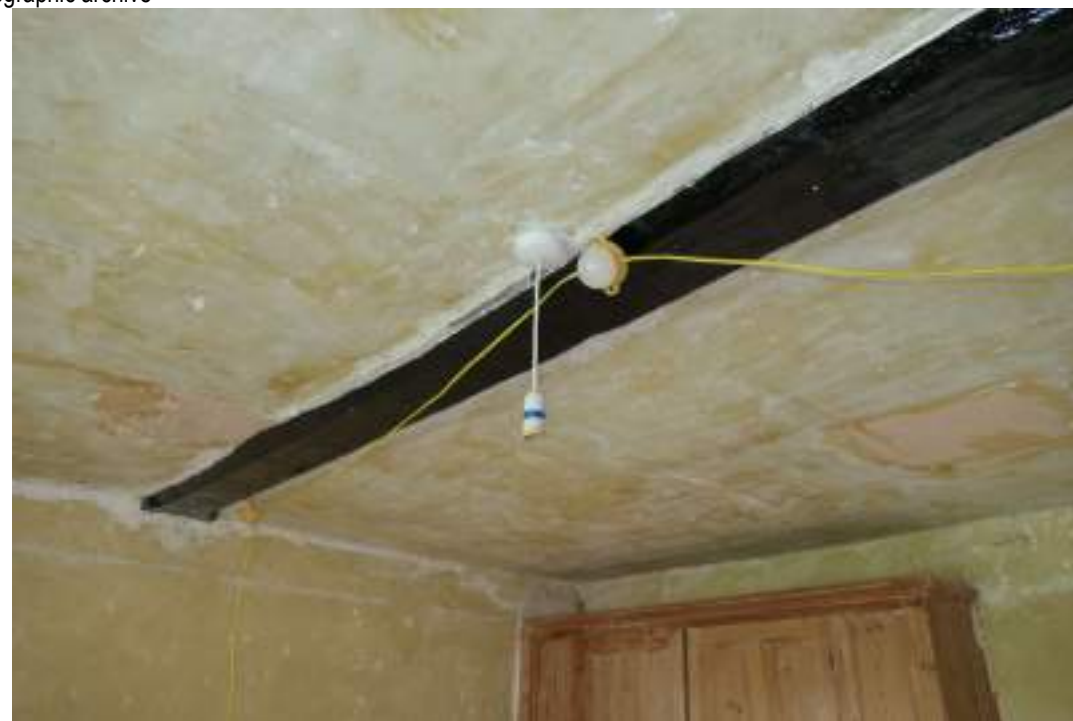
EEX62136\_Photograph\_186  
Detail of chamfered bridging joist, with curved stepped stops. Photograph taken facing west.

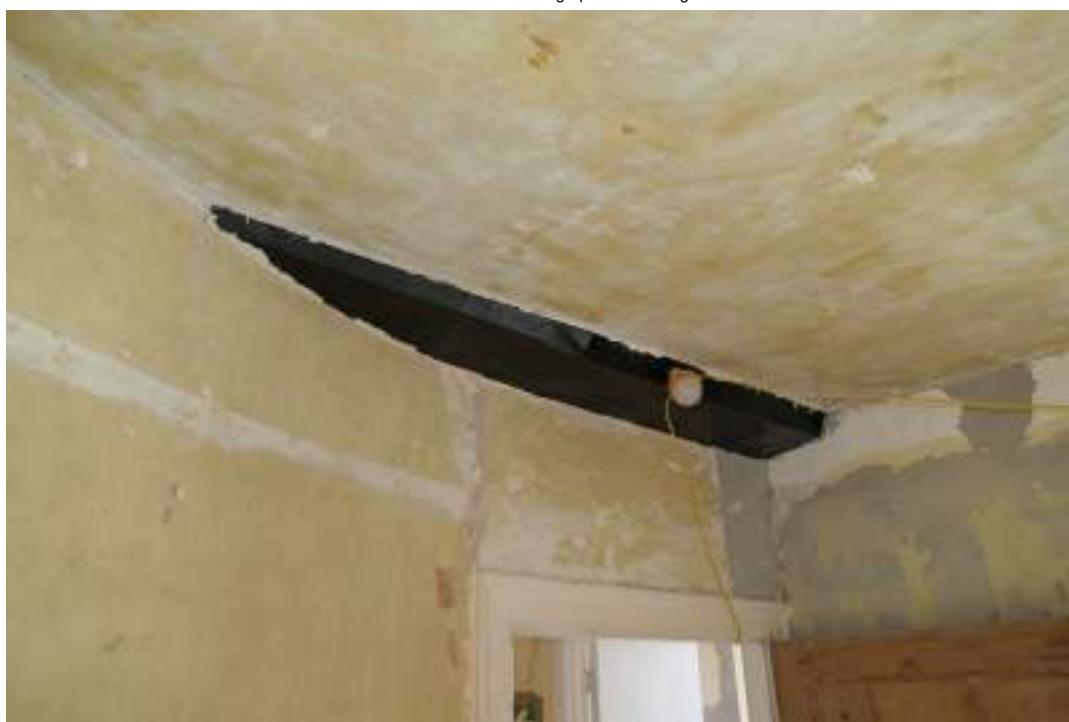
EEX62136\_Photograph\_187  
Detail of exposed chamfered binding in ceiling of bedroom 2. Photograph taken facing south-east.

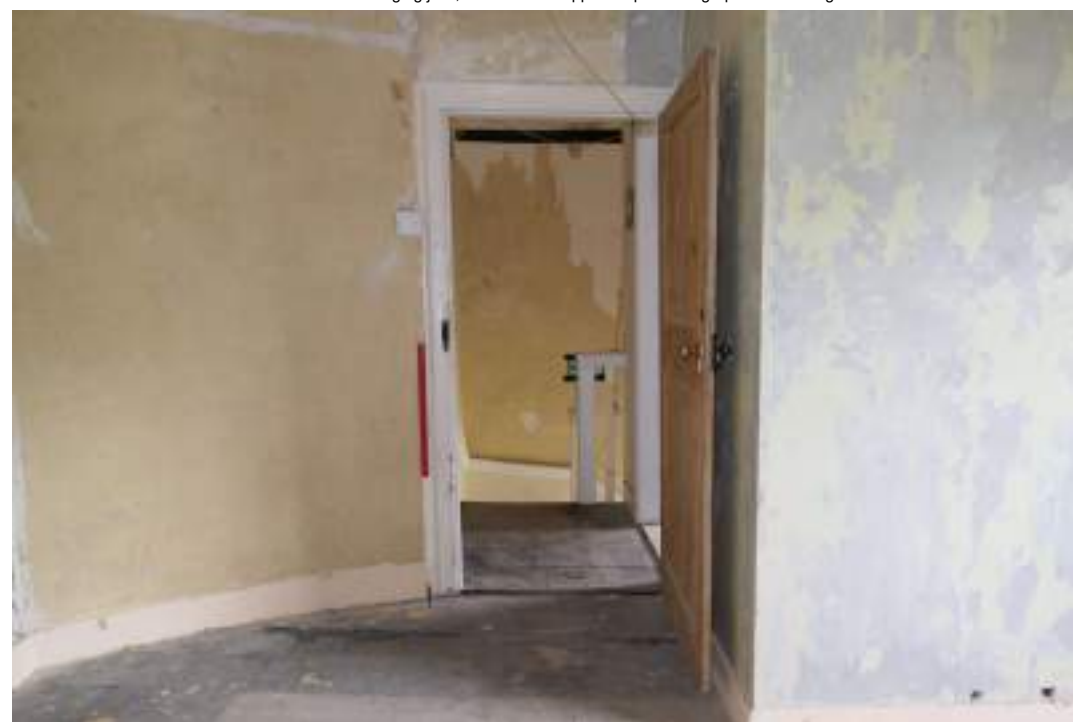
EEX62136\_Photograph\_188  
Detail of door in north-eastern wall of bedroom 2. Photograph taken facing north-east.

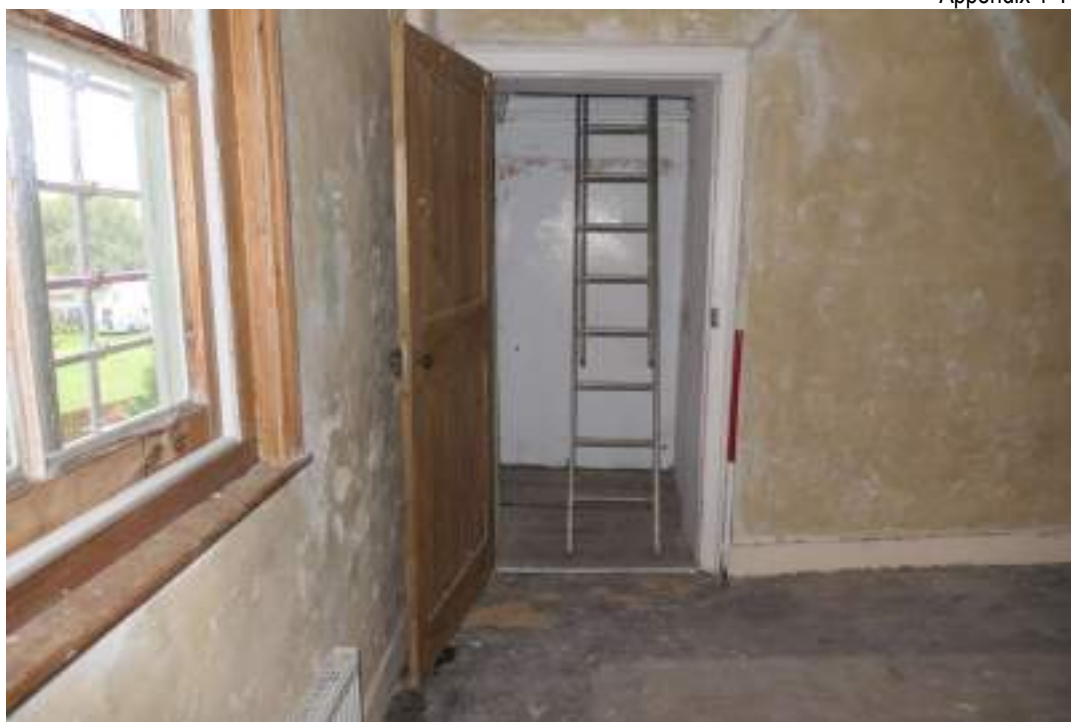
EEX62136\_Photograph\_189  
Detail of door to loft access in bedroom 2. Photograph taken facing south-west.
