**CAT Report 2267  
Issued May 2026**

**Historic building recording and archaeological  
excavation at Dorewards Hall, The Chase, Bocking,  
Essex, CM7 5LS**

**October 2025 and March 2026**

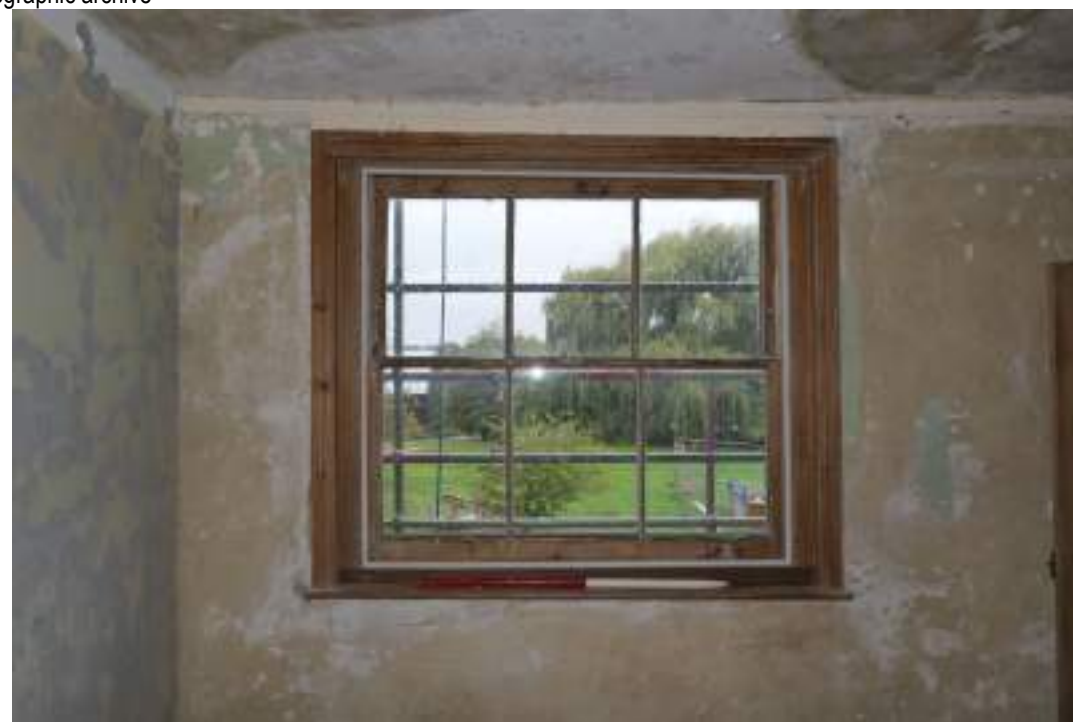
EEX62136\_Photograph\_190  
Detail of window in south-eastern wall of bedroom 2. Photograph taken facing south-east.

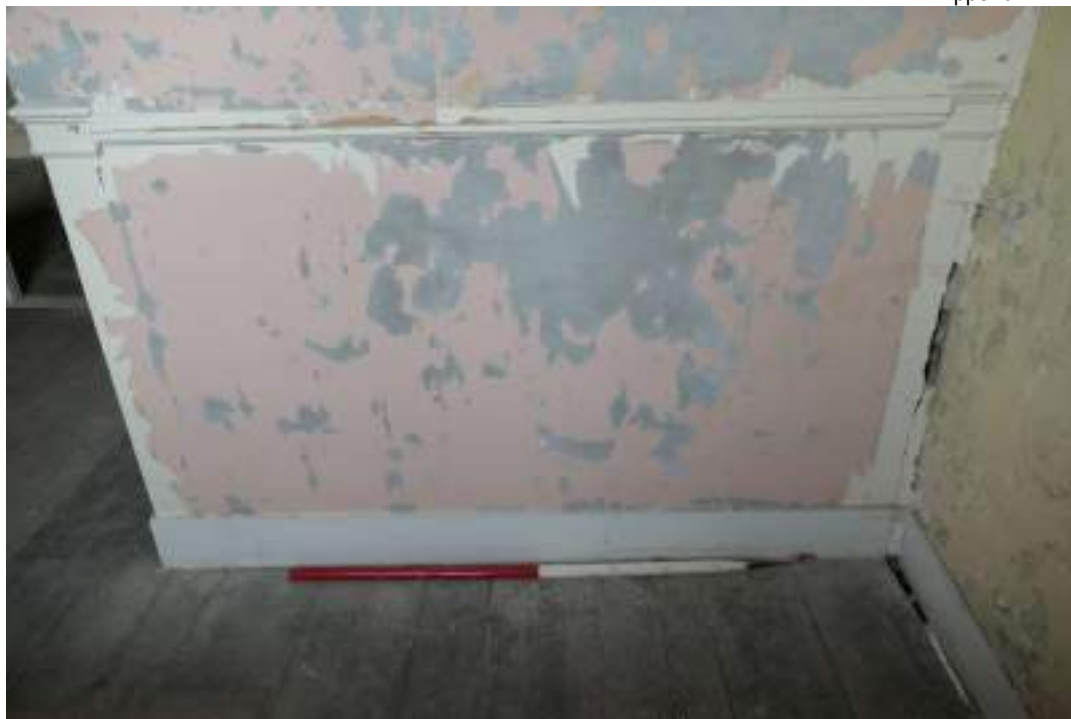
EEX62136\_Photograph\_193  
Detail of stair baultrade incorporated in to wall in bedroom 3. Photograph taken facing north-west.

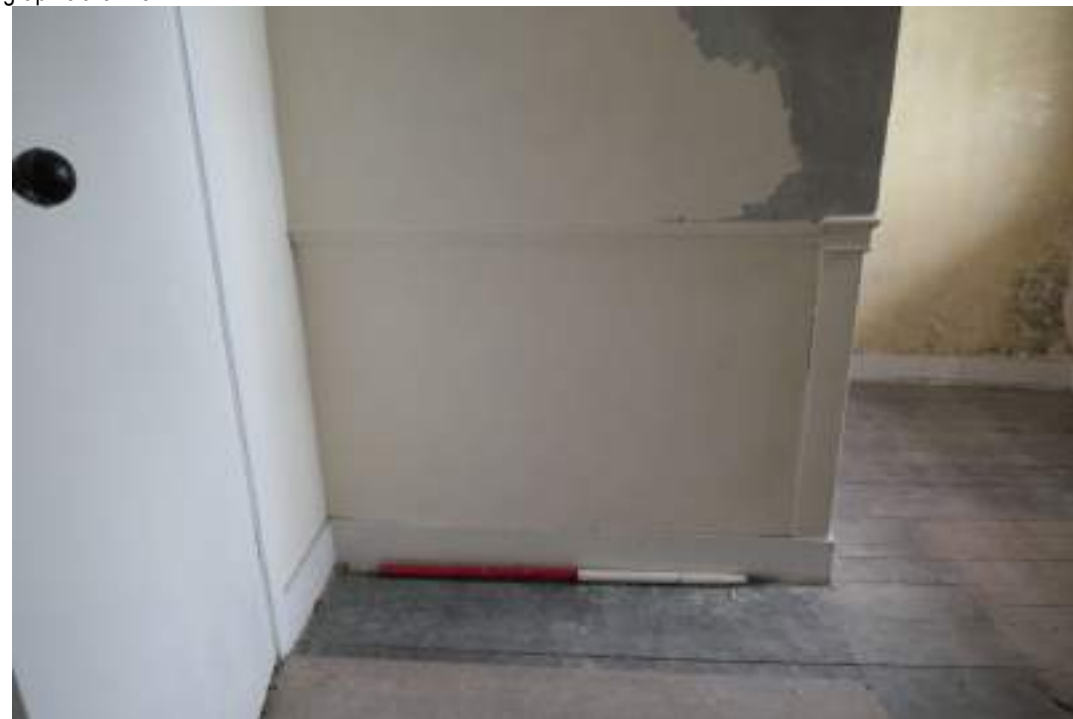
EEX62136\_Photograph\_194  
Detail of stair balustrade incorporated in to wall in bedroom 3. Photograph taken facing north-east.

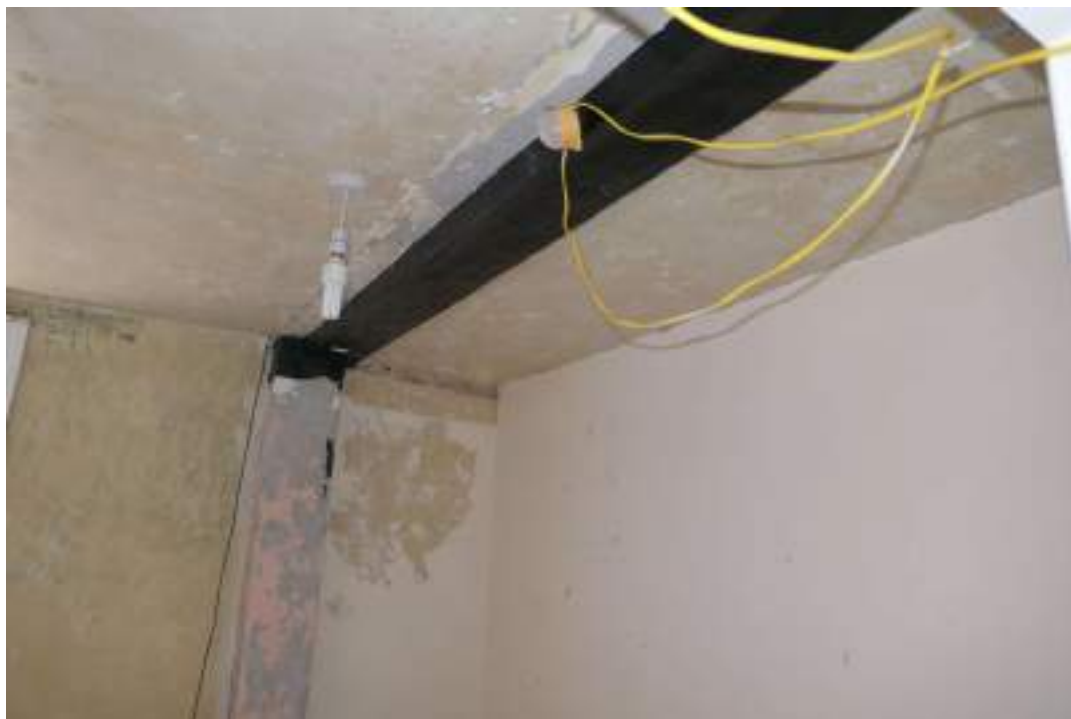
EEX62136\_Photograph\_195  
Detail of exposed square beam in ceiling of bedroom 3. Photograph taken facing south.

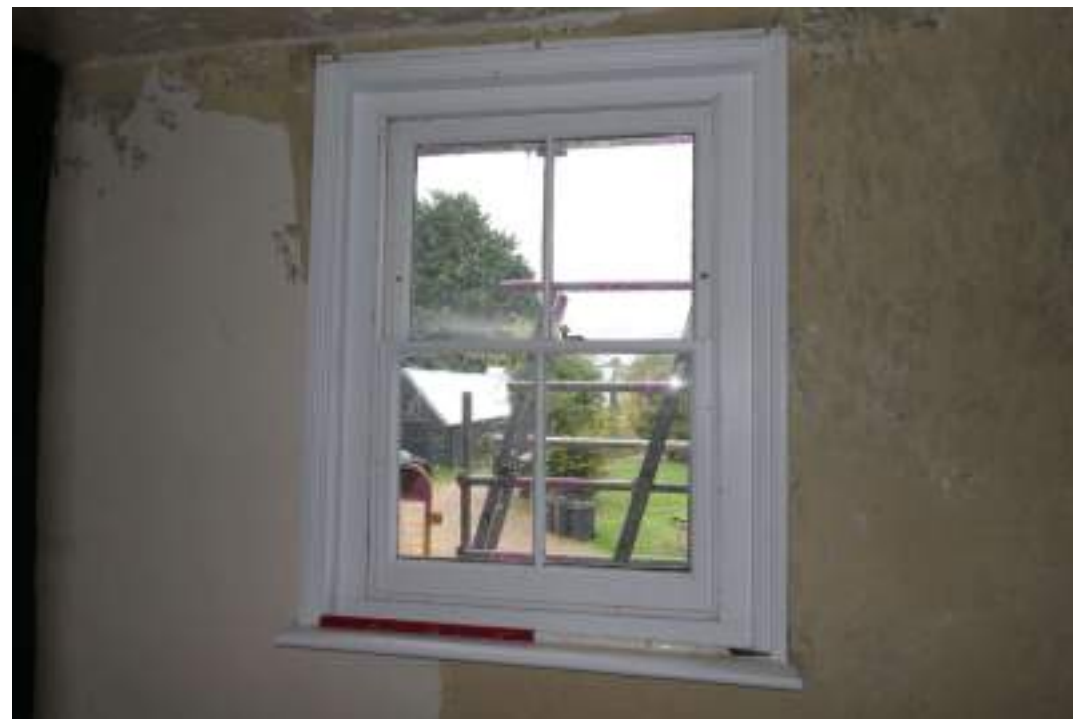
EEX62136\_Photograph\_196  
Detail of window in south-eastern wall of bedroom 3. Photograph taken facing east south-east.

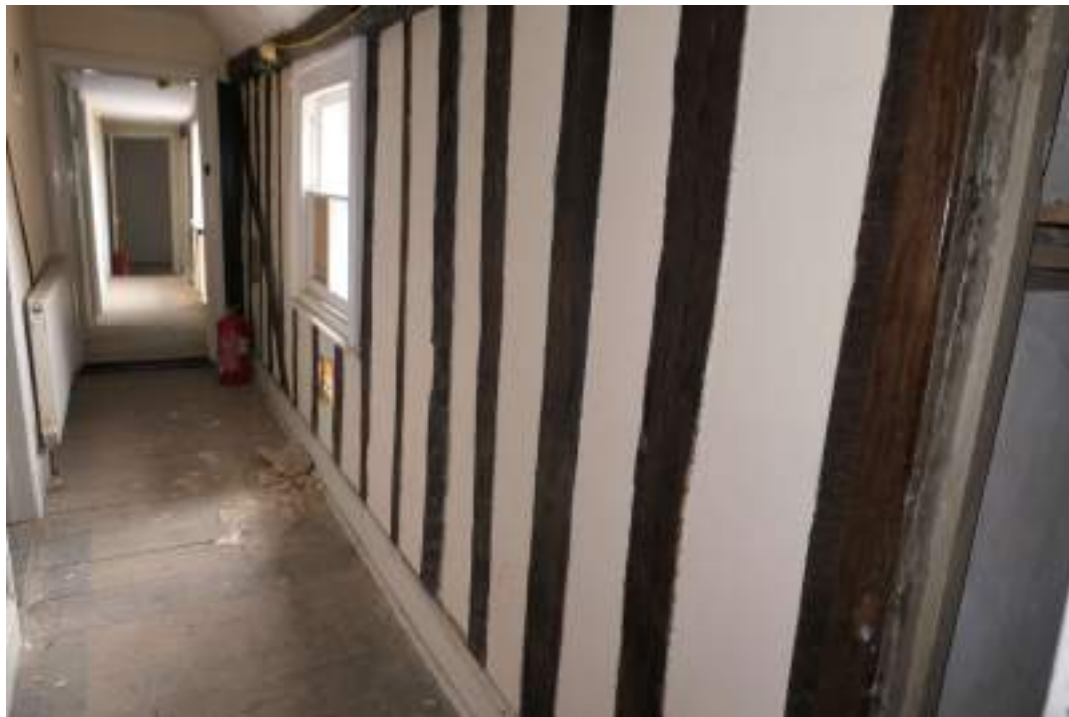
EEX62136\_PhotoGraph\_199  
Detail of exposed timber-framing in south-eastern wall of corridor 4. Photograph taken facing east.

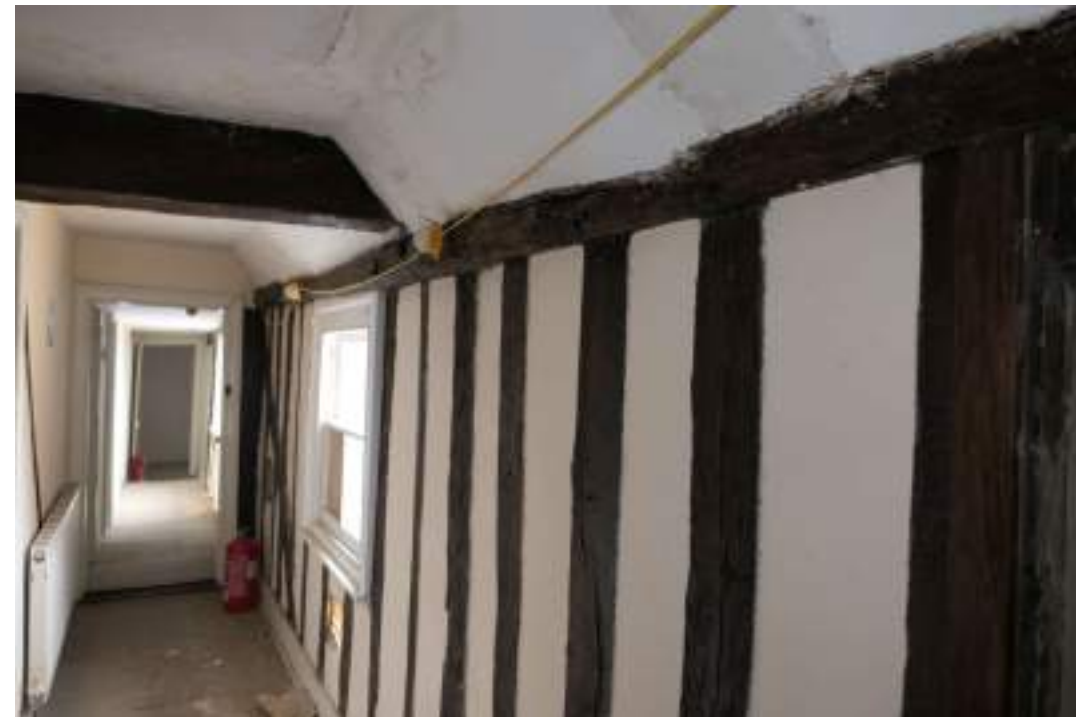
EEX62136\_PhotoGraph\_200  
Detail of exposed timber-framing in south-eastern wall of corridor 4. Photograph taken facing east.

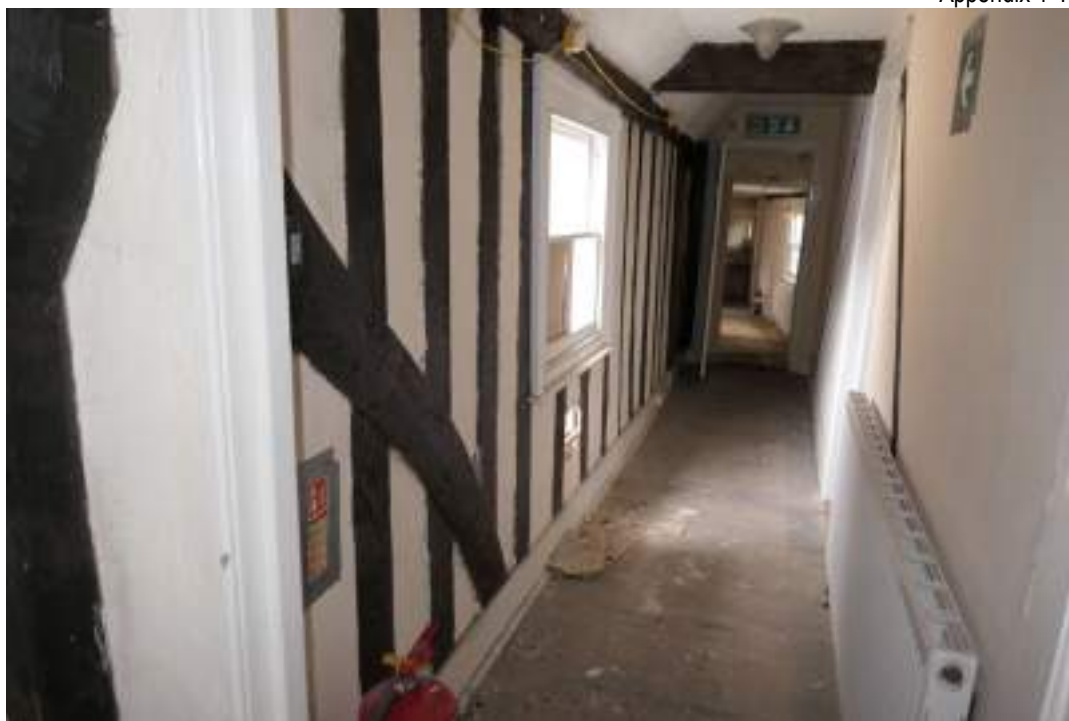
EEX62136\_Photograph\_201  
Detail of the exposed timber-framing in south-eastern wall of corridor 4. Photograph taken facing south.

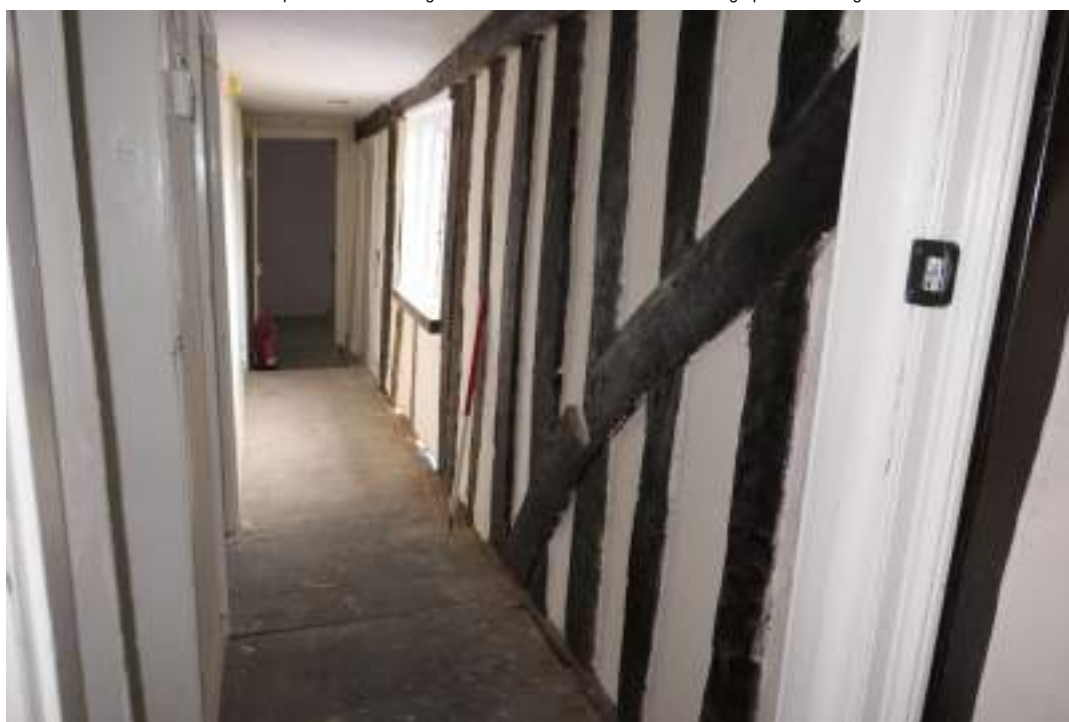
EEX62136\_Photograph\_203  
Detail of exposed timber-framing in south-eastern wall of corridor 4. Photograph taken facing east south-east.

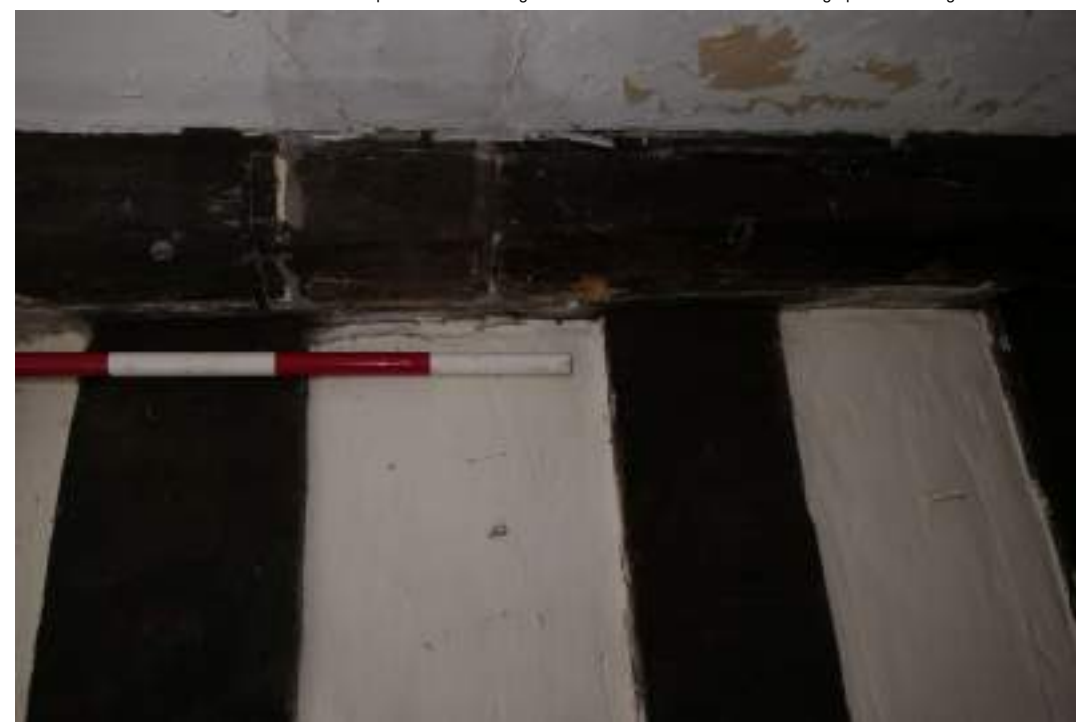
EEX62136\_Photograph\_204  
Detail of scarf-joint in wall-plate in south-eastern wall of corridor 4. Photograph taken facing south-east.

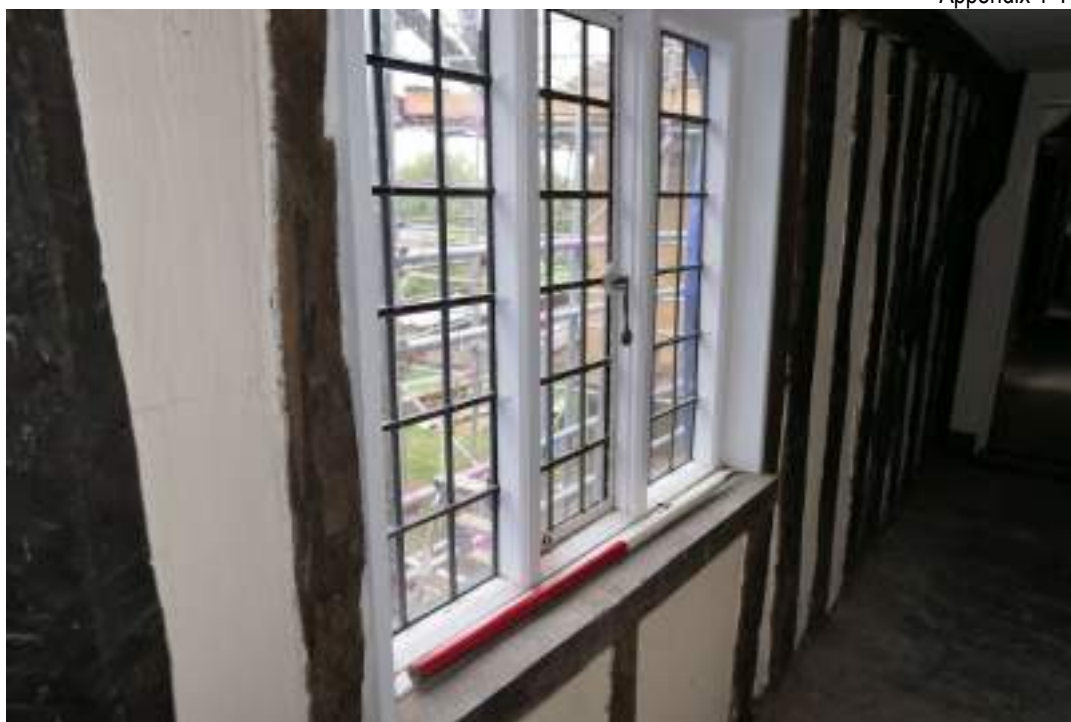
EEX62136\_Photograph\_205  
Detail of window in south-eastern wall of corridor 4. Photograph taken facing south.

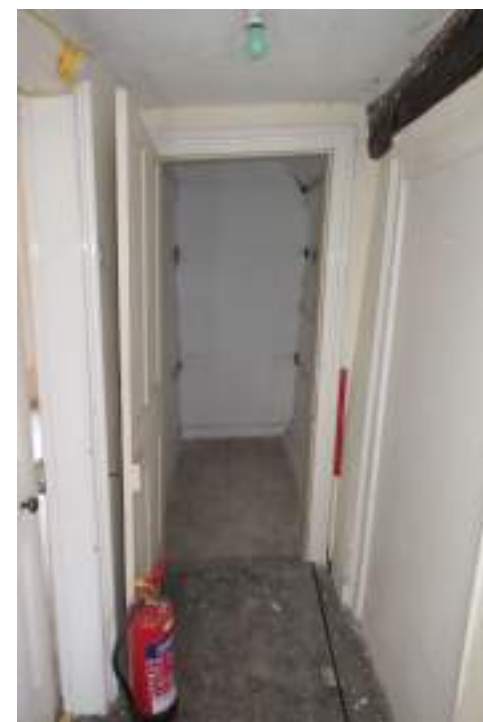
EEX62136\_Photograph\_206  
Detail of door to cupboard in north-eastern wall of corridor 4. Photograph taken facing north-east.

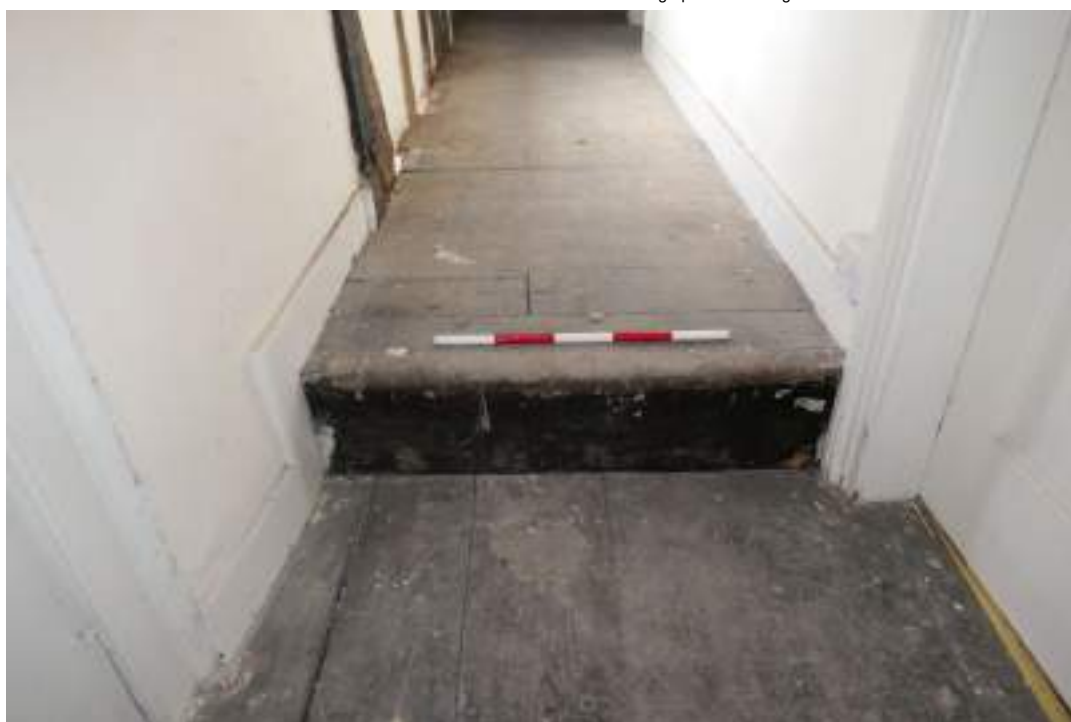
EEX62136\_Photograph\_207  
Detail of step in corridor 4. Photograph taken facing south-west.

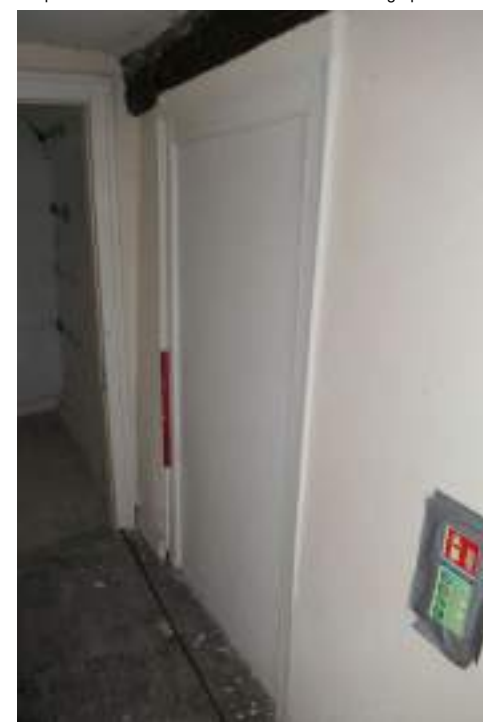
EEX62136\_Photograph\_208  
Detail of blocked doorway in south-eastern wall of corridor 4. Photograph taken facing east south-east.

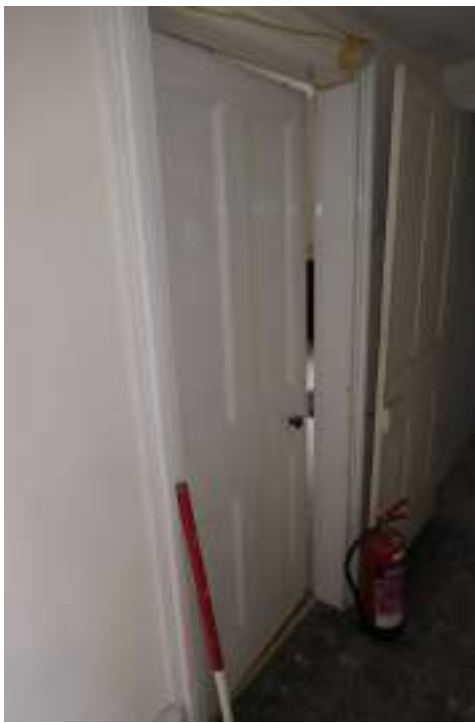
EEX62136\_Photograph\_209  
Detail of doorway in north-western wall of corridor 4. Photograph taken facing north.

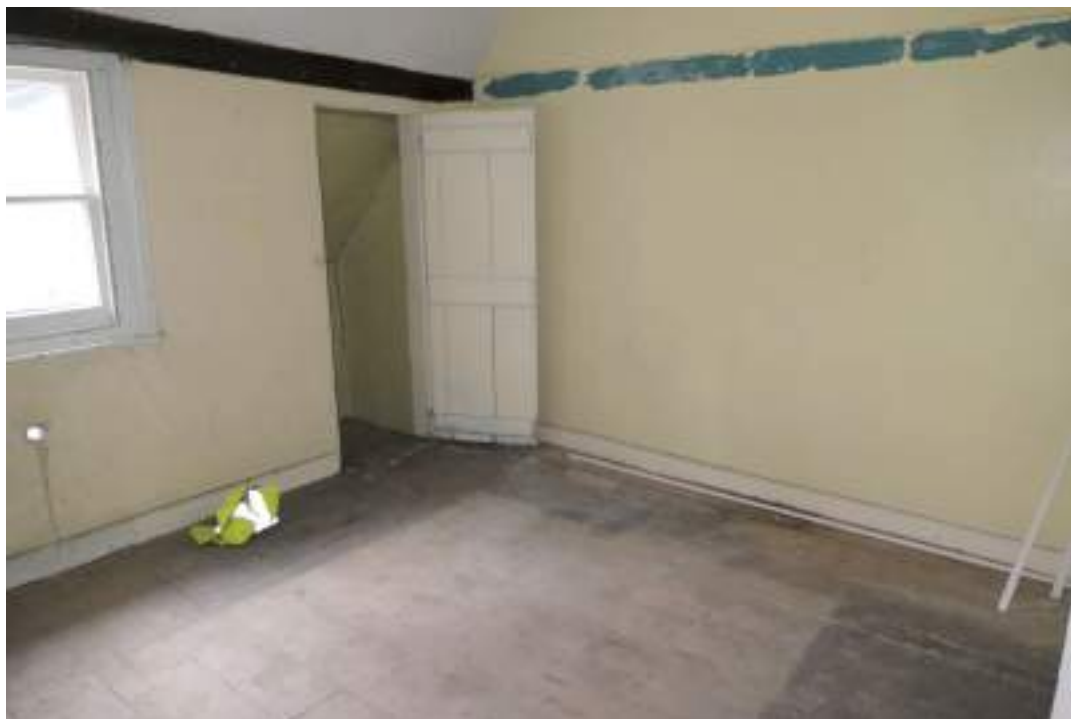
EEX62136\_Photograph\_218  
Detail of exposed beam in north-western wall of bedroom 6. Photograph taken facing north.

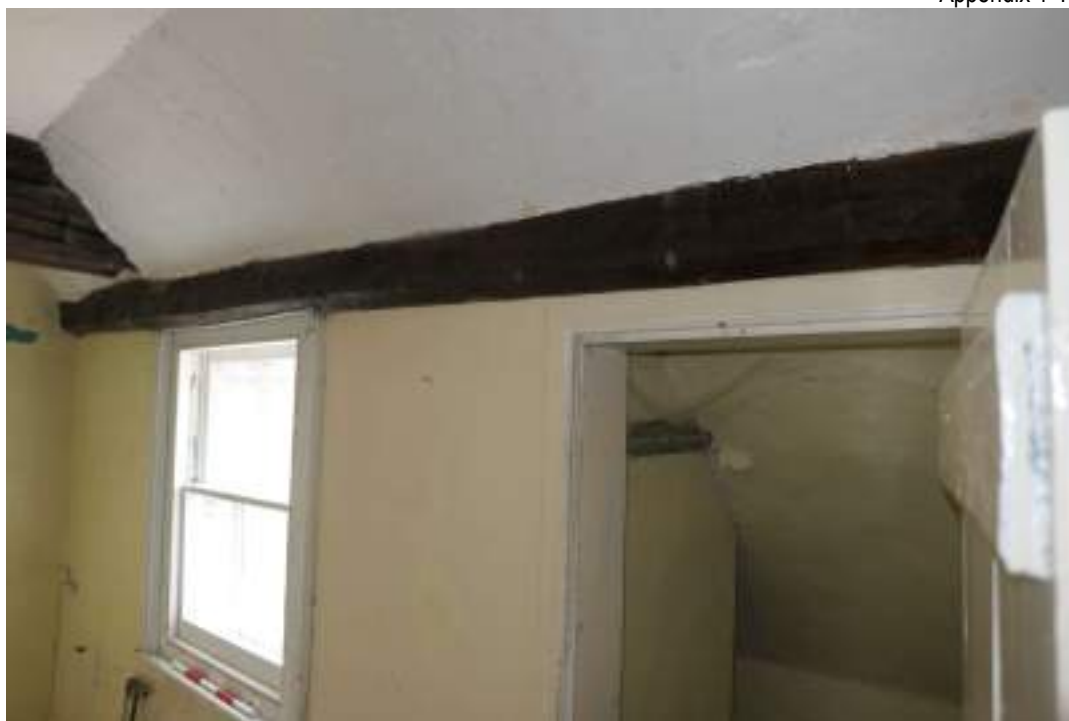
EEX62136\_Photograph\_224  
Detail of reused tie-beam in ceiling of bedroom 5. Photograph taken facing south.

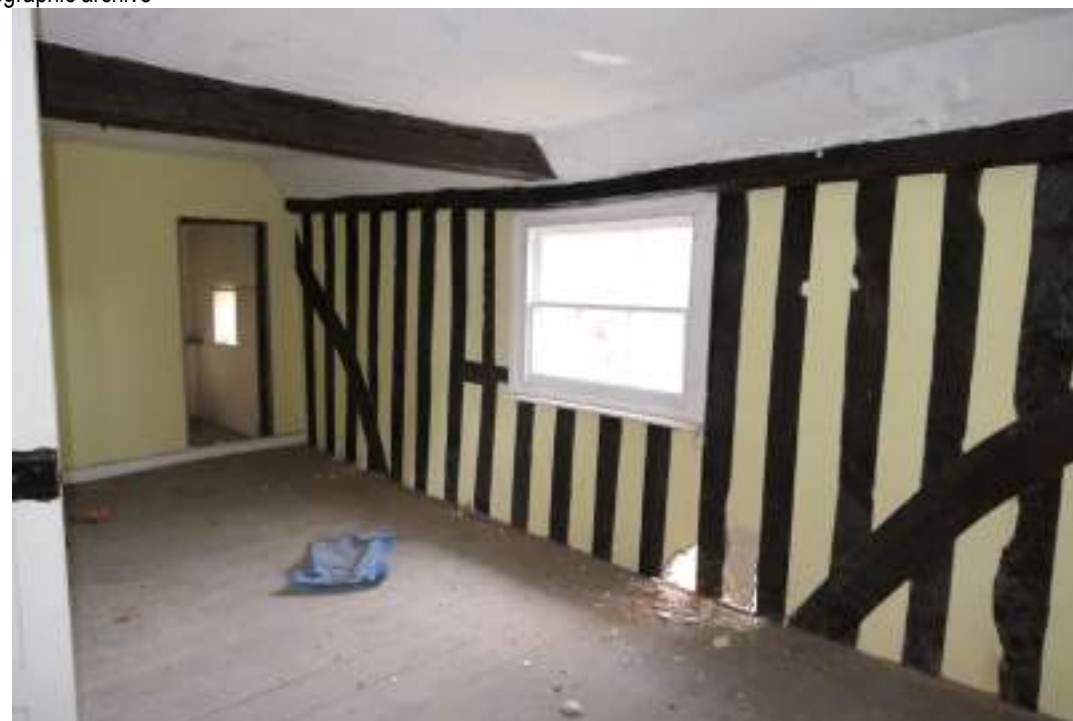
EEX62136\_Photograph\_225  
Detail of exposed wall-plate in north-western wall of bedroom 5. Photograph taken facing west north-west.

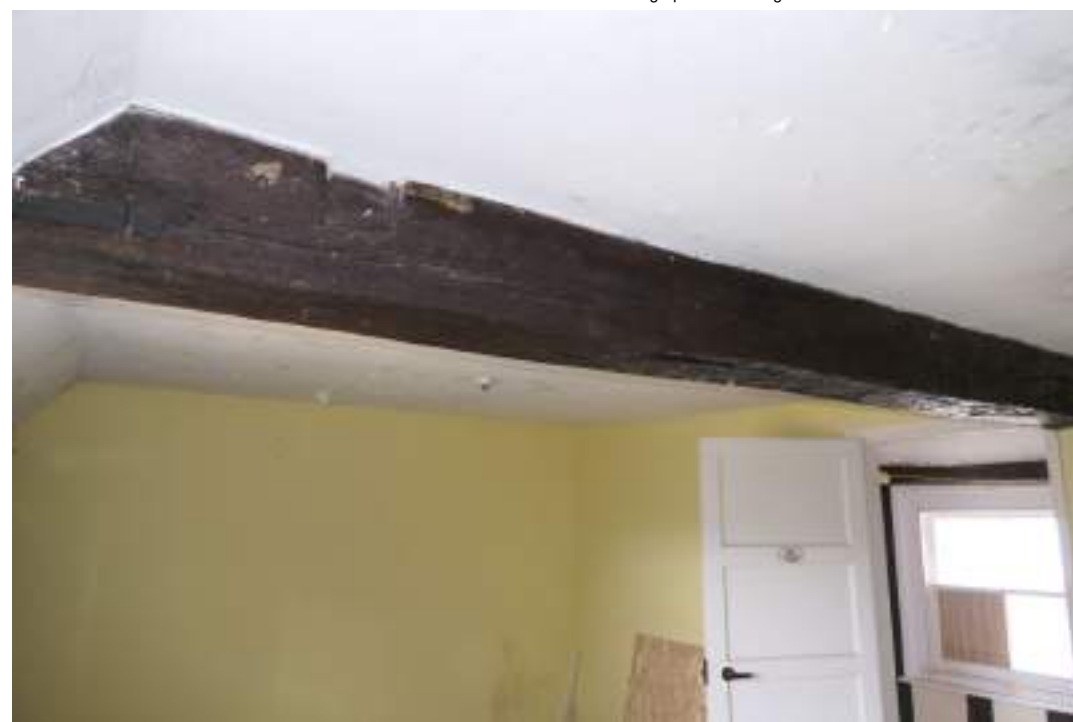
EEX62136\_Photograph\_231  
Detail of exposed timber-framing in north-western wall of bedroom 4. Photograph taken facing north.

The north-western wall of bedroom 4, located in range 5, has exposed timber-framing (Photograph 45). The framing is constructed from hand-sawn timbers and comprises a number of studs with concealed curved tension bracing. Adjacent to a six-light sash window, a central rail interrupts one of the studs, suggesting that the window is a replacement for an original mullion window (Photograph 45). A scarf-joint, in the wall-plate, has been reinforced with a metal plate, obscuring the typology of the joint (Photograph 46). A large tie-beam is present in the centre of the ceiling, which displays evidence it has been reused and has a metal strap added. A small cupboard space in the north-western wall of bedroom 4 was uncovered during the renovation works, adjacent to a fireplace opening which had also been sealed.

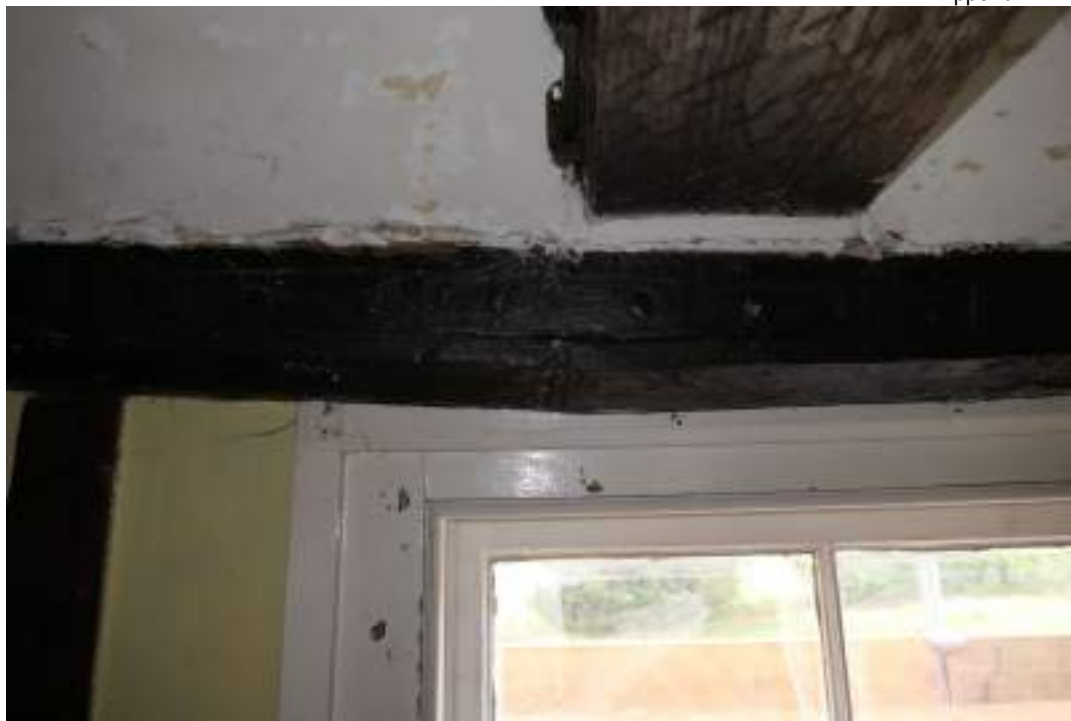
EEX62136\_Photograph\_232  
Detail of exposed tie-beam in ceiling of bedroom 4. Photograph taken facing east.

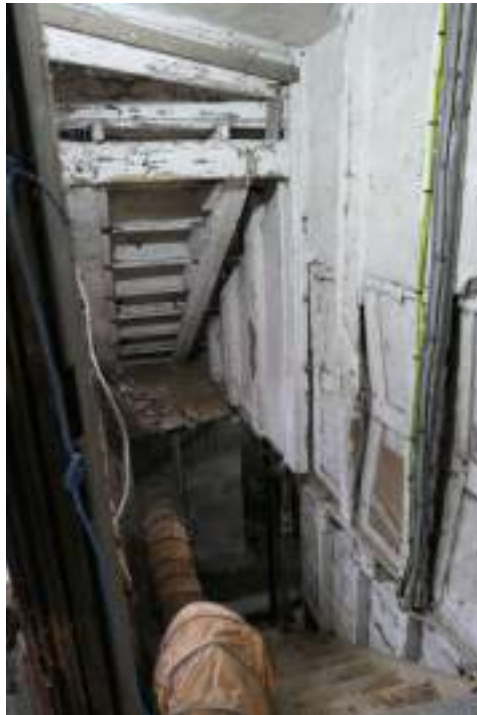
EEX62136\_PhotoGraph\_238  
Detail of jowled post in south-eastern wall of corridor 4. Photograph taken facing south.

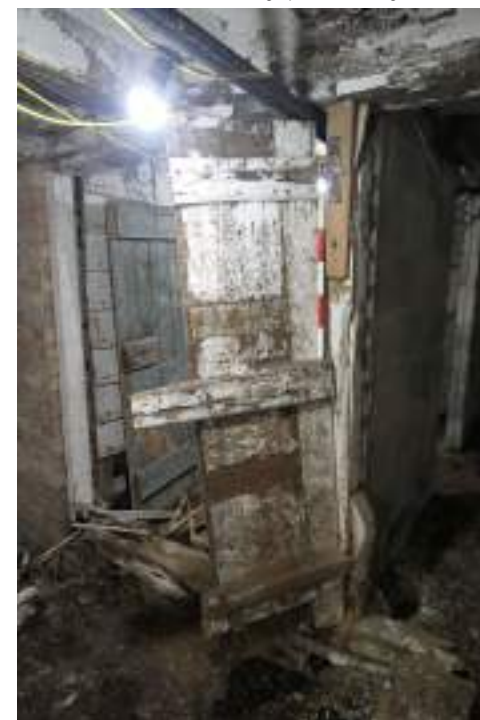
EEX62136\_PhotoGraph\_243  
Detail of reused sill-beam in basement. Photograph taken facing south.

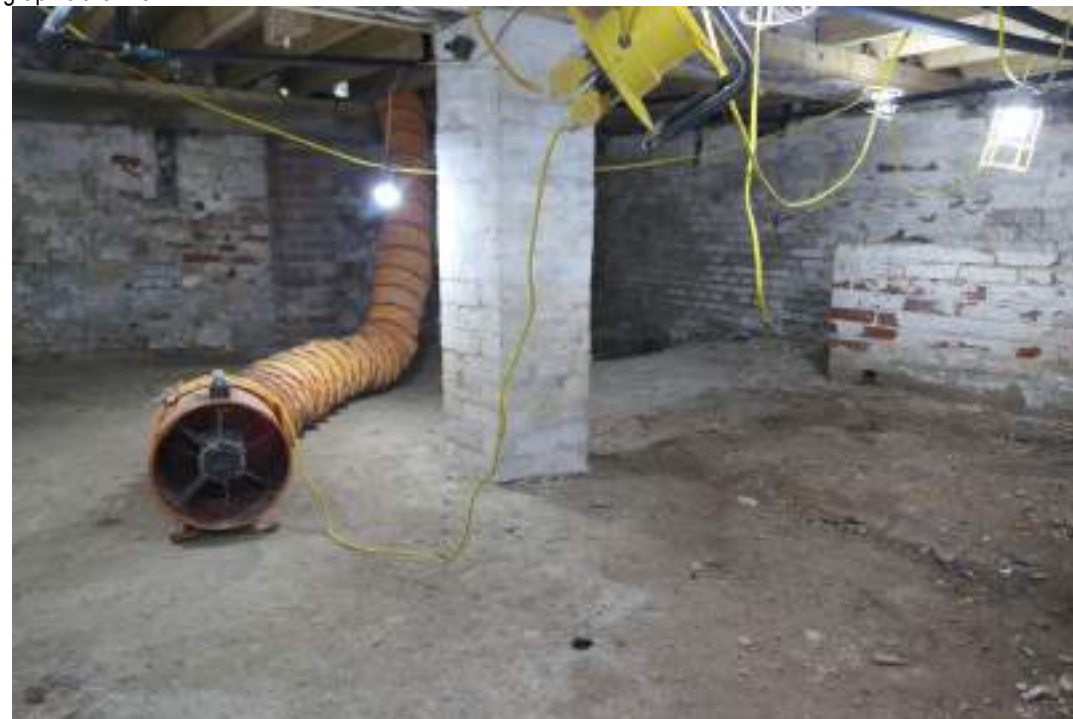
EEX62136\_Photograph\_250  
Interior of basement. Photograph taken facing west.

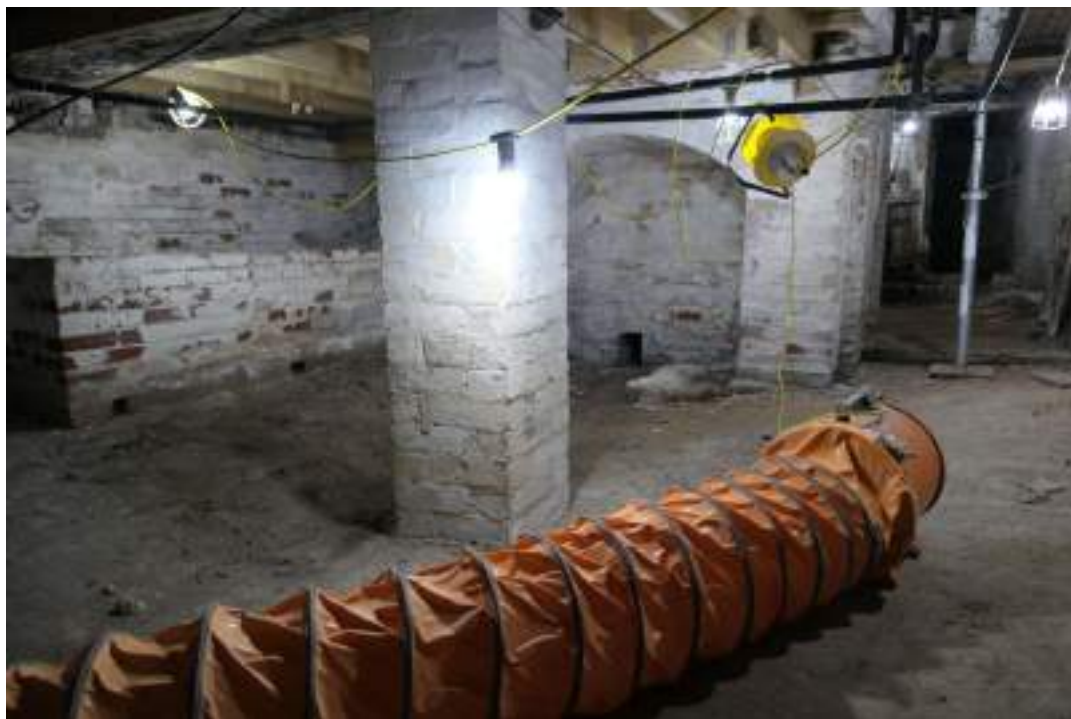
EEX62136\_Photograph\_251  
Interior of basement. Photograph taken facing north.

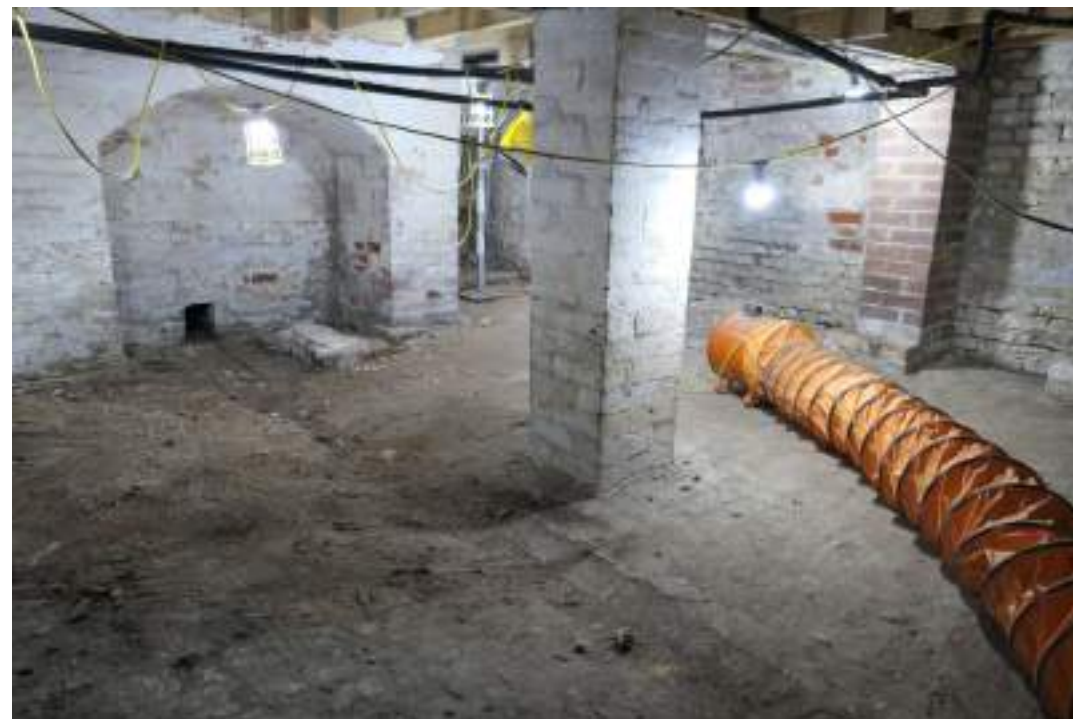
EEX62136\_Photograph\_252  
Interior of basement. Photograph taken facing east.

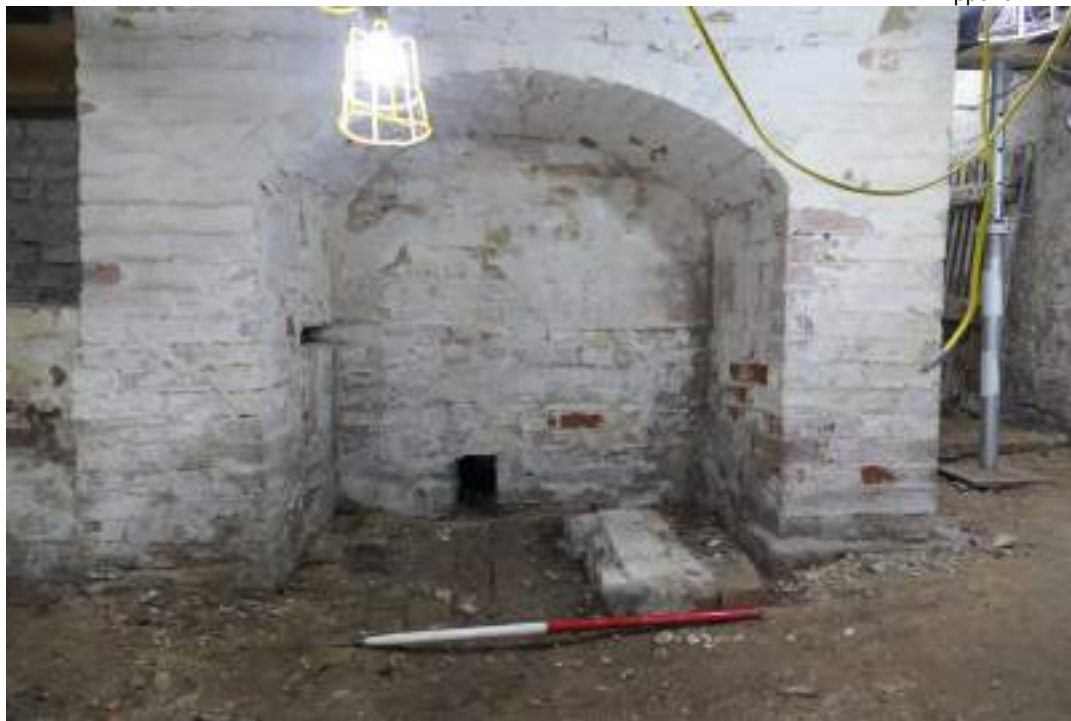
EEX62136\_Photograph\_253  
Detail of brick arch in basement. Photograph taken facing north-east.

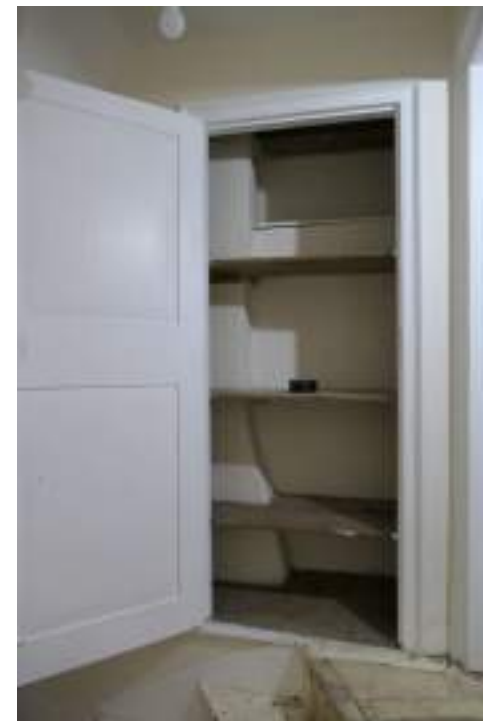
EEX62136\_Photograph\_254  
Interior of cupboard in corridor 3. Photograph taken facing north north-west.

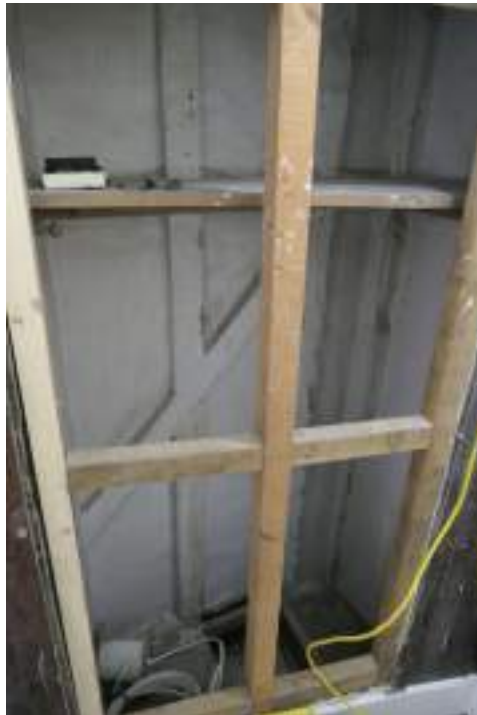
EEX62136\_Photograph\_255  
Detail of hidden alcove in south-eastern wall of corridor 4. Photograph taken facing south-east.

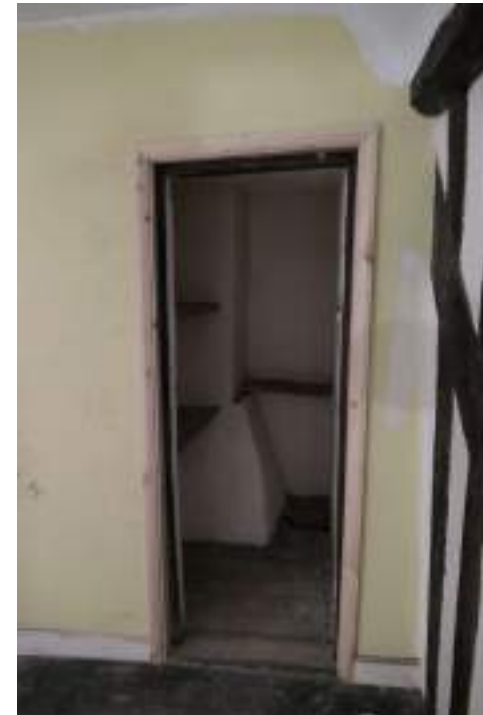
EEX62136\_Photograph\_256  
Detail of hidden alcove in bedroom 4. Photograph taken facing south-west.

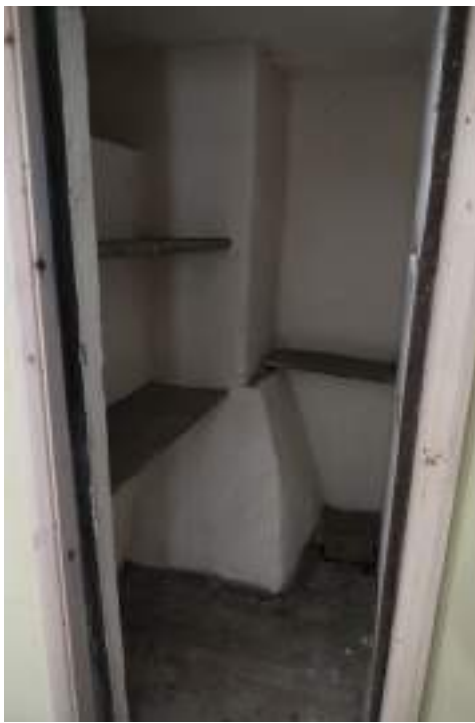
EEX62136\_Photograph\_257  
Detail of hidden alcove in bedroom 4. Photograph taken facing south-west.

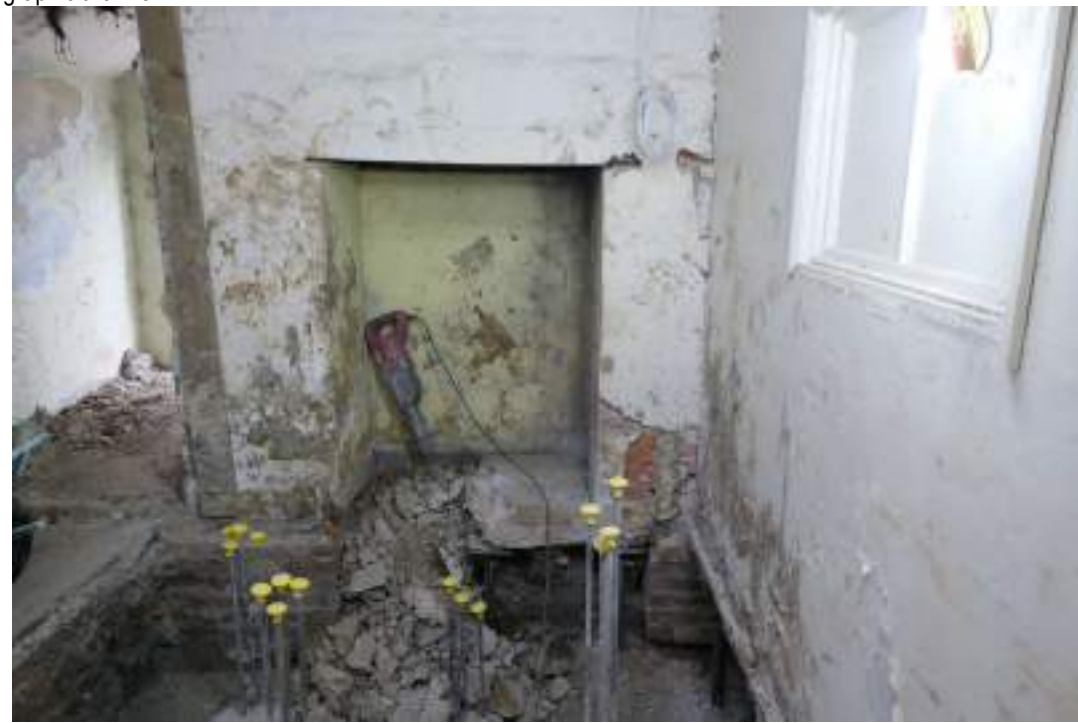
EEX62136\_Photograph\_258  
Detail of fireplace in spare room 1 during reinforcement works. Photograph taken facing north-east.

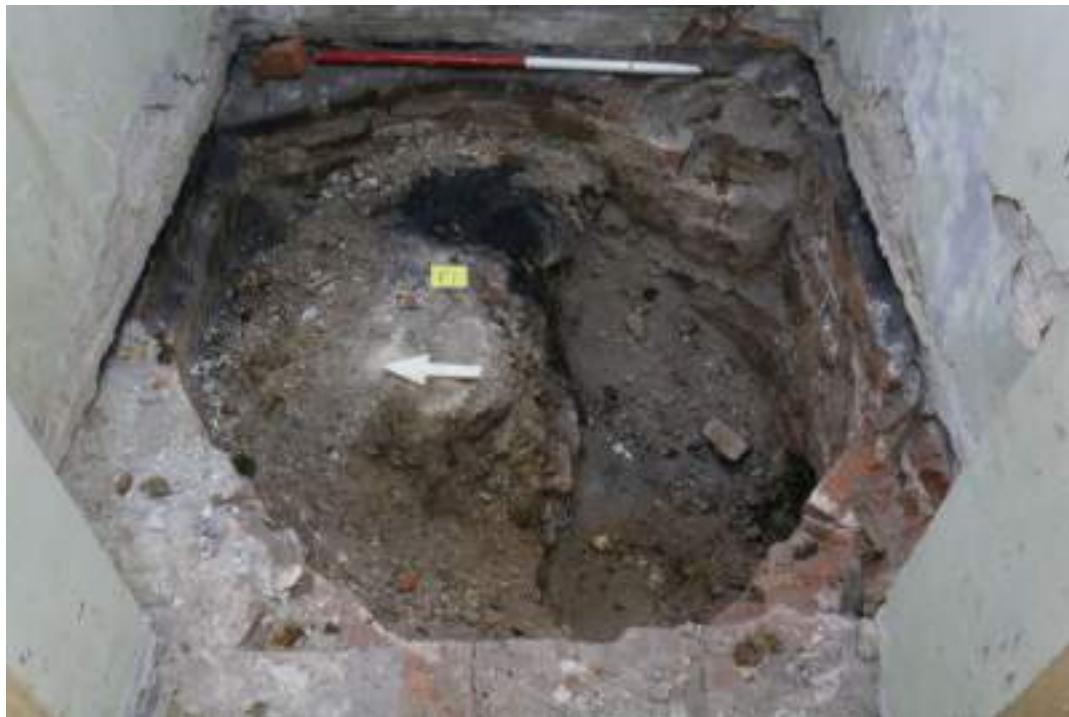
EEX62137\_Photograph\_001  
Well F1 pre-excitation. Photograph taken facing east.

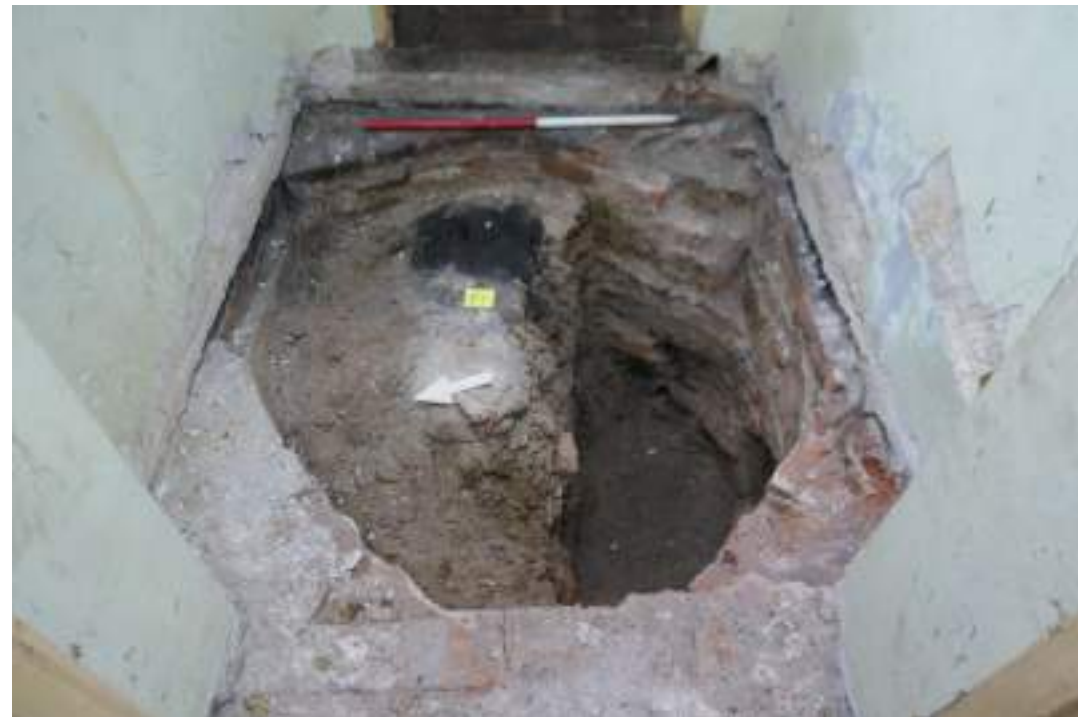
EEX62137\_Photograph\_002  
Well F1. Photograph taken facing east south-east.
