**CAT Report 2267  
Issued May 2026**

**Historic building recording and archaeological  
excavation at Dorewards Hall, The Chase, Bocking,  
Essex, CM7 5LS**

**October 2025 and March 2026**

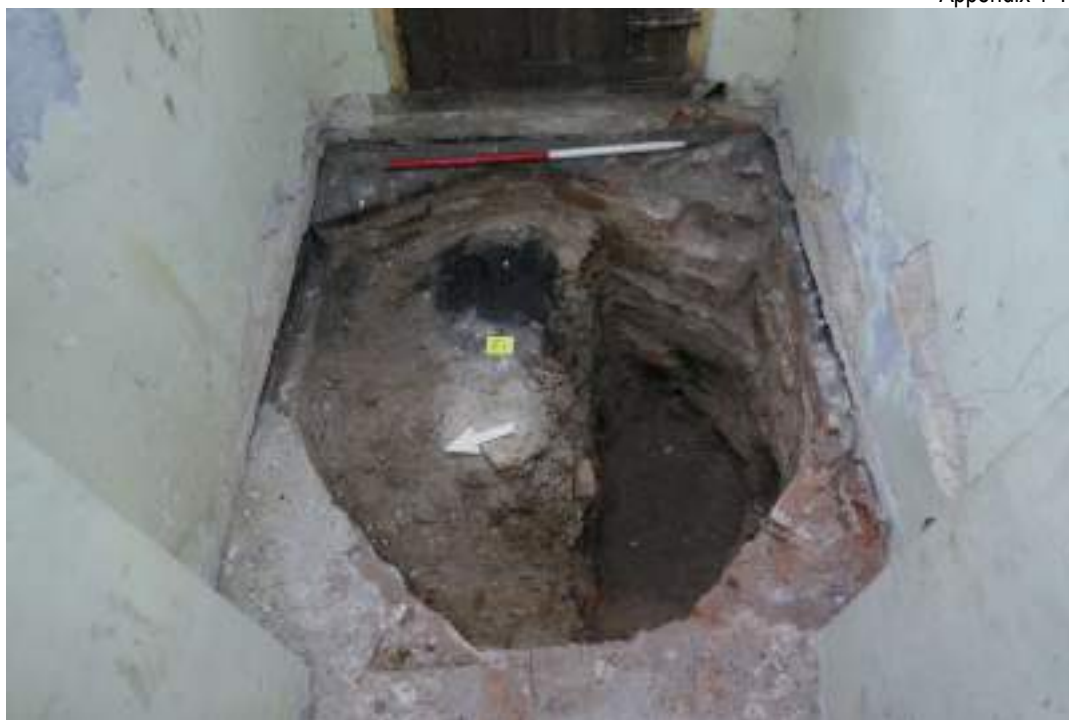
EEX62137\_Photograph\_003  
Well F1. Photograph taken facing east south-east.

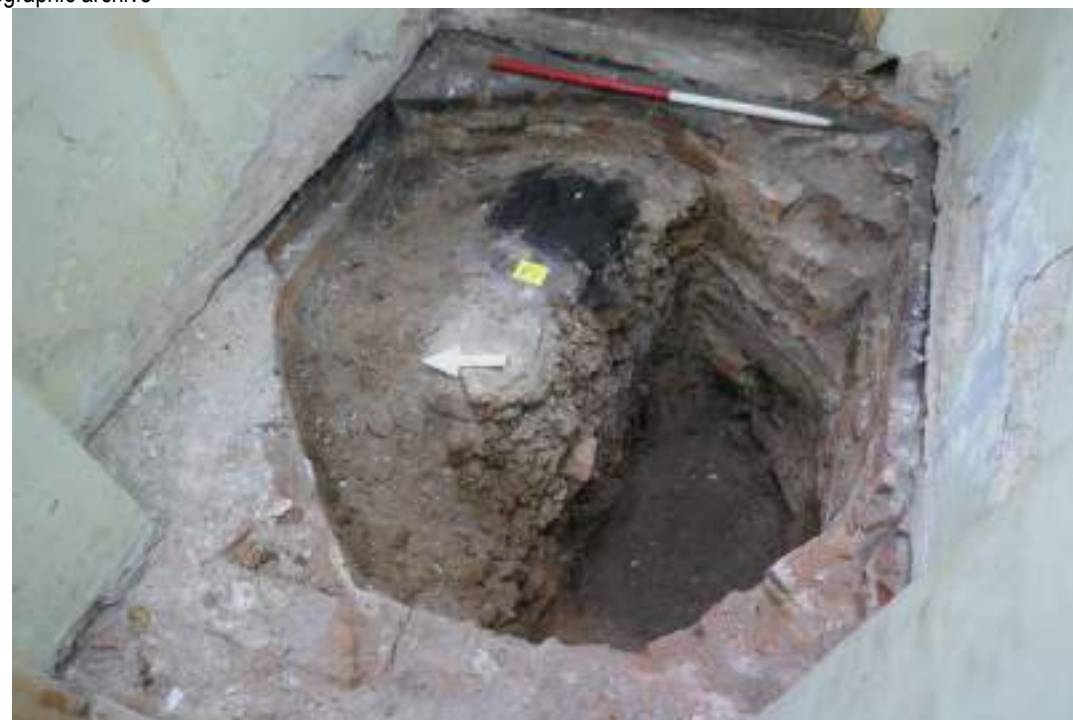
EEX62137\_Photograph\_004  
Well F1. Photograph taken facing east.

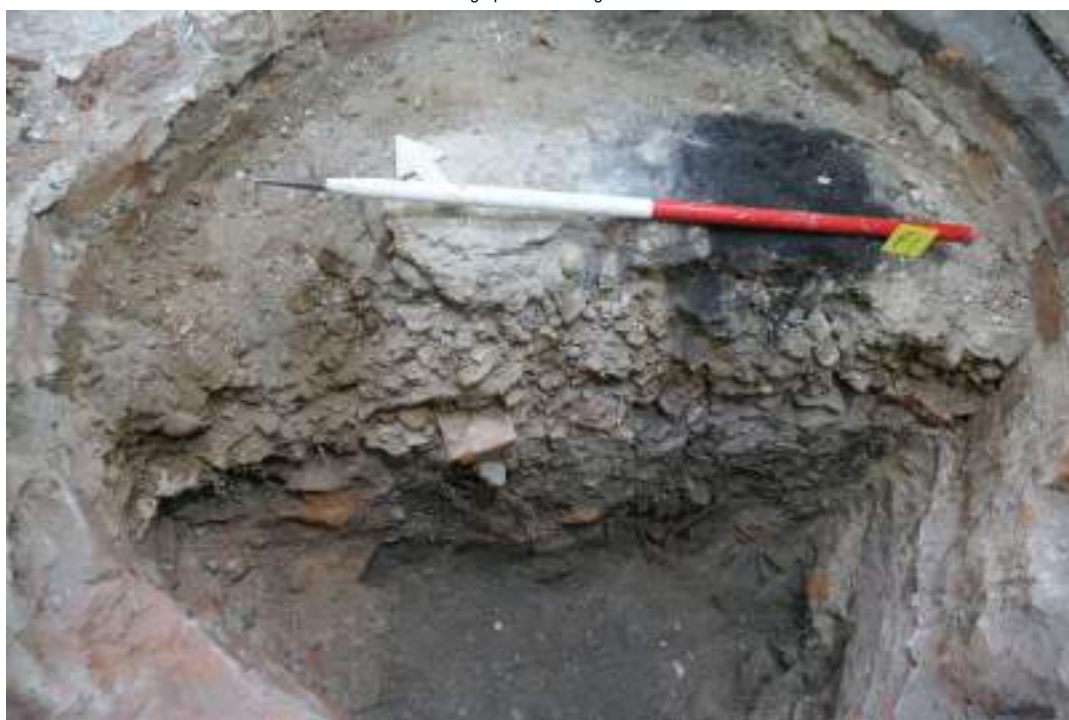
EEX62137\_Photograph\_005  
Well F1. Photograph taken facing north-east.

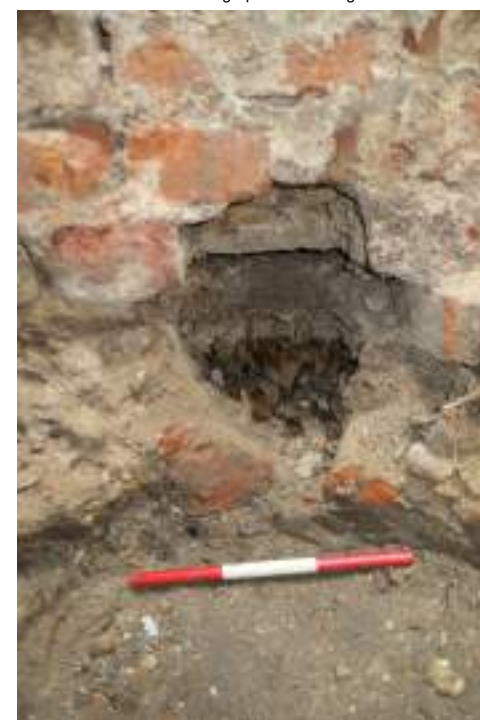
EEX62137\_Photograph\_006  
Detail of hole in brickwork of well F1. Photograph taken facing south-east.

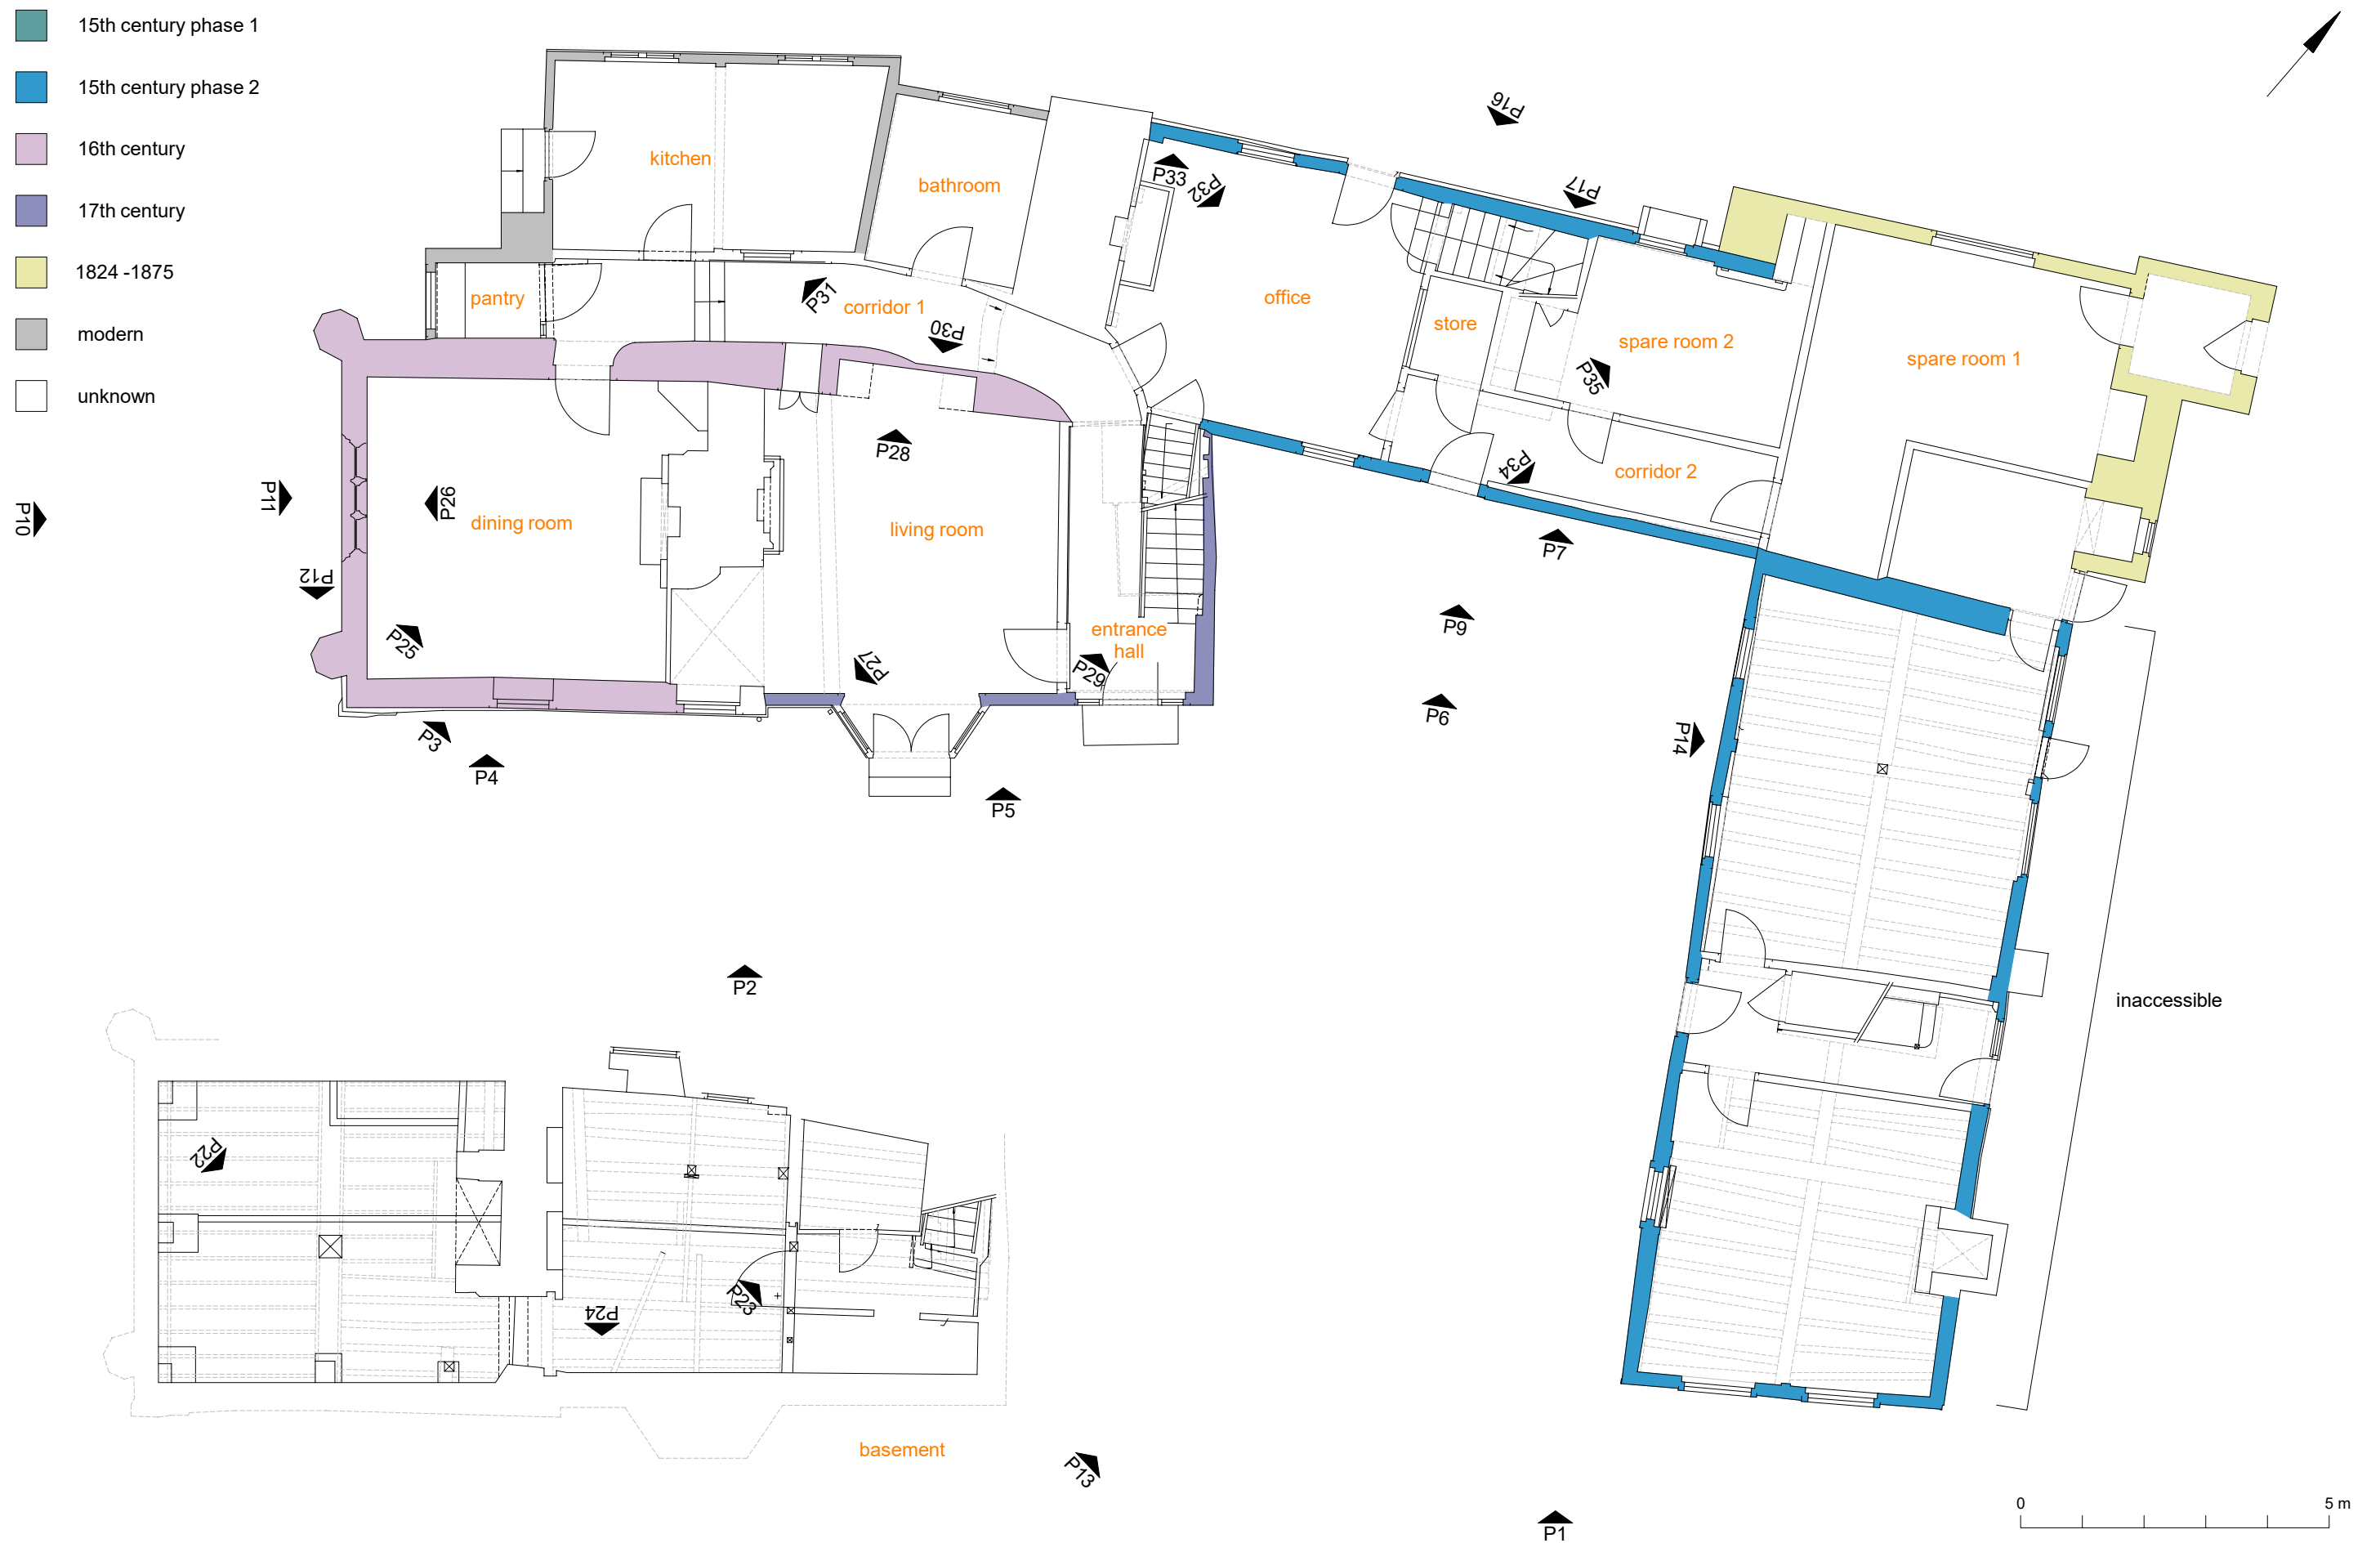
Fig 3 Ground floor and basement floor plans. Room names in orange. Location and direction of photographs reproduced in the text shown.

For locations of rooms, see Figs 2 and 3. Unless stated otherwise, the walls and ceilings of Dorewards Hall are plastered and painted and the floors are exposed floorboards.

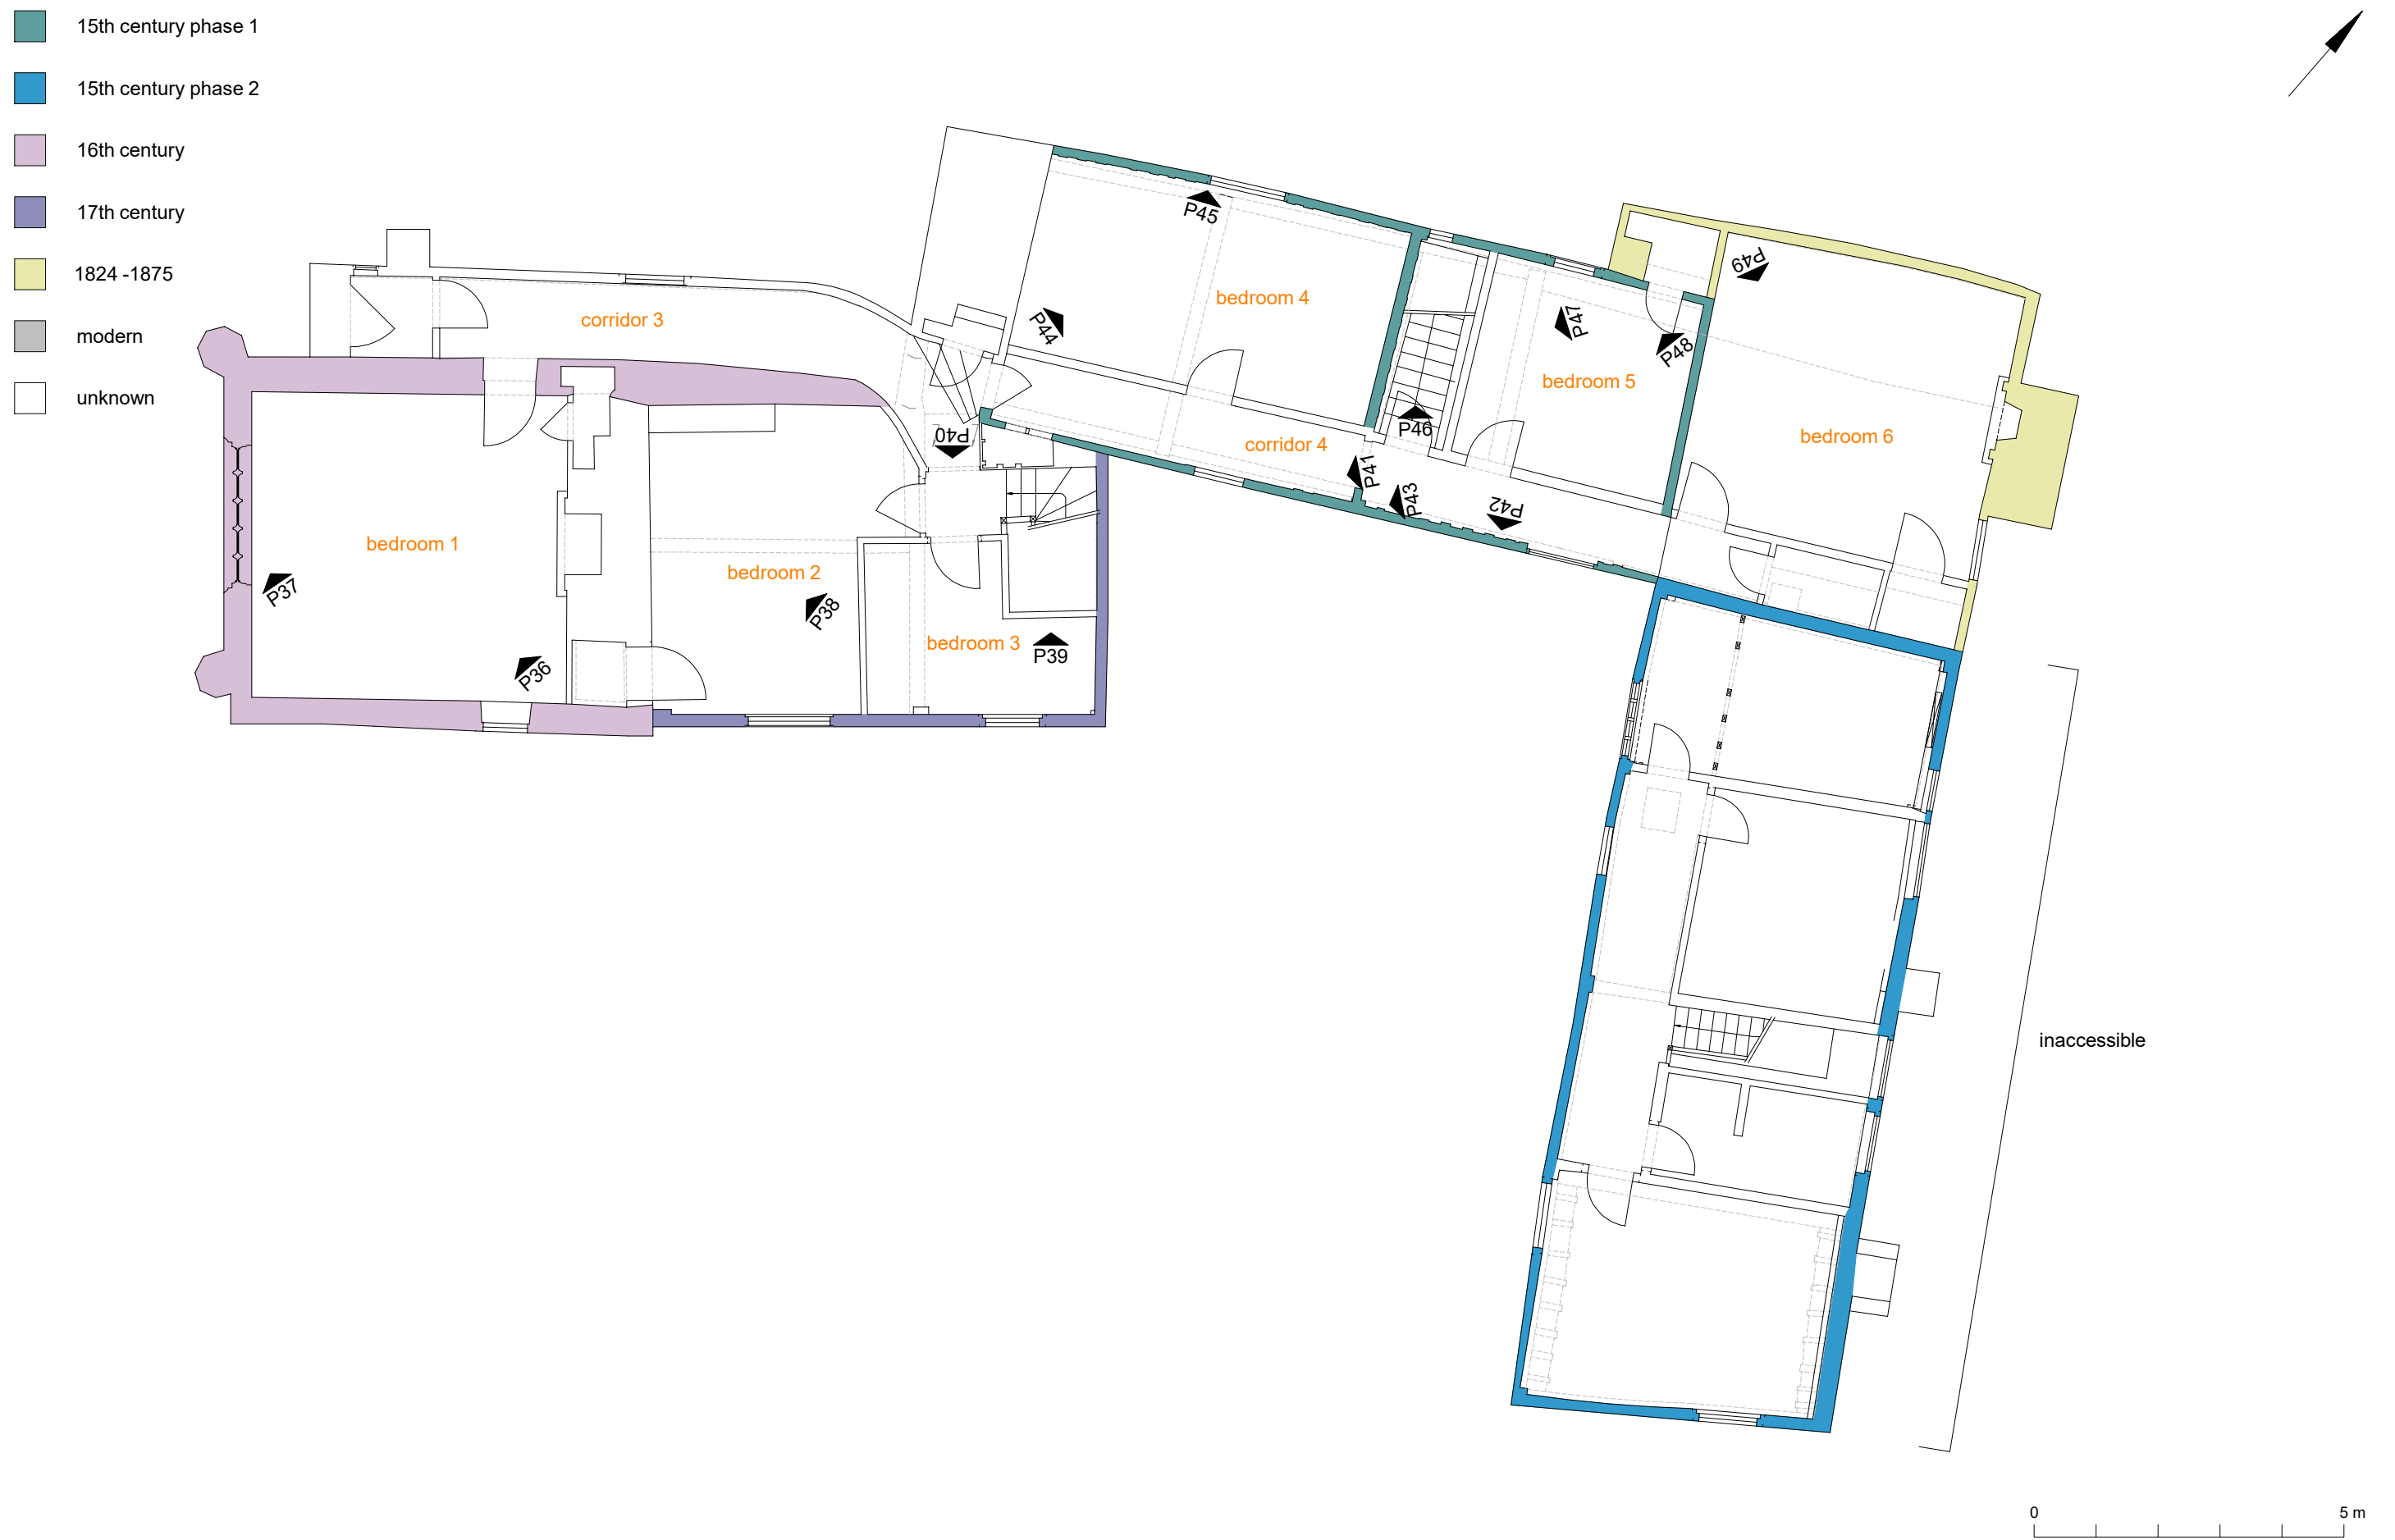
Fig 4 First floor plans. Room names in orange. Location and direction of photographs reproduced in the text shown.
